Engine malfunction involving Cessna 208B, VH-LNH

near Kununurra Airport, Western Australia, 8 August 2015

ATSB Transport Safety Report
Aviation Occurrence Investigation
AO-2015-094
Final – 27 May 2016

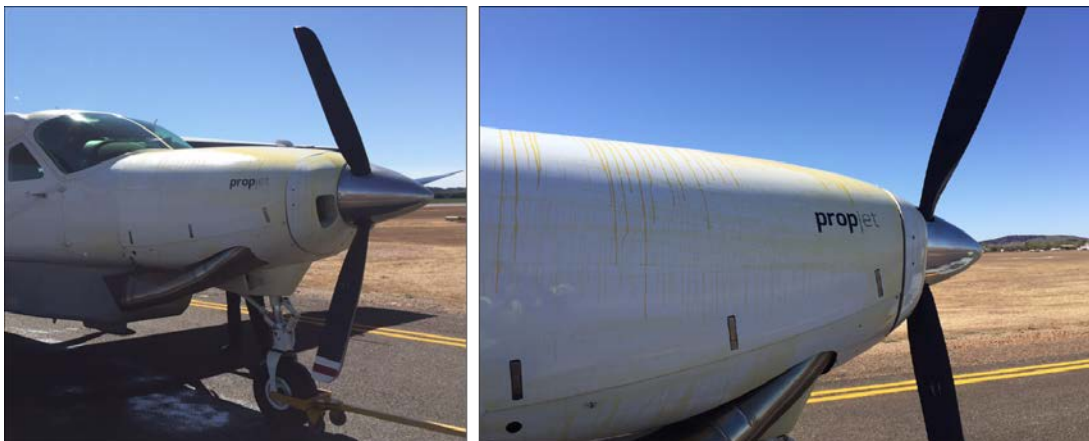
After exiting the runway and coming to a stop, the pilot completed the engine shut-down checks. No reaction was felt or heard when the pilot selected the propeller lever to the feather position as part of the shutdown procedure (normally, there was an audible change as the pitch of the propeller changed). After exiting the aircraft, the pilot found that the propeller was in the feather position, and had seized. The extent of oil loss was also apparent, with oil smeared over much of the forward fuselage, particularly the engine cowls and windscreen (Figure 1).

Figure 1: Photographs of VH-LNH after the aircraft had landed, with oil visible on the engine cowl and forward fuselage

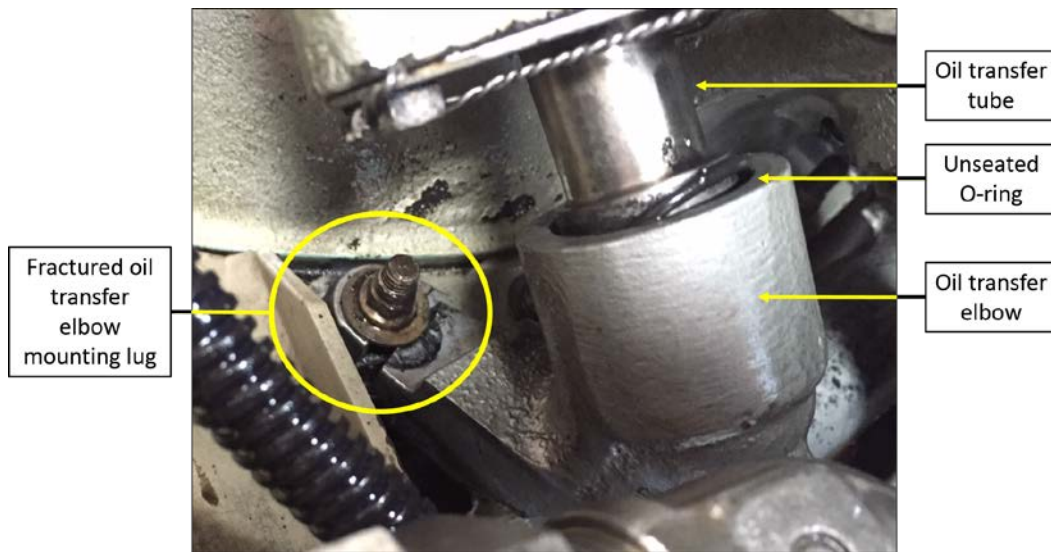
Subsequent on-site inspection of the engine by engineering staff revealed that an oil leak had developed at a join between the oil transfer elbow and oil transfer tube at the forward end of the engine. This assembly was part of a larger assembly that transferred oil under pressure to the reduction gearbox at the front of the engine. One of the oil transfer elbow mounting lugs (that secured the elbow to engine assembly) was found to be fractured, allowing the oil transfer elbow to move and unseat the O-ring between the elbow and the tube (Figures 2 and 3).

Figure 2: Photograph (in situ) showing fractured oil transfer elbow mounting lug and the unseated O-ring seal

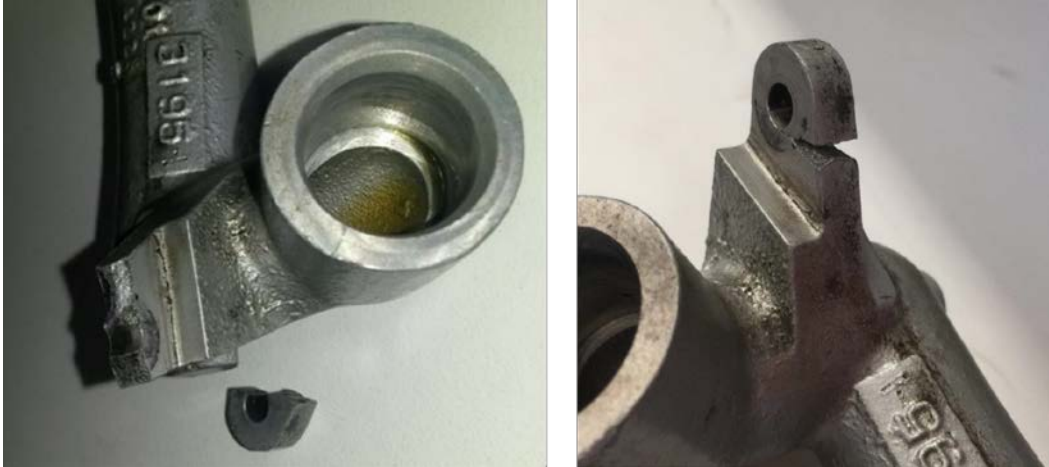
Inspection of the engine confirmed that an oil transfer elbow mounting lug had fractured and the report noted that the ‘hardware holding it in place was loose’. The lug was found to have completely broken through, and it was noted that a segment of the lug was missing (Figure 4). The report also noted that the O-ring (see Figures 2 and 3) had moved.

Figure 4: Fractured lug (the figure on the right shows that a segment of the lug was missing)

- The fracture of the lug occurred due to fatigue originating from multiple locations on the side of the mounting lug that meets with the face of the mounting flange. The fatigue mode was found to be high-cycle, under unidirectional bending.

- Wear and imprint marks on the securing assembly (bolt, nut and washer) and the fractured lug suggested that the bolt was sitting askew in the bore of the flange to which the elbow mounting lug was secured. The report commented that this wear pattern was consistent with a lack of pre-load on the bolt.

- The lack of pre-load on the bolt that secured the mounting lug to the flange was considered to be the initiating factor that led to fracture of the mounting lug. The reason for the lack of pre-load on the bolt could not be ascertained.

Prior to this incident, the operator was already in the practice of periodically inspecting the area of the fractured lug (although those inspections did not alert the operator to the problem in this case). In response to this incident, the operator intends to expand the periodic inspection to include removal of the bolt and an inspection of the internal radius of the mounting lug for signs of crack development.
