# Separation issue involving a de Havilland DH-82A (Tiger Moth), VH-BJE and a Robinson R44, VH-HOQ

at Redcliffe (ALA), Queensland, on 7 November 2015

**ATSB Transport Safety Report**  
Aviation Occurrence Investigation  
AO-2015-130  
Final – 13 April 2016

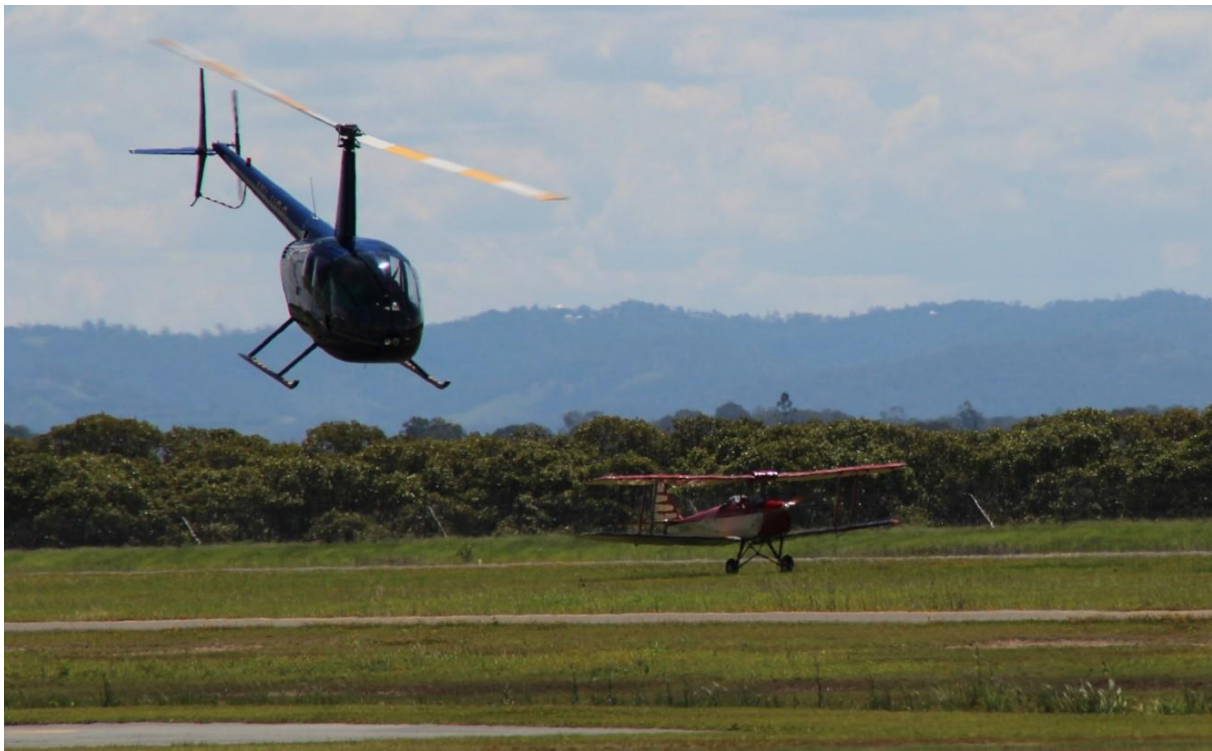
**Figure 2: BJE during the take-off run just prior to HOQ conducting the left turn**

The pilot of BJE lined up for departure on the grass beside the runway, because the aircraft was fitted with a tail skid, not a tail wheel. The grass area for BJE's take off was within the runway strip to the side of the runway closest to the taxiway. BJE commenced the take-off run and, shortly after, the pilot noticed HOQ flying on a parallel track to BJE (Figure 2). The helicopter was to the right, slightly ahead and above BJE, and in close proximity.

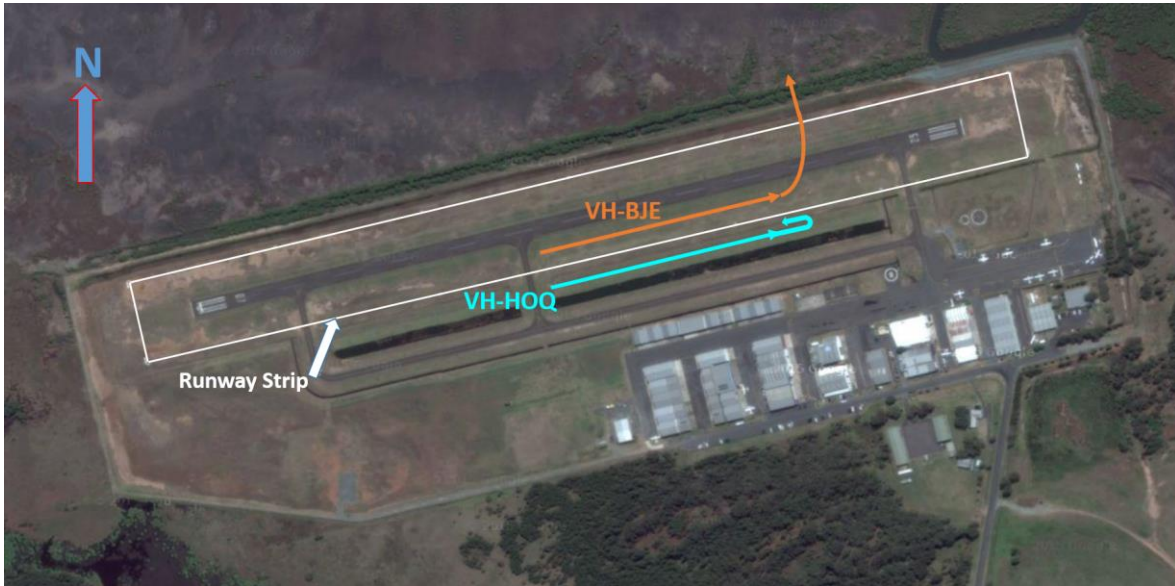
**Figure 3: Redcliffe aerodrome showing the runway strip (white). The take-off run and left turn of BJE is indicated in orange. The track of HOQ when conducting the engine failures during taxi and the reversal turn is indicated in blue.**

Shortly after becoming airborne from the grass runway, at about 50 to 60 ft above ground level (AGL), the pilot of BJE saw the helicopter commence a left turn towards the runway. Thinking that there was going to be a collision, the pilot of BJE took avoiding action by conducting a hard left turn, with a high angle of bank, at low altitude. The approximate tracks of the aircraft are depicted in Figure 3.

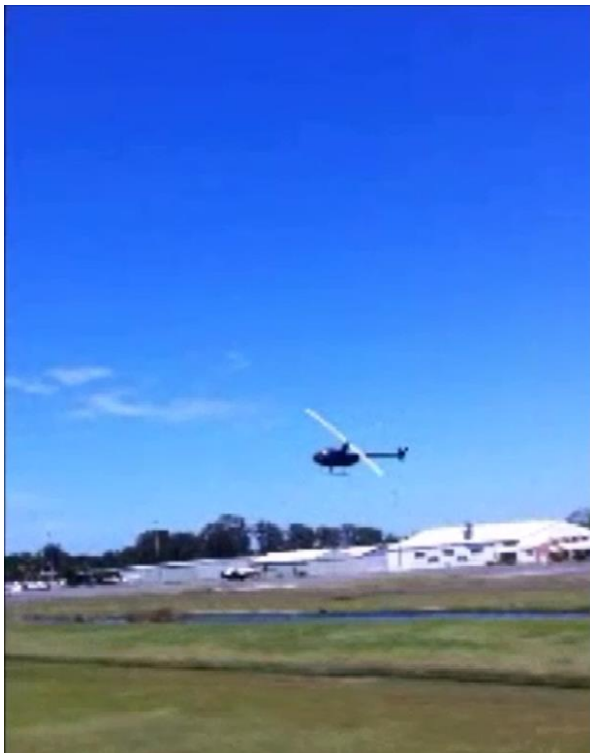
**Figure 4: View from the Tiger Moth when the helicopter was approximately half way through the reversal turn**

The instructor in HOQ was executing a reversal turn in order to reposition the helicopter for further training (Figure 4). The manoeuvre involved a 180-degree left turn, to reverse the direction of flight, with an increase in height to about 50-60ft and a bank angle of about 50°. The turn and track back down the grassed area would keep the helicopter outside the runway strip and clear of BJE. However, as the instructor had not advised their intentions on the CTAF, the pilot of BJE was unaware that the helicopter was going to remain clear of the aircraft.

Pilots are encouraged to 'err on the side of caution' when considering when to make broadcasts on CTAF, particularly when the aircraft operations are likely to be in close proximity to other aircraft.
