Wirestrike and collision with terrain involving a Robinson R44, VH-HXY

90 km N of Hughenden, Queensland, on 14 February 2016

ATSB Transport Safety Report
Aviation Occurrence Investigation
AO-2016-010
Final – 13 April 2016

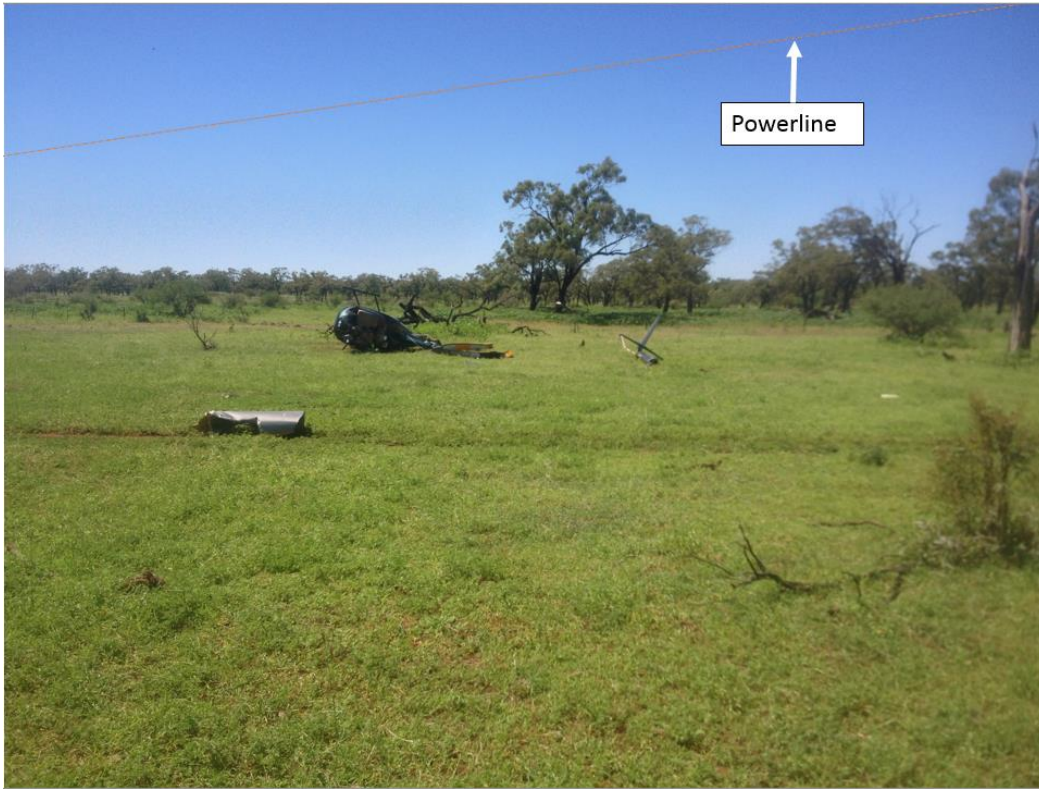
As the helicopter rounded the tree, at an airspeed of about 50 kt, the skids struck the powerlines. The pilot heard the wires contact the helicopter and it decelerated rapidly. The pilot lowered the collective¹ and pulled back on the cyclic² control, but the helicopter rolled forwards over the wires, descended rapidly, and collided with the ground left side down in a nose-down attitude.

The wire was hooked on the helicopter's right skid, with electrical power still running through it. After the blades stopped turning, the pilot exited the helicopter. The pilot was not injured and the helicopter was destroyed (Figure 1).

Figure 1: Accident site of Robinson R44 helicopter, registered VH-HXY

ATSB research indicates that in 63 per cent of reported wirestrike incidents, pilots were aware of the position of the wire before they struck it. In this instance, the pilot was aware of the powerline however, they were unable to see the wires from the helicopter's position on the ground due to a tree. The pilot's attention was then diverted to the cattle and did not maintain awareness of the wires.

The ATSB publication [Avoidable Accidents No. 2 – Wirestrikes involving known wires: A manageable aerial agricultural hazard](#), explains strategies to help minimise the risk of striking wires while flying. Pilots are reminded to avoid unnecessary distractions and to refocus when distracted. Distraction, combined with difficulty in seeing wires makes them extremely hard to avoid at the last minute.
