# Incorrect configuration resulting in a collision with terrain involving Cessna R182, VH- PFZ

58 km SW of Ingham ALA, Queensland, 14 February 2016

**ATSB Transport Safety Report**  
Aviation Occurrence Investigation  
AO-2016-011  
Final – 27 May 2016

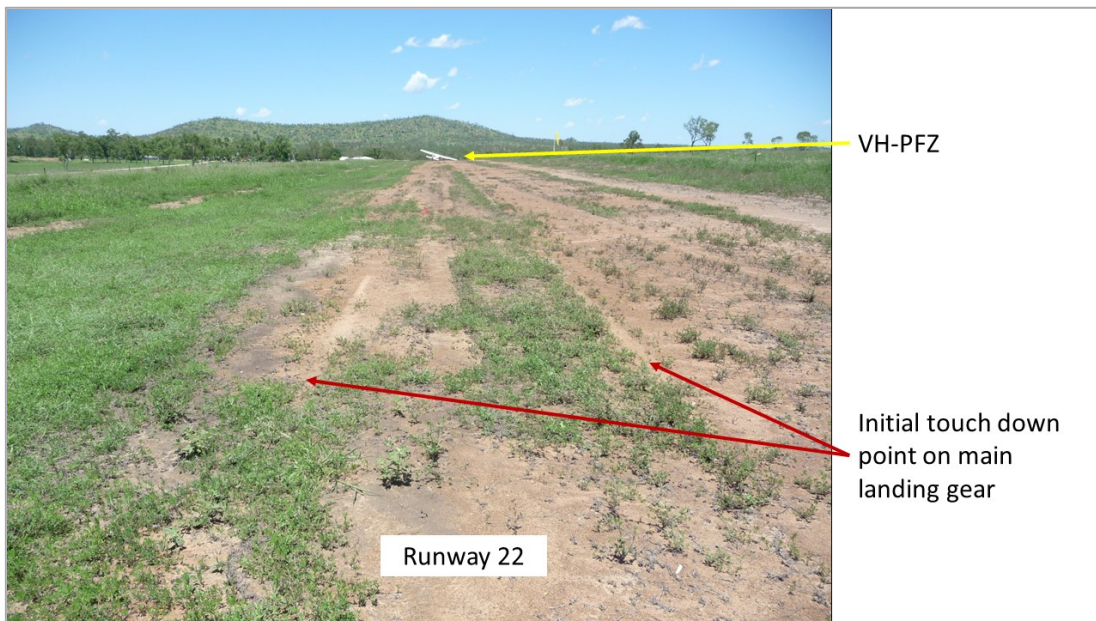
The pilot described the approach and initial touchdown as a little faster and higher than normal, with the touchdown point about 300 m into the 1,100 m airstrip (Figure 1). The aircraft ballooned slightly. At about 10-15 ft above ground level, the pilot commenced a go-around and applied full throttle, with the propeller remaining at 2,000 RPM. With an airspeed of 64 kt, the pilot assessed there was sufficient airspeed to climb out, so retracted all of the flap and then the landing gear.

**Figure 1: Initial touchdown point on runway 22, and VH-PFZ (far end)**

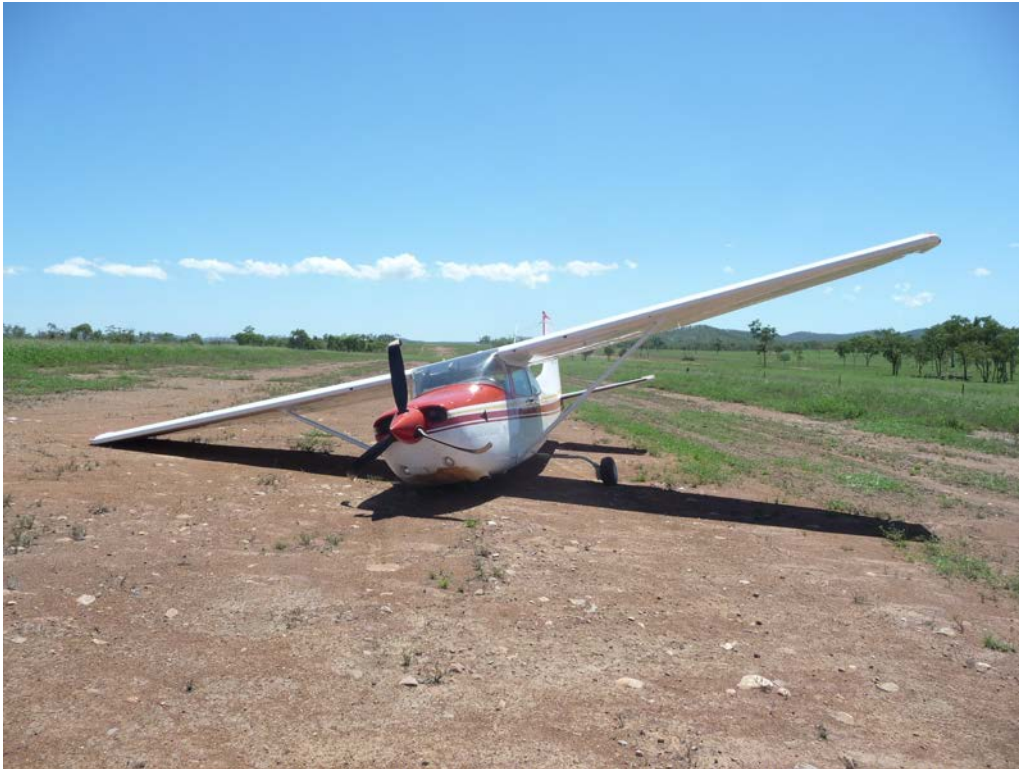
However, the aircraft began to sink, and the nose dropped. Moments later, the main landing gear struck the ground. This second ‘touchdown’ was about 265 m beyond the first, (about 565 m along the airstrip). The pilot attempted to keep the nose of the aircraft raised. However, the propeller struck the ground and the pilot realised that the nose wheel had retracted, so closed the throttle. The aircraft continued to skid along the runway. The propeller stopped rotating when the aircraft had travelled about another 77 m. The aircraft then continued to slide sideways, and the right main landing gear retracted (Figure 2). The pilot was not injured, but the aircraft sustained substantial damage.

**Figure 2: VH-PFZ showing retracted nose wheel and right landing gear, and damaged propeller**

The pilot summarised that engine RPM was insufficient to produce enough thrust to maintain altitude and climb at the critical point of change in aircraft configuration, while retracting the flap and landing gear.

Although the aircraft could have landed safely in this configuration, attempting to climb with the propeller still at 2,000 RPM created a chain of events from which the pilot did not recover.

The pilot's decision to retract the flaps all at once, followed immediately by the landing gear, prior to obtaining a positive rate of climb at a low altitude also decreased the aircraft's performance.
