# Wirestrike and collision with terrain involving Robinson R22, VH-LYW

88 km NE Roma, Queensland, 20 February 2016

**ATSB Transport Safety Report**  
Aviation Occurrence Investigation  
AO-2016-013  
Final – 27 May 2016

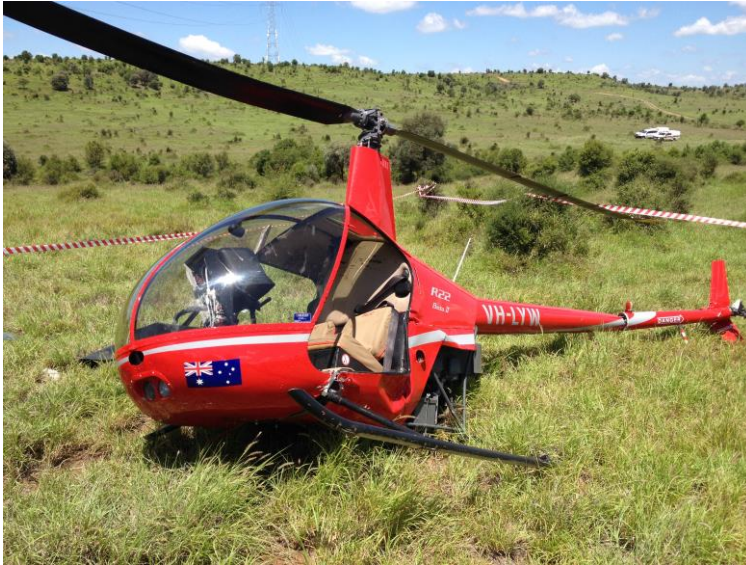
The helicopter was vibrating and the pilot turned it away from the wires. The tail rotor then failed and the helicopter yawed around. The helicopter descended rapidly and continued to rotate. The pilot entered an autorotation, and closed the throttle, overriding the governor. As the helicopter neared the ground, the low rotor revolutions per minute warning horn sounded, and the pilot raised collective<sup>1</sup> to try to cushion the landing. The helicopter collided with the ground nearly upright, and sustained substantial damage (Figure 1). The pilot was seriously injured.

**Figure 1: Accident site showing damage to VH-LYW**
