**Australian Transport Safety Bureau**

# Near collision between Schempp-Hirth Janus glider, VH-GWQ, and Rolladen- Schneider LS3-A glider, VH-CQP

3 km NW of Mount Beauty, Victoria, 28 March 2016

**ATSB Transport Safety Report**  
Aviation Occurrence Investigation  
AO-2016-032  
Final – 8 September 2016

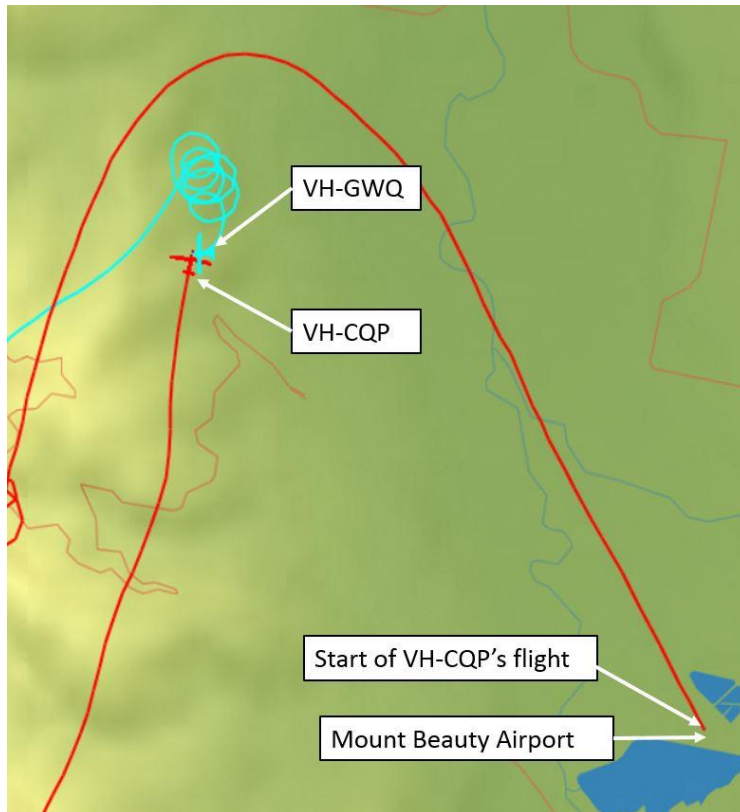
**Figure 1: Relative tracks of gliders VH-GWQ and VH-CQP and positions at 1355:02**

At that time, GWQ was thermalling and in a right bank at about 40–45°, and had completed four orbits. The front seat pilot sighted a glider approaching from the opposite direction at about the same altitude. They assumed that the glider would join the thermal behind them, in the same direction, and on the opposite side of the orbit, in accordance with normal procedures. The front seat pilot asked the rear seat pilot whether they could see the glider, who responded ‘no’. The FLARM fitted to their glider indicated that there was another glider in close proximity and the rear seat pilot looked outside to see where it was.

The front seat pilot assessed that the approaching glider was not going to manoeuvre to join the thermal or to avoid a collision, so took control of the glider and pushed the stick forwards to descend rapidly. The other glider (CQP) passed overhead.

The pilot of CQP sighted a glider pass below, and estimated there was less than 100 ft vertical separation. Both gliders continued their flight for about another hour after which GWQ landed at Porepunkah and CPQ landed at Mount Beauty without further incident.

According to the flight data recorded by the gliders’ flight logger, at 1354:58, CQP was at 3,606 ft and GWQ at 3,523 ft. Four seconds later as the gliders’ paths crossed, CQP was at 3,605 ft and GWQ had descended to 3,458 ft.

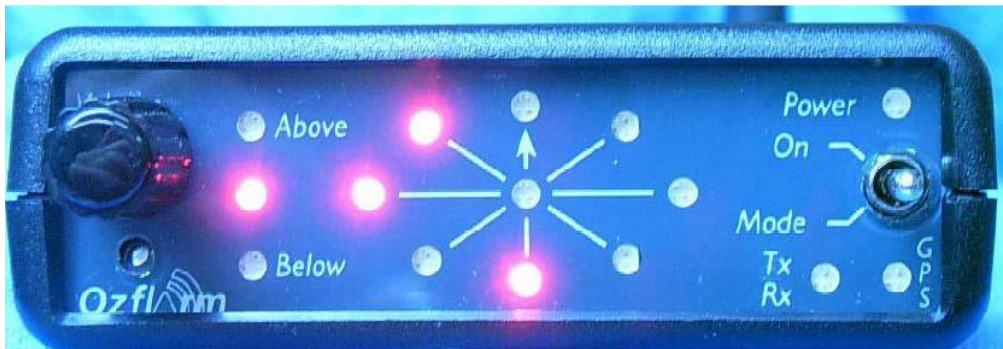
**Figure 2: OZflarm display**

FLARM is a collision avoidance system that shows other similarly equipped aircraft in the vicinity. The display shows the approximate direction of detected traffic and whether it is above, below or at about the same level (Figure 2).

The pilot of CQP reported that they had flown gliders fitted with FLARM for 7–8 years and had never heard it make a noise before. This may have been because they had never been close enough to another glider to trigger the alarm before. They were briefed and had a briefing note circulated by the gliding club when they were first installed. The pilot did not think there were any other gliders in the vicinity, and did not associate the alarm with FLARM.

The pilot in the rear seat further reported that the FLARM unit in CQP had recently been upgraded to a PowerFlarm. This may have included a new display, and also may have been indicating ADS-B transmissions. Changes to display and aural warnings of the FLARM fitted to CQP may have been confusing for the pilot of CQP.

It is essential that when equipment is installed in an aircraft, pilots have an understanding of its operation and are familiar with its characteristics.
