Australian Transport Safety Bureau

Fuel starvation involving Lancair ES, VH-DFH

22 km NW Mansfield (ALA), Victoria, 18 April 2016

ATSB Transport Safety Report
Aviation Occurrence Investigation
AO-2016-037
Final – 28 September 2016

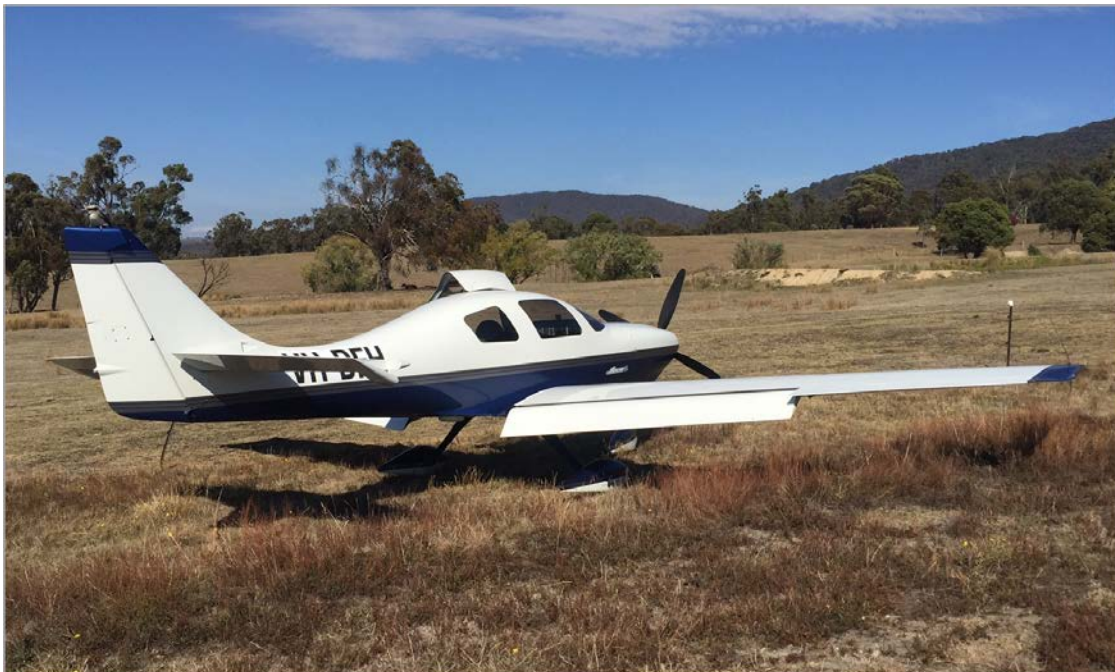
Figure 1: DFH at the accident site

The aircraft touched down about 25 m before the threshold on a grass area. The aircraft bounced slightly, touching down again on the grass area beside the airstrip. The left wing contacted an electric fence post and came to a stop a further 100 m after the initial touch down point (Figure 1). The pilot exited the aircraft after turning off all the electrical and engine controls. The pilot was not injured and the aircraft had minor damage.

The pilot reported that the aircraft was inspected subsequent to the incident at an aircraft maintenance facility and no defects were found with the aircraft or engine. The maintenance personnel assessed that fuel starvation¹ was the probable reason for the power loss due to the way the aircraft had been parked on an incline prior to taxi and take-off. The pilot reported that the aircraft has two independent fuel tanks, one in each of the slim line wings. During the pre-flight inspection, the aircraft was situated with the left wing on the downhill side for a little over half an hour. It is believed that the fuel drained away from the fuel pick up toward the wing tip through a one-way flapper valve² reducing the quantity of fuel available in the sump area where the left wing fuel pick up is located. The pilot reported that the left fuel tank had been selected for the taxi and take-off.

The owner is considering installing a placard in the aircraft to remind pilots when the aircraft is parked on an incline to consider which fuel tank to select for take-off.
