Loss of control involving Robinson R22, VH-WGB

221 km ENE of Port Hedland Airport, Western Australia, 12 May 2016

ATSB Transport Safety Report
Aviation Occurrence Investigation
AO-2016-047
Final – 25 August 2016

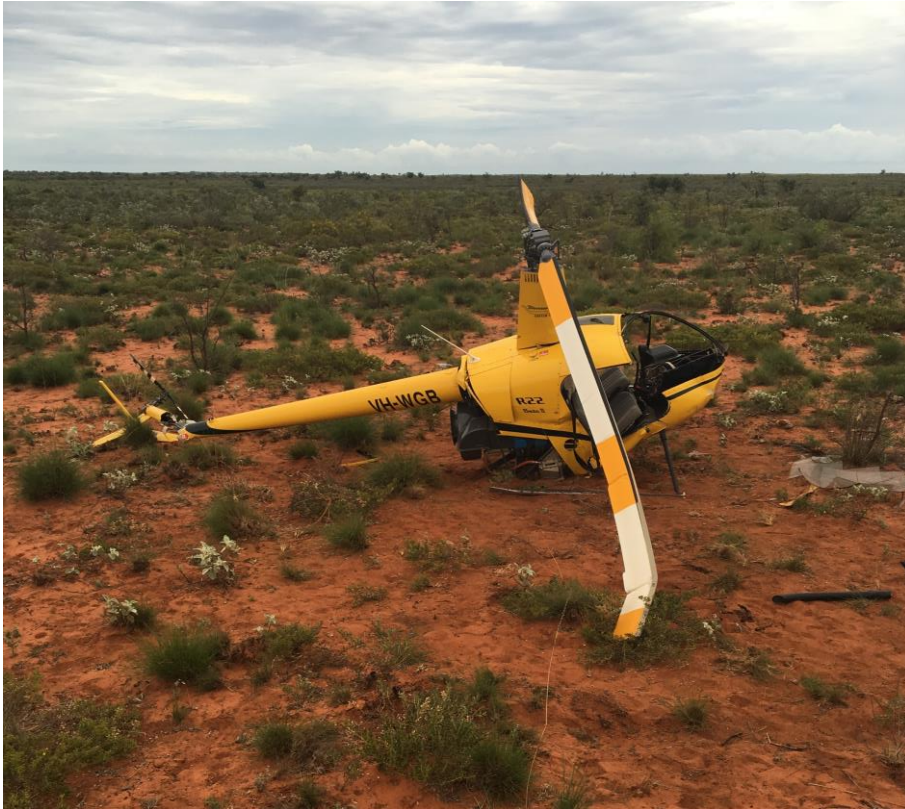
The helicopter collided with the ground in a level attitude. The helicopter skids and seat collapsed following ground contact. During the accident sequence, the main rotor blades severed the tail boom. The pilot's helmet struck the cyclic and the pilot sustained minor injuries. The aircraft was substantially damaged (Figure 1).

Figure 1: Accident site showing damage to VH-WGB

When the pilot manoeuvred the helicopter into wind, it flew through two relative wind directions conducive to an LTE event. The pilot commented that they entered the turn at about 40 kt airspeed, but was actively scanning between flying the helicopter and observing the aerial mustering activity. It is likely that during the turn, the airspeed combined with the relative wind direction to initiate an LTE event. The recommended actions to recover from an LTE include the application of forward cyclic to increase airspeed. This could place the helicopter into a low-G condition if an abrupt forward cyclic input is made, and increase the risk of striking the tail boom if the forward cyclic input is followed by an abrupt and/or large aft cyclic input.

To avoid the conditions which could lead to main rotor blade/fuselage contact accidents, the Robinson R22 Pilot’s operating handbook recommends the following procedures for pilots:

- maintain cruise airspeeds between 60 kt and less than $0.9 V_{NE}^6$, but no lower than 57 kt
- use maximum power on revolutions per minute at all times during powered flight
- avoid sideslip during flight and maintain in-trim flight at all times
- avoid large, rapid forward cyclic inputs in forward flight, and abrupt control inputs in turbulence.

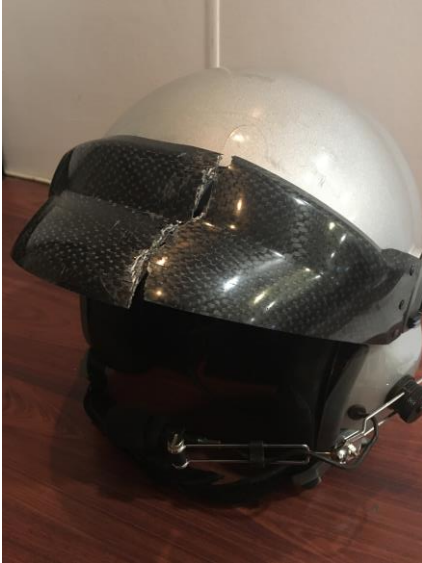
- the wind was steady at about 15 kt from the south-east with occasional gusts to 20 kt
- the pilot was not sure what the 'kick' was, but thought it was due to the wind
- the pilot did not recognise a low gravity (weightless) situation and may have applied incorrect cyclic technique, resulting in the main rotor striking the tail boom
- the pilot thought that the tail boom was severed shortly after the kick because there was no response from the pedals to counteract the yaw and the helicopter immediately entered a nose down spiral
- the pilot's helmet was damaged during the collision, when it struck and broke the cyclic (Figure 2)
- wearing the helmet probably prevented a more serious injury from occurring.

Figure 2: Damage to pilot's helmet

This accident highlights the effectiveness of wearing a helmet to prevent a more serious injury. ATSB report [AO-2014-058](#) provides an account of a serious head injury to an R22 pilot who was
