Near collision involving Piper PA-28, VH-MJT, and Airbus Helicopters EC 130, VH-ZVO

Bankstown Airport, New South Wales, 20 May 2016

ATSB Transport Safety Report
Aviation Occurrence Investigation
AO-2016-053
Final – 25 August 2016

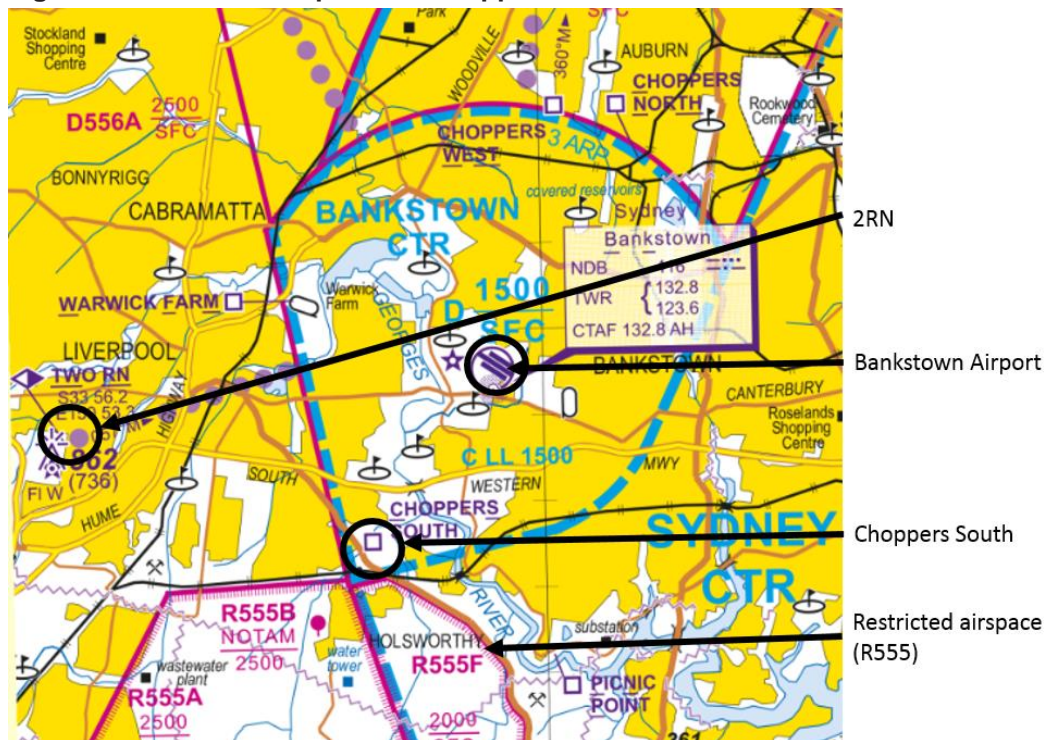
Figure 1: Bankstown Airport and Choppers South

On 20 May 2016, the pilot of an Airbus Helicopters EC 130 T2 helicopter, registered VH-ZVO (ZVO), was conducting a ferry flight from Port Kembla to Bankstown Airport, New South Wales, with an engineer, who was also a crewmember, on board. At about 1437 Eastern Standard Time (EST), the pilot of ZVO contacted Bankstown Tower air traffic control (ATC), advising they were at 2RN approach point at 1,000 ft and inbound to Bankstown (Figure 1). The aerodrome controller (ADC) cleared ZVO to track to Bankstown via the Choppers South approach point at 500 ft.

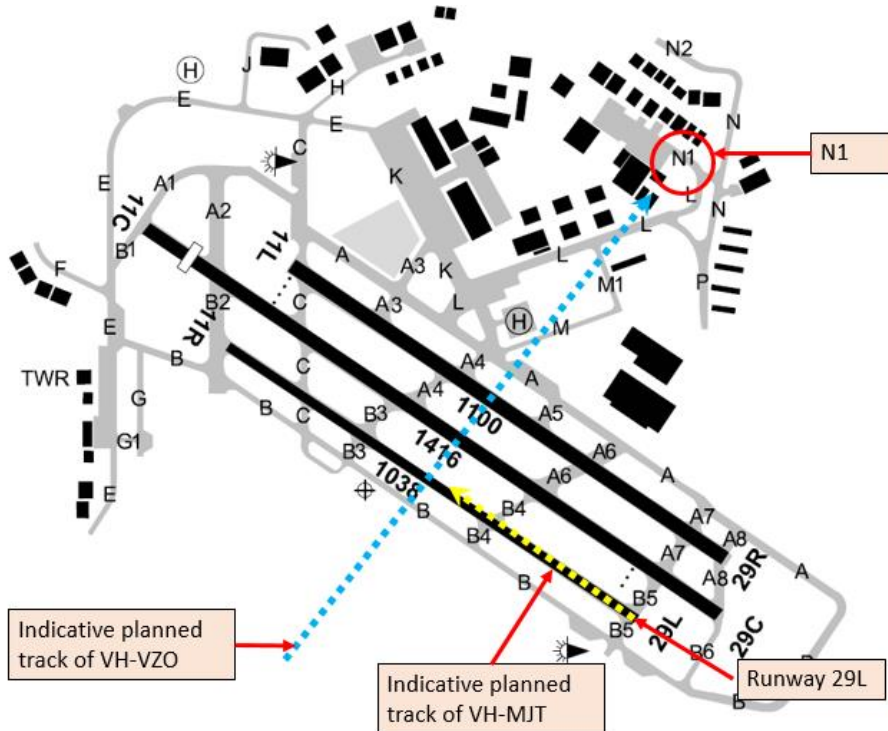
Figure 2: Bankstown Airport showing indicative tracks

At about 1439, the pilot of ZVO called at Choppers South at 500 ft and the ADC cleared ZVO to overfly the runways midfield (which included crossing all three runways – 29 left, centre and right), at 500 ft and then to join the circuit on the downwind leg for a landing at taxiway N1 (Figure 2). The ADC also advised the pilot of ZVO of traffic, which was another helicopter then overhead the

As ZVO crossed the airport boundary, the engineer sighted the aeroplane (MJT) and alerted the pilot. The pilot then saw MJT in the go-around, at the same height as ZVO, and immediately conducted a left turn to increase separation between the helicopter and the aeroplane. MJT was about midfield (half way along the runway) when the instructor sighted the helicopter (ZVO) taking avoiding action.
