# Loss of control and collision with terrain involving Cessna 206 floatplane, VH-NTK

6 km SE of Southport Airport, Queensland, on 5 June 2016

**ATSB Transport Safety Report**  
Aviation Occurrence Investigation  
AO-2016-055  
Final – 25 August 2016

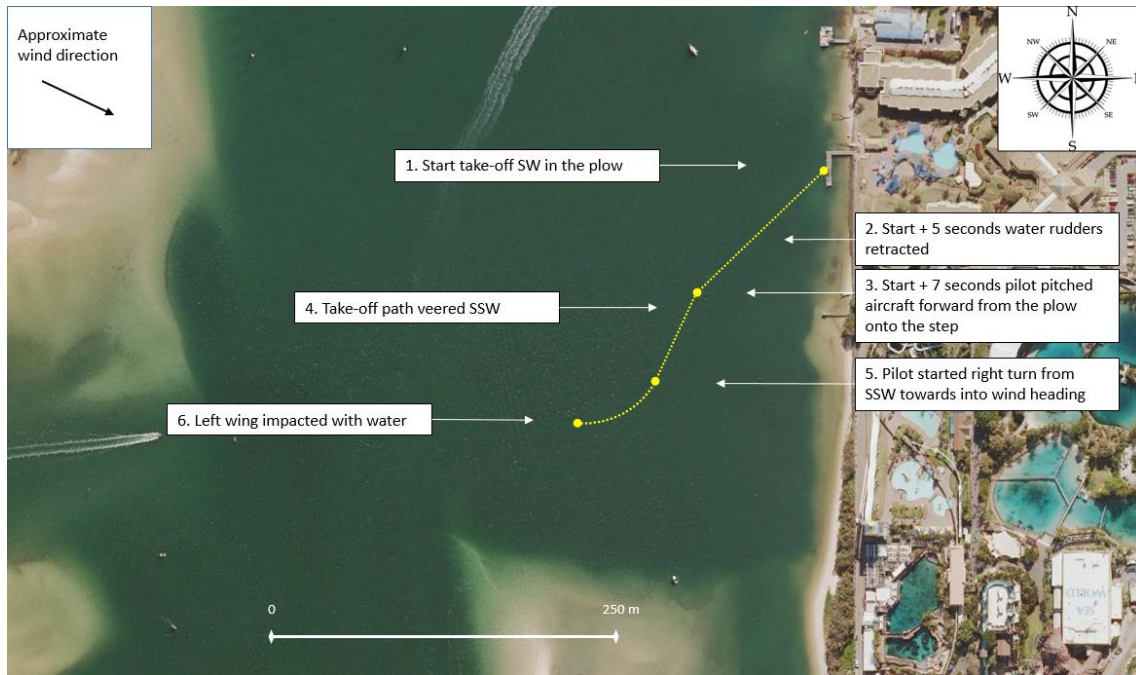
**Figure 1: Approximate take-off path and key events**

The wind was blowing from the west-north-west (WNW) at about 18 kt, with gusts of variable speed. The take-off direction to the north-west (NW) was too restrictive due to the presence of boats in the area, so the pilot elected to begin the take-off towards the south-west (SW) (Figure 1). Taking off to the SW would be through a jet-ski course and a crosswind from the right. Once clear of the jet-ski course, the pilot intended to veer right onto a more westerly (into wind) heading to complete the take-off.

The pilot could not prevent the veer to the left, even with full right rudder, so after sighting the jet-ski course barrels, the pilot pitched the aircraft backwards into the plowing position to improve directional control on the water.<sup>5</sup> The pilot then alternated pitching the aircraft between the plow and step position in order to gradually veer to the right onto a more westerly heading (textbox 5 in Figure 1).

As the aircraft was passing a SW heading and was turning towards WSW, the right wing lifted and the aircraft rolled<sup>6</sup> to the left. The roll continued, despite the application of full right aileron by the pilot, until the left wing impacted the water. The aircraft rotated to the left through about 270° and the nose and propeller ploughed into the water. The aircraft then came to a stop in an upright position, facing in a westerly direction (Figure 1).

- The channel at the operating base is orientated north-south, which restricts movements orientated east-west, therefore if the wind is forecast to gust more than 20 kt from the west, or within 30° either side of west, the take-off must be rejected.
- If the aircraft veers to the left during the take-off run and requires full control inputs, then reject the take-off.

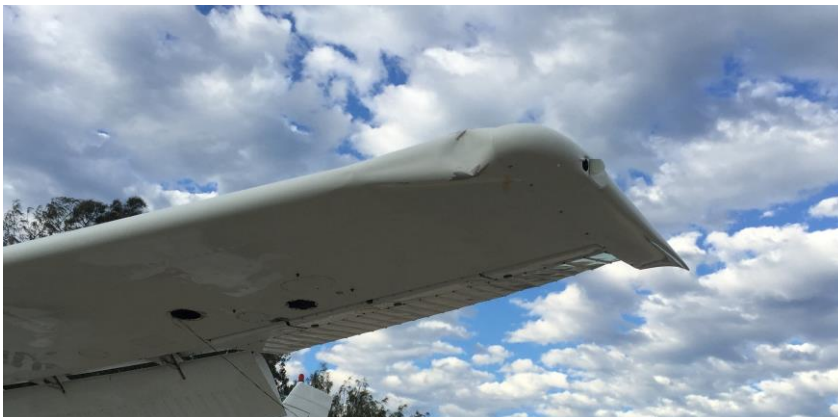
**Figure 2: VH-NTK left wing damage**

The pilot assessed the condition of the aircraft and elected not to evacuate the passengers. The aircraft was then towed to shore by a jet-ski. There were no injuries and the aircraft was substantially damaged (Figure 2 and 3).
