Controlled flight into terrain involving Agusta A109, VH-XPB

Ellerston, New South Wales, 10 June 2016

ATSB Transport Safety Report
Aviation Occurrence Investigation
AO-2016-060
Final – 28 September 2016

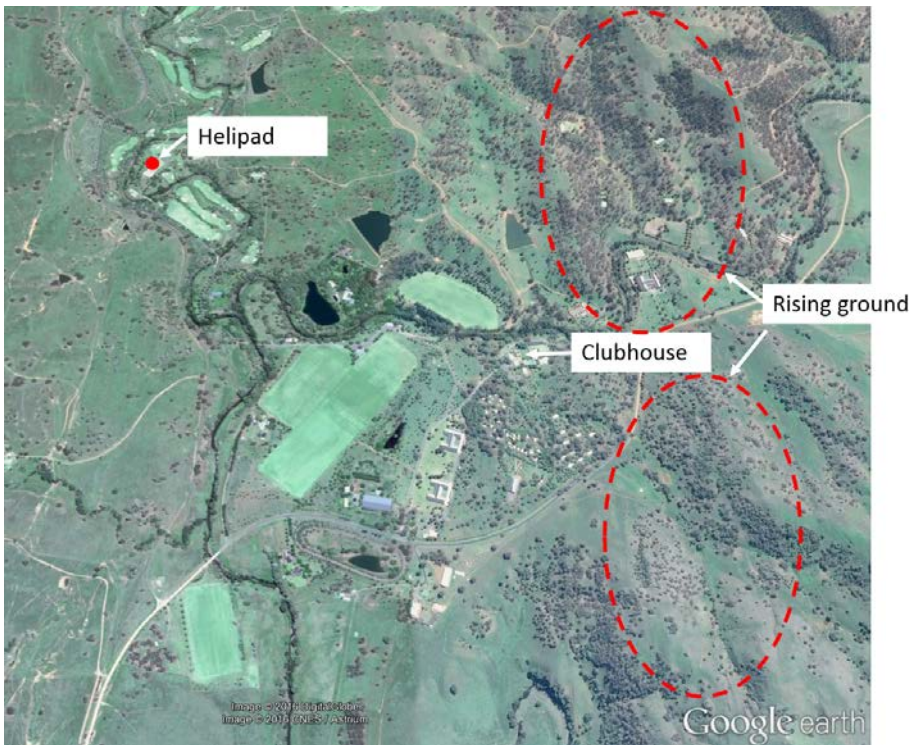
When about 3 NM from Ellerston, with the property in sight, the pilot commenced a descent to 3,500 ft, to ensure adequate terrain clearance for arrival overhead the GPS position of the helipad (Figure 1). During the descent, the pilot sighted the lights from the buildings at Ellerston and visually confirmed they were at the intended location.

Figure 1: Ellerston property

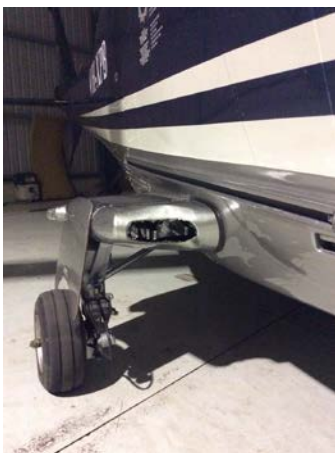
After landing, the passengers disembarked and the pilot refuelled the helicopter. The pilot then conducted a ferry flight to Camden Airport, NSW. After arriving in Camden, the helicopter was pushed into a well-lit hangar, at which stage damage to the helicopter was detected. It was apparent that the helicopter had struck a tree branch, causing damage to the right side landing lights, horizontal stabiliser, vertical fin and rotating beacon (Figure 2). It was unclear exactly when the helicopter had struck a tree.

Figure 2: Damage to right landing light of VH-XPB

The pilot assessed that the helicopter probably struck a branch when the 200 ft warning sounded. The pilot did not hear or feel the collision, but at the time the warning sounded, the pilot rapidly raised full collective and their workload was high. If the collision with the tree branch had occurred later during the approach to the helipad, the pilot thought they would have heard or felt it due to lower airspeed and engine power settings. The pilot was not aware of having struck anything and no damage was detected during refuelling at Ellerston.
