Separation issue due to runway incursion involving Cessna 172, VH-EKV, and Beech 58, VH-MLB

Alice Springs Airport, Northern Territory, 16 June 2016

ATSB Transport Safety Report
Aviation Occurrence Investigation
AO-2016-062
Final – 14 October 2016

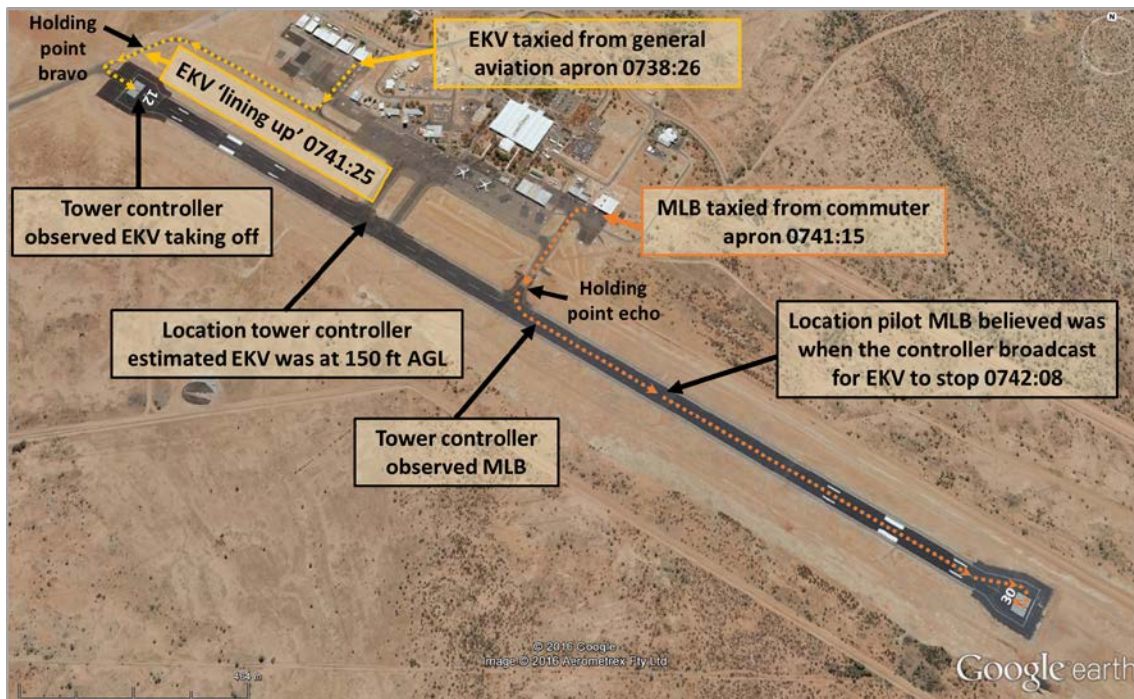
The aircraft was located on the general aviation apron and taxied for holding point bravo for runway 12 (yellow line in Figure 1). The pilot of EKV broadcast a taxi call on the CTAF.

Figure 1: Alice Springs Airport showing the taxi routes and relevant locations of EKV (yellow line) and MLB (orange line)

At 0741:15, the pilot of a Beech 58 aircraft, registered VH-MLB (MLB), broadcast a taxi call on the CTAF (the readability was 2, as the call was badly broken and very hard to understand). The aircraft was located on the commuter apron and taxied for holding point echo with the intention of then backtracking on the runway in preparation for a runway 30 departure (for a flight to Nyirripi) (orange line in Figure 1). The pilot and two passengers were on board the charter flight.

The pilot of MLB approached holding point echo and reported looking for other aircraft on approach or lined up on either runway (12 or 30). The pilot of MLB did not see any other aircraft and had not heard any other aircraft on the CTAF except for the PA32, so entered the runway and commenced backtracking runway 30 (orange line in Figure 1).

An air traffic controller arrived in the control tower (which was due to open at 0800) and observed a Cessna 172 aircraft (EKV) taking off on runway 12 and a Beech 58 aircraft (MLB) taxiing on the same runway, about half way down the runway (Figure 1). The controller advised the pilot of EKV to stop immediately.
