Wheels up landing involving Piper PA31, VH-ETW

Birdsville Airport, Queensland, on 4 July 2016

ATSB Transport Safety Report
Aviation Occurrence Investigation
AO-2016-072
Final – 14 December 2016

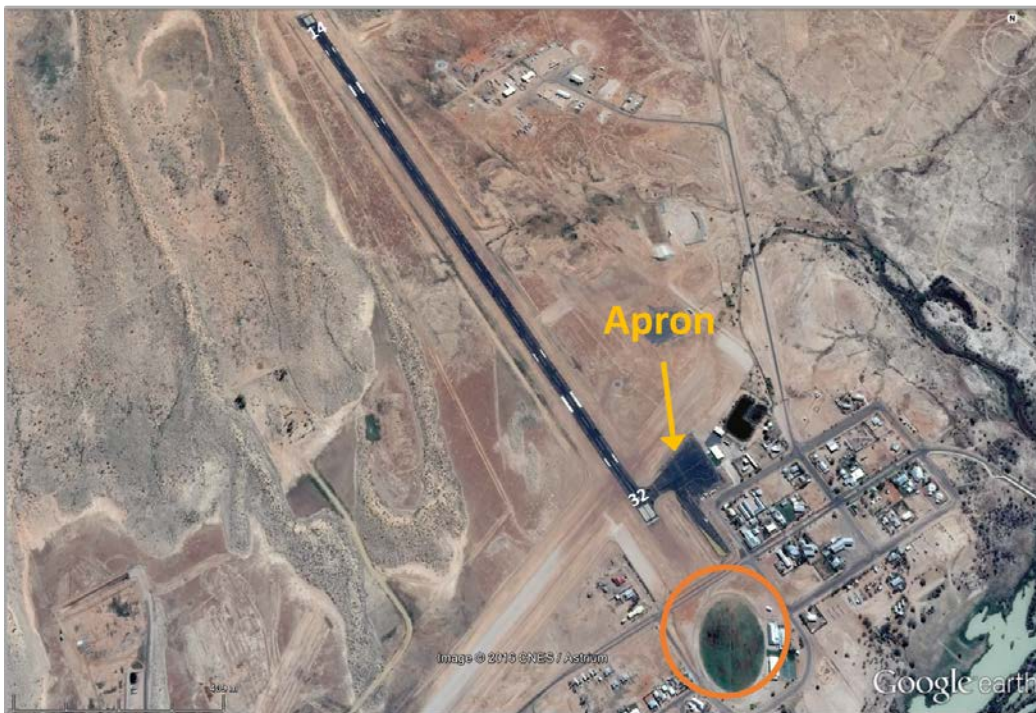
The pilot of ETW overflew the airport at about 2,500 ft on the upwind end of runway 32 to reduce the possibility of a conflict with the arriving SAAB (Figure 1). ETW joined for a wide downwind leg of the circuit and the pilot lowered the landing gear. The pilot observed that the SAAB that had now landed had not vacated the runway, so the pilot retracted the landing gear and extended the downwind leg to allow further time for the SAAB to vacate the runway.

Figure 1: Birdsville airport showing the location of runway 32, the parking apron and where the birds (hawks) were generally located off the end of runway 32 (orange circle).

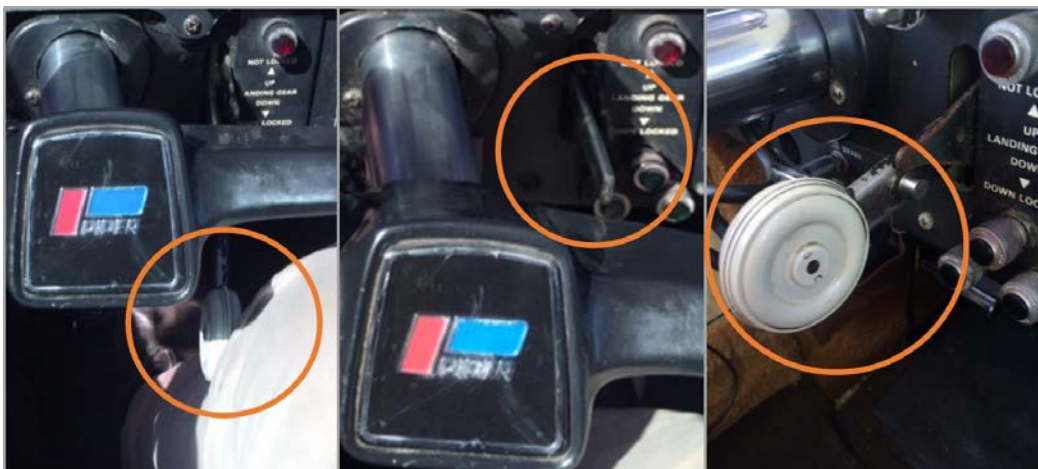
Figure 2: ETW landing gear selector handle partially detached, against the pilot’s knee.

ETW landing gear selector handle removed.

PA31 landing gear selector handle installed.

The landing gear handle is attached to the landing gear lever by a sleeve that fits over the end of the lever and is held in place by a pin, which is retained by a split pin. In this incident, the pin and split pin had fallen out of the landing gear handle and lever. In addition to connecting the handle to

An inspection of the aircraft determined that when the gear handle was moved to the landing gear down position, it would normally return to the down neutral position. However, on the occurrence flight, the gear handle pin fell out. Without the gear handle pin to stop the landing gear lever at the gear handle stop, the lever continued to the gear up position (past the down neutral position to the

up position) The landing gear retracted without the pilot being aware. However, the gear down and locked lights should have still illuminated prior to landing if the landing gear was down and locked.

Aircraft defect rectification to ensure the aircraft is serviceable before further flight.

- of the importance of the gear control handle locking mechanism
- to inspect the gear control handle on a regular basis for faults or damage
- to look at additional options for confirming that the landing gear is down with the use of active control towers or having contact details of ground crew readily available to inspect the landing gear during a fly over.

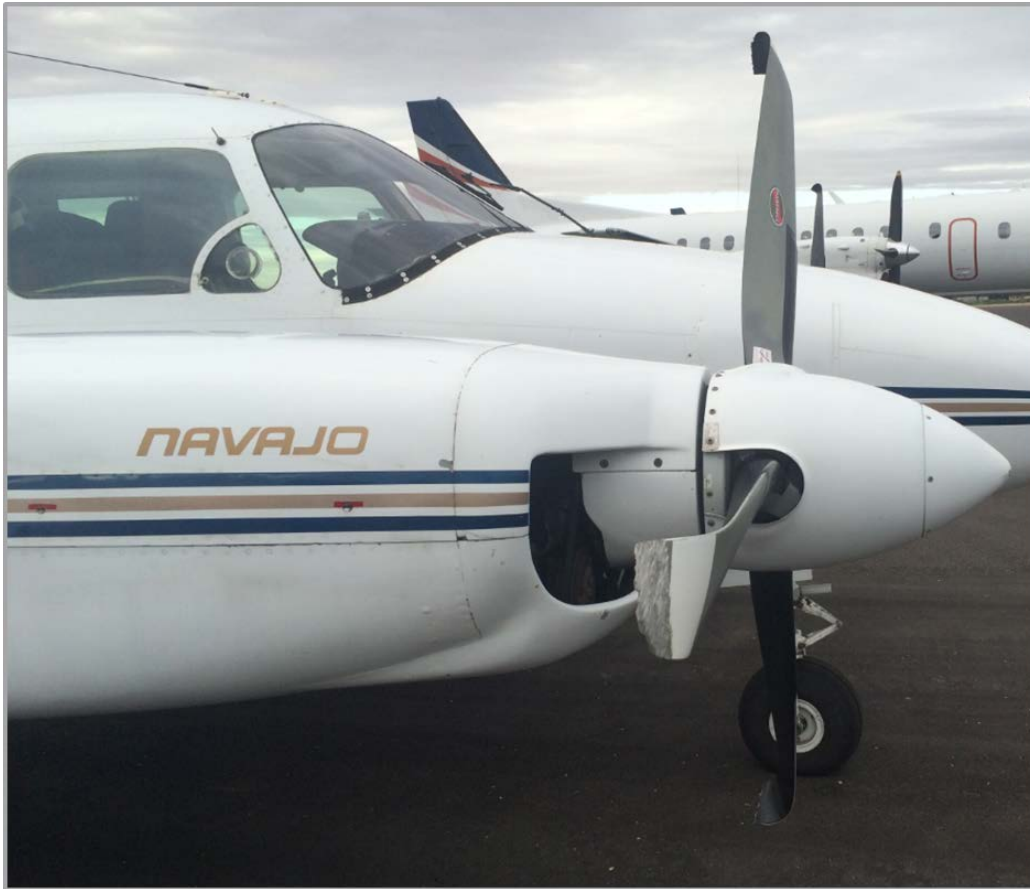
At about 200 ft on final approach, the pilot observed a significant number of birds (hawks) (see orange circle in Figure 1). Due to a 15kt crosswind, as the pilot flared the aircraft for landing, the aircraft moved to the right side of the runway and the pilot then noticed that the aircraft had a slightly higher nose attitude than normal. As the attitude kept increasing, the pilot slowly advanced the throttles, then the rear footstep touched the runway and made a scraping noise. The pilot decided not to close the throttles as the aircraft was not on the runway centreline and they continued to advance the throttles. As the speed increased, the aircraft attitude adjusted and the propellers struck the runway. The aircraft speed had increased to take off speed and the pilot assessed that the safest option was to continue with a take-off. The pilot did not notice any abnormalities with the engines.

The pilot conducted a circuit, selected and held the landing gear handle in the down position and the aircraft landed without further incident. The pilot and passengers were uninjured and the aircraft had minor damage to the propellers (Figure 3).

Figure 3: Damage to ETW propellers

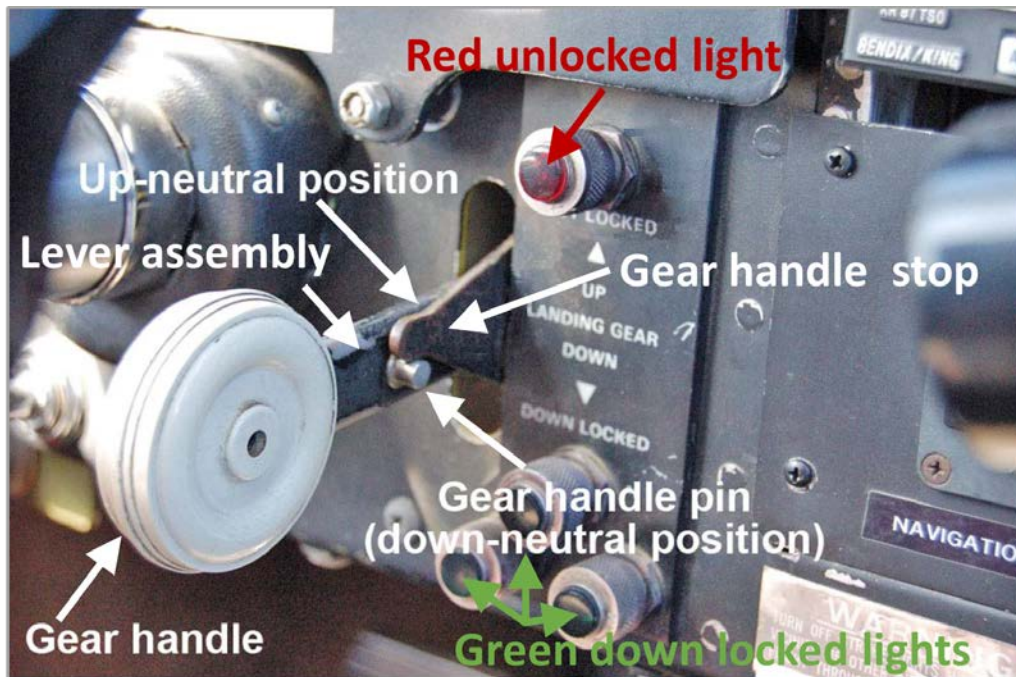
the lever, the pin also interacts with a gear handle stop (Figure 4). The landing gear handle is designed so the handle is spring-loaded to a forward position (towards the instrument panel). The pin on the inboard side of the handle rests against the gear handle stop for the neutral up and neutral down position. This ensures that the landing gear handle cannot unintentionally be moved beyond the neutral stop.

To select the landing gear down, the gear handle is pulled away from the instrument panel, down and over the gear handle stop to the full down position. When the landing gear is fully extended and locked, the landing gear handle will then return automatically to the down-neutral position where it is held by the pin against the gear handle stop.

Located on the instrument panel, above and to the right of the landing gear handle are one red and three green indicator lights (Figure 4). The red light will illuminate when the gear is not locked and the gear handle is either in the up or down position. When each of the individual gear is down and locked the respective green light will illuminate. There is no indication light when the gear is up and locked. When power from either engine is reduced below 10 to 12 inches of manifold pressure, a horn in the cockpit should sound if the gear is not down and locked.

Figure 4: Landing gear selector handle showing the gear handle, lever assembly, gear handle pin and the up and down neutral positions. In addition, the red unlocked light and the green down locked lights.
