Precautionary landing involving Cessna 150, VH-TDZ, and Cessna 152, VH-KTL

22 km WSW of Exmouth (ALA), Western Australia, 3 July 2016

ATSB Transport Safety Report
Aviation Occurrence Investigation
AO-2016-073
Final – 28 September 2016

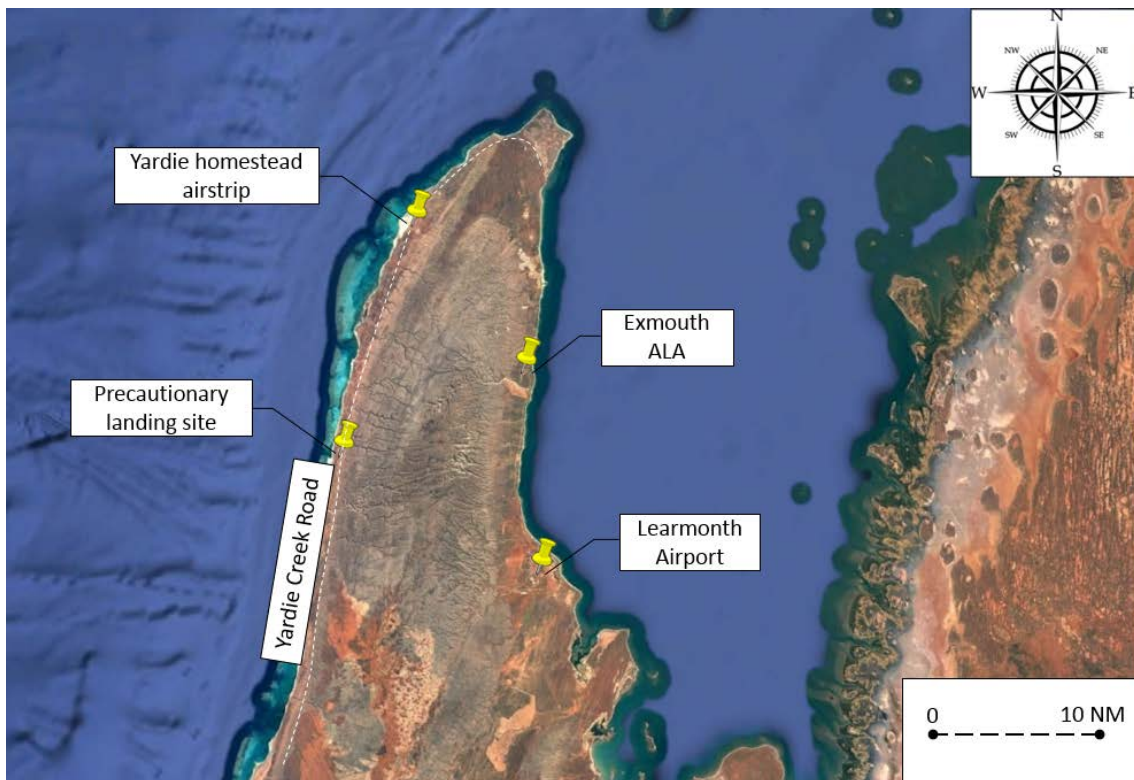
Figure 1: Exmouth peninsula with key locations

The first aircraft then returned to Exmouth ALA by flying over water around the north of the peninsula below the cloud base. The pilots of KTL and TDZ considered the weather conditions to the north to be unsuitable and therefore they decided to orbit overhead Yardie Creek Road (Figure 1) near the western coast of the peninsula to see if the weather conditions would improve. The pilot of KTL identified a straight section of the road, orientated north-south, as suitable for a precautionary landing. The pilot of TDZ also orbited over the road below the cloud base of about 500 ft.

(Figure 1). After about 5–6 orbits, the pilot of KTL assessed that the weather was deteriorating, and after confirming that the road was clear of vehicles and other obstacles, conducted a landing on the road in a southerly direction. The pilot of KTL parked their aircraft at the southern end of the straight section of road and attempted to block the road while waiting for the pilot of TDZ to land.

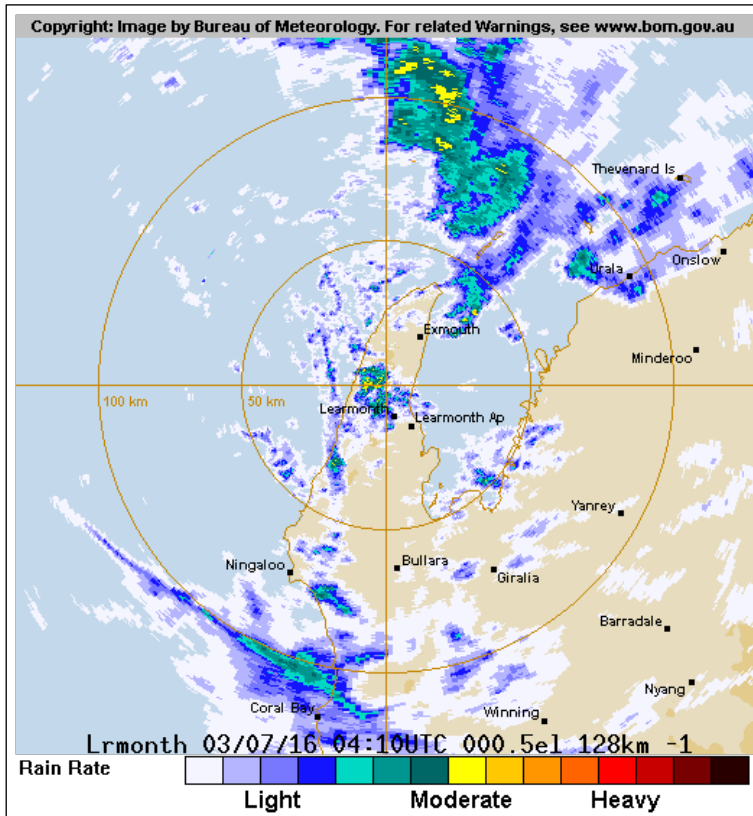
Figure 3: Weather radar image depicting rainfall 1210 WST

Figure 3 depicts the rainfall detected by the Learmonth weather radar at 1210, about the time that the pilots conducted their precautionary landing on the west coast.

The pilot of KTL reported that the cloud base was 'about 300 ft' and visibility was 'about 4 km', but reduced to 'about 3 km to the north' at the time of their precautionary landing. The pilot of TDZ, which landed after KTL, reported that the cloud base was 'about 500 ft' and visibility was 'about 2-3 NM' at the time of their precautionary landing.
