Wirestrike involving Robinson R22, VH-HRL

63 km W of Blackall Airport, Queensland, 27 July 2016

ATSB Transport Safety Report
Aviation Occurrence Investigation
AO-2016-086
Final – 14 October 2016

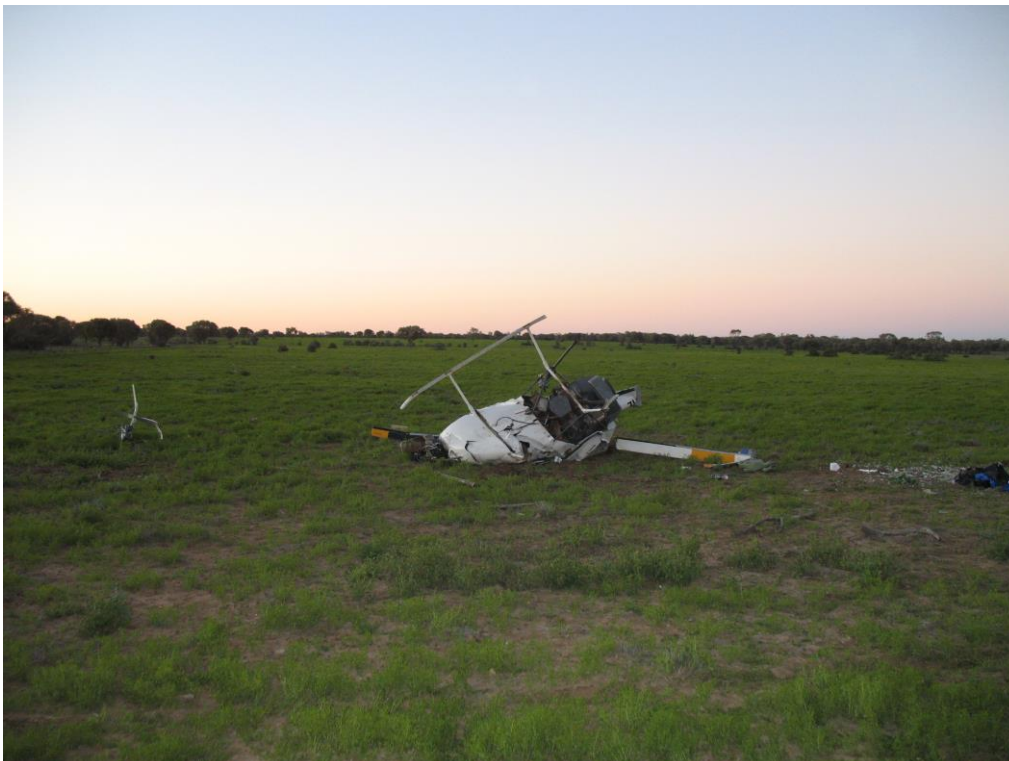
Figure 1: Accident site showing damage to VH-HRL

At about 1500, while inspecting the powerlines in the area, the line workers located the wreckage of HRL. The windshield and right skid of the helicopter had struck the single wire, which was strung east-west across a cleared area, 4.8 m above the ground. The first point of impact of the helicopter was about 31 m beyond the powerline and it then collided with the ground inverted about 18 m further away. During that impact, it appeared that the pilot's seatbelt sheared through and the pilot was ejected from the helicopter sustaining serious injuries. The wire had been stretched about 30 m, two power poles broke off and another two were pulled out of the ground. The helicopter was destroyed (Figure 1).

The helicopter struck the powerline in a clearing, mid-span between two power poles about 250 to 300 m apart. The helicopter was travelling across the direction of the powerline.

Based on the forward speed indicated by the distance of the wreckage from the wires, and the marks left in the ground by the helicopter main rotor blades, the helicopter engine was probably producing power at the time it struck the wire.
