Low fuel and precautionary landing involving Cessna 172H, VH-WKB

30 km N of Broome Airport, Western Australia, 1 August 2016

ATSB Transport Safety Report
Aviation Occurrence Investigation
AO-2016-087
Final – 14 October 2016

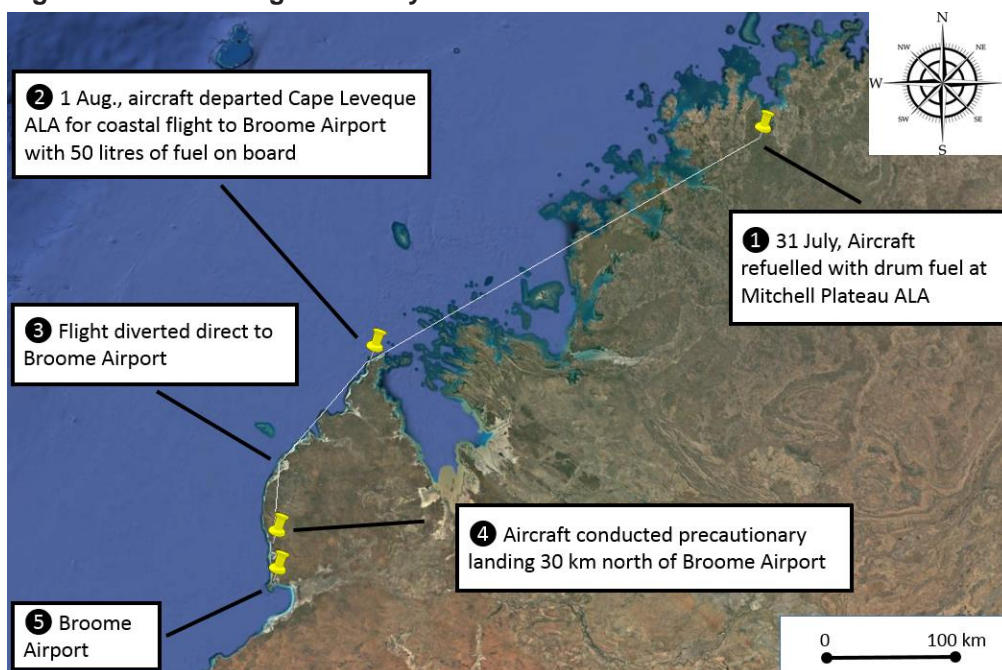
Figure 1: VH-WBK flight with key events

The pilot identified a clear section of straight road ahead, broadcast a MAYDAY¹ call and landed the aircraft on the Manari road, about 30 kilometres north of Broome airport (Figure 1). The aircraft had been flying for about one hour and 10 minutes. There were no injuries and the aircraft was not damaged.

The day prior to the incident flight, the pilot flew the aircraft to Mitchell Plateau ALA, where it was refuelled with aviation fuel from a drum, and then onward to Cape Leveque (Figure 1). The use of fuel from a drum at Mitchell Plateau precluded an accurate fuel flow check by the pilot and there was no fuel stock available at Cape Leveque during their overnight stay.
