Wheels up landing involving Beech 58, VH-UZO

Gove airport, Northern Territory, 8 August 2016

ATSB Transport Safety Report
Aviation Occurrence Investigation
AO-2016-089
Final – 14 October 2016

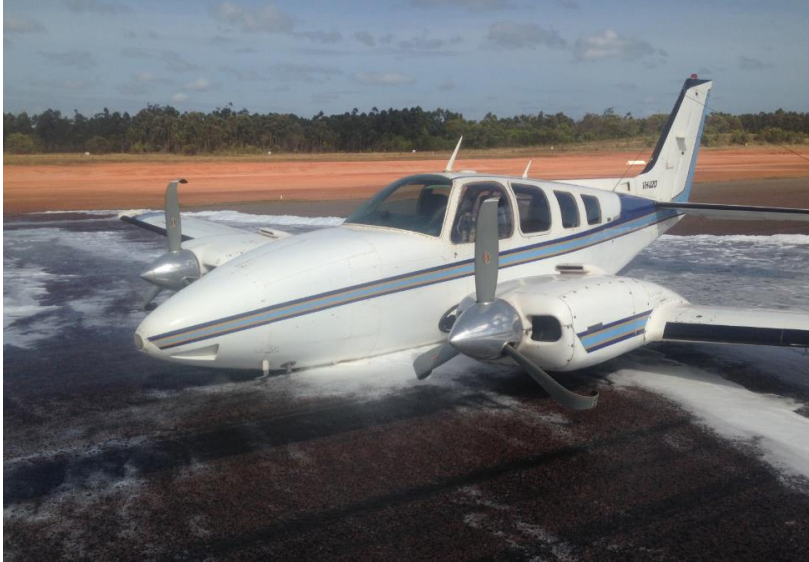
Figure 1: VH-UZO after the wheels up landing

came to a stop (Figure 1), the occupants immediately exited the aircraft. The pilot directed the passengers to a safe location behind the aircraft.

No persons were injured and the aircraft was substantially damaged in the accident.

A post-accident examination of the landing gear system found that the gear box shaft bearing had fractured. This bearing secures and aligns the shaft worm drive, which attaches both the emergency handle mechanism and the electric motor to the gear box. Failure of the bearing allowed the shaft worm drive to disconnect from the gearing. The drive became jammed, causing further damage to the gear box. Damage to the gear box prevented normal operation and caused the electric motor to overload and trip the circuit breaker. The bearing failure also prevented the emergency handle from connecting to the gear box.
