# Engine shut down involving Boeing 787, VH-VKK

370 km north of Guam, 6 August 2016

**ATSB Transport Safety Report**  
Aviation Occurrence Investigation  
AO-2016-095  
Final – 14 December 2016

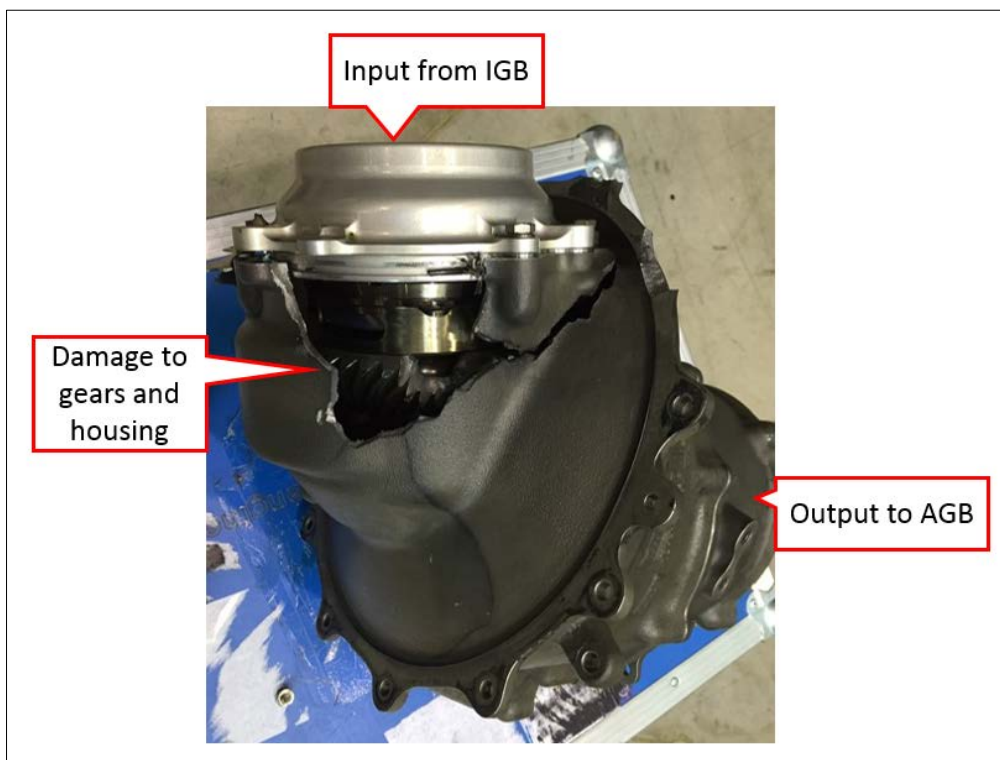
**Figure 2: Transfer gearbox damage**

On inspection, the TGB housing was found to be fractured (Figure 2). The TGB oil screen was found with metallic debris and the engine oil DMS sensor was found with metallic debris (Figure 3). The manufacturer’s inspection of the TGB failure indicated it was consistent with a known failure mode of the TGB described in their service bulletin (SB) 72-0298.

Pre-modified TGBs have a radial bevel gear with potential resonance modes (see *Resonance*) in the engine operating range. Excitation of resonance modes may lead to a gear fracture, which can result in engine oil loss and an in-flight shut down. The SB modification introduces a new damper ring groove to the radial bevel gear and a damper ring to mitigate the excitation of the resonance modes.

In light of the incident, Jetstar amended their TGB modification schedule in order to prioritise at least one engine TGB on each aircraft airframe in their fleet at the earliest opportunity (known as deairing or decoupling). The fleet was completely deaired from 26 August 2016. Jetstar completed the modification programme for their fleet in November 2016.

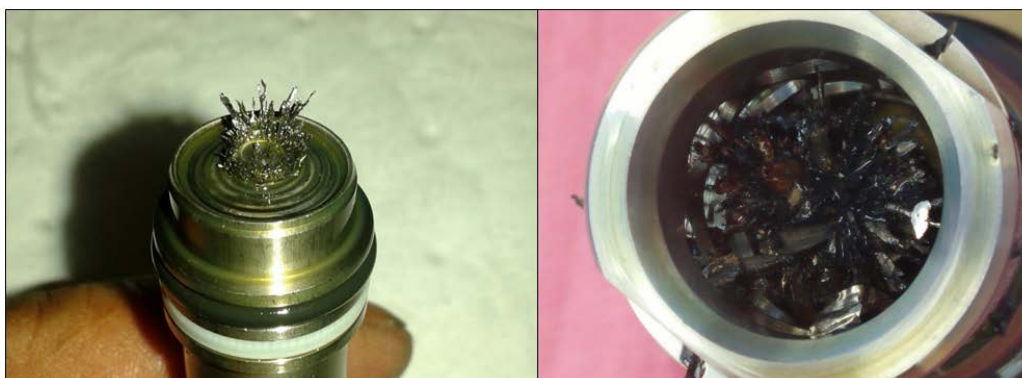
**Figure 3: DMS sensor and TGB oil screen metallic debris**

On the incident flight, the right engine oil system started to detect chips from about one hour into the flight. The chip count reached seven when the crew were alerted to disconnect the number 2 generator. At 1415 a status message was generated for ENG OIL DMS R, which indicated the chip count for the right engine had reached eight.
