Separation issue due to runway incursion involving Gippsland Aeronautics GA-8, VH-BFL, and Cessna 210, VH-NLV

Mitchell Plateau ALA, Western Australia, 9 August 2016

ATSB Transport Safety Report
Aviation Occurrence Investigation
AO-2016-097
Final – 14 October 2016

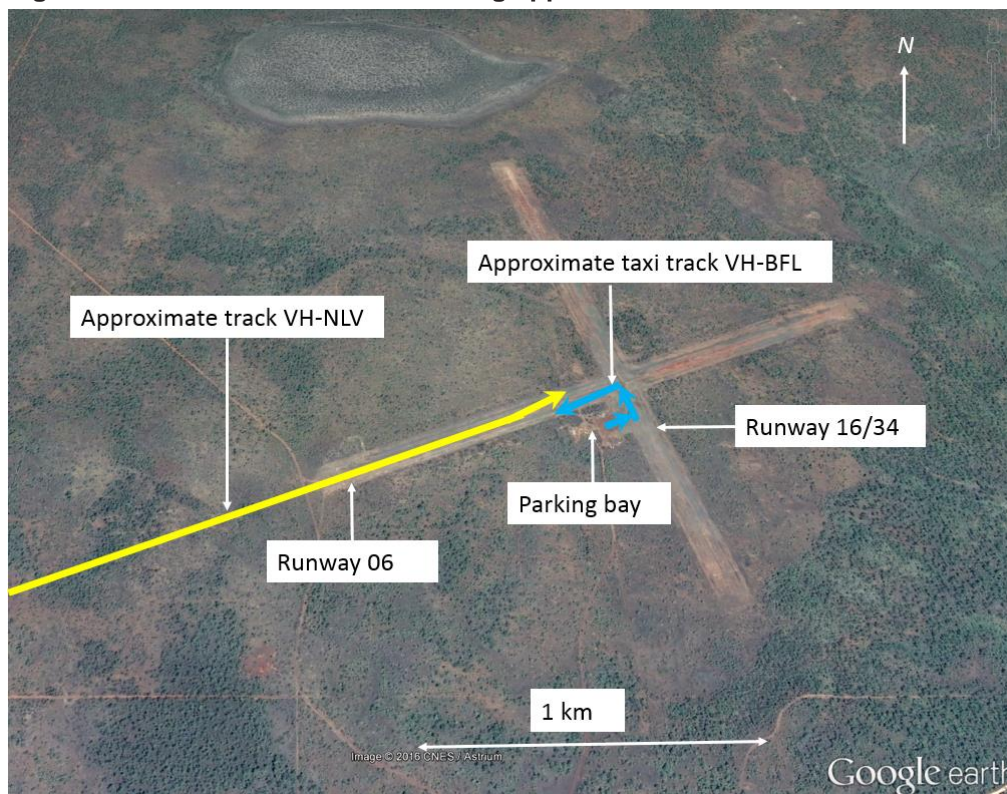
Figure 1: Mitchell Plateau ALA showing approximate aircraft tracks

Shortly before 1100, after completing orbits overhead Mitchell Falls, about 9 NM south-west of Mitchell Plateau ALA, the pilot of NLV positioned the aircraft to track for a straight-in approach to runway 06 at Mitchell Plateau ALA (Figure 1).
