# Take-offs without runway lighting involving Embraer ERJ-135 VH-JTG

Tamworth Airport, New South Wales, 19 and 28 August 2016

**ATSB Transport Safety Report**  
Aviation Occurrence Investigation  
AO-2016-108  
Final – 17 January 2017

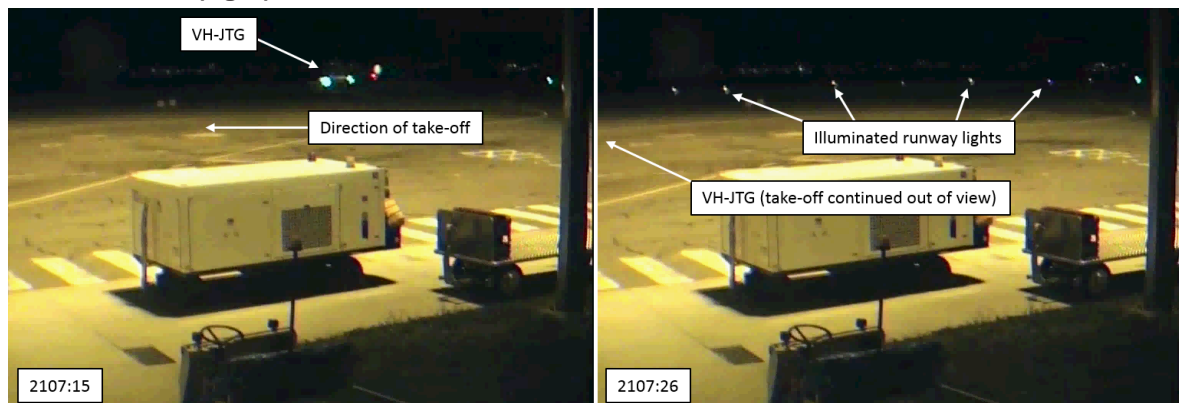
On 19 August 2016, a JetGo Australia Embraer EMB-135LR, registered VH-JTG (JTG), operated scheduled passenger flight JG65 from Tamworth, New South Wales (NSW), to Brisbane, Queensland (Qld). At 2104 Eastern Standard Time (EST), the aircraft began to taxi from parking bay 1 to runway 30 right (30R) with the taxiway and runway lights not activated (Figure 1). At 2107, the captain taxied the aircraft onto the runway and immediately began the take-off run. During the take-off run, at a speed of about 70 knots, the first officer detected the runway lights were not illuminated and activated them using the pilot activated lighting (PAL) (Figure 2). The flight crew continued the take-off.

Figure 2: Take-off run of JTG on 19 August showing runway lights not activated (left) and then activated (right)

On 19 August, at 2039, the AFRU broadcast ‘Tamworth Airport CTAF, lights 10 minutes remaining’, the lights then extinguished at 2049. At 2107, during the take-off run of JTG, the first officer broadcast an AFRU + PAL activation sequence on the Tamworth CTAF and the runway lights illuminated.

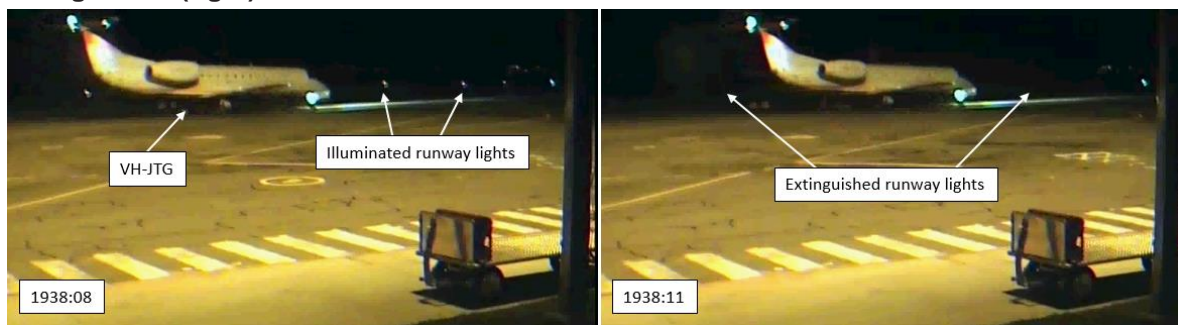
On 28 August 2016, the same aircraft operated scheduled passenger flight JG65 from Tamworth to Brisbane. At 1937, the aircraft began to taxi from parking bay 1 to runway 30R. As the aircraft taxied, the runway and taxiway lights extinguished (Figure 3). The flight crew continued to taxi, lined up on runway 30R and selected the aircraft landing lights on. At 1940, 48 seconds after lining up, the aircraft began the take-off run and departed runway 30R with the runway lights not activated.

**Figure 3: JTG taxiing on 28 August with runway lights illuminated (left) and then extinguished (right)**

On 28 August, at 1928, the AFRU broadcast ‘Tamworth Airport CTAF, lights 10 minutes remaining’, the lights then extinguished at 1938. At 2007, an AFRU + PAL activation sequence was broadcast by another aircraft and the runway lights illuminated.

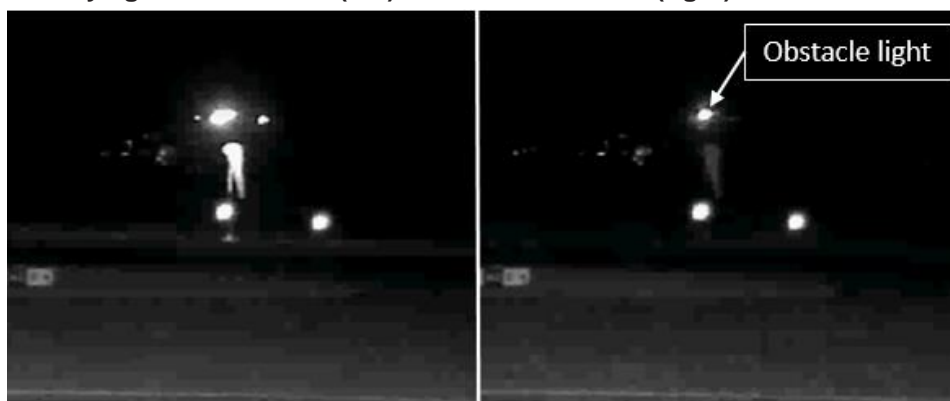
**Figure 4: Flashing primary wind indicator showing the windsock illuminated when the runway lights were active (left) and not illuminated (right)**

- The primary wind indicator at Tamworth is situated so that it is illuminated by light from the adjacent apron lighting and a red obstacle light is located above the windsock. On subsequent flights to Tamworth, the first officer has observed that this gives the appearance of the windsock being illuminated when the runway lighting is extinguished (Figure 4).

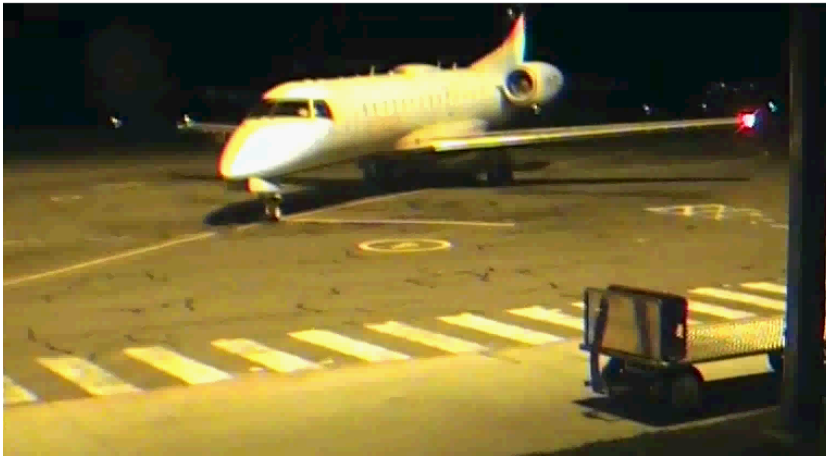
**Figure 5: JTG parked at bay 1**

Prior to both incidents, the aircraft parked at bay 1 for the embarkation of passengers (Figure 5). This bay is substantially lit by apron floodlights. These lights are not part of the PAL system and remain illuminated when the PAL system extinguishes the runway and taxiway lights.

All three flight crew commented that the apron lighting degraded night-vision and the short taxi from bay 1 to runway 30R did not allow time for eyes to adjust to the dark surrounds of the runway.
