Collision with terrain during mustering involving Robinson R22, VH-PFX

15 km S of Coen, Queensland, 18 September 2016

ATSB Transport Safety Report
Aviation Occurrence Investigation
AO-2016-120
Final – 14 December 2016

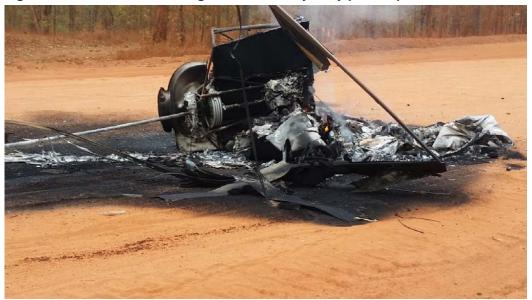
As the helicopter slid along the ground, it caught fire. The pilot exited with minor injuries and the helicopter was destroyed (Figure 1).

Figure 1: Accident site showing VH-PFX destroyed by post-impact fire

VH-PFX was not fitted with bladder fuel tanks. Although the bladder tanks could have been fitted at any time, as the aircraft had not yet reached the 2,200-hour overhaul or 12-year inspection period, it was not yet required to be fitted with bladder fuel tanks.
