# Taxiing collision involving Boeing 717, VH-NXN, and Fokker 100, VH-NHF

Paraburdoo Airport, Western Australia, 5 October 2016

**ATSB Transport Safety Report**  
Aviation Occurrence Investigation  
AO-2016-129  
Final – 17 January 2017

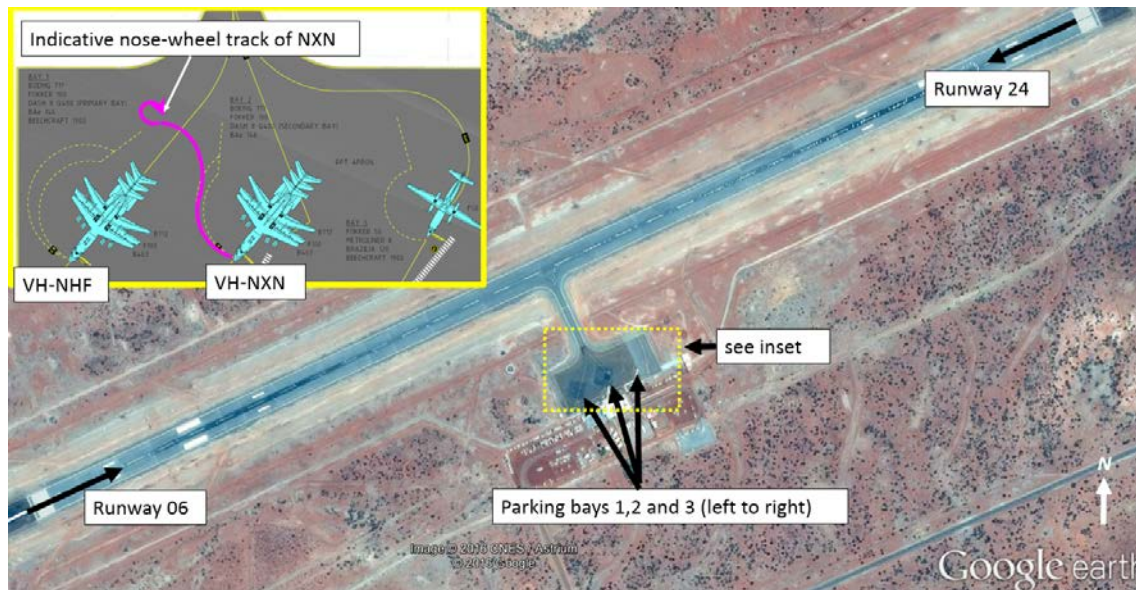
The aircraft had been parked on Bay 2 facing south-west towards the terminal building, and the flight crew planned to depart from runway 24 (Figure 1). The captain commenced taxiing, turning the aircraft around to the right in accordance with the normal taxi procedure. As the aircraft turned, the captain sighted a company B717 aircraft about to land on runway 06. The captain quickly assessed that due to limited apron space at Paraburdoo, they needed to taxi behind a Network Aviation Fokker F28 MK 0100 (F100) aircraft, registered VH-NHF (NHF), which was parked on Bay 1, also facing the terminal, to allow the inbound B717 room to pass and taxi to Bay 2, which they had just vacated.

**Figure 1: Paraburdoo Airport showing runways and parking bays**

clear and continued taxiing around the back of the F100, then turned the aircraft sharply around to the right (Figure 1 insert). The aim was to leave enough room for the inbound B717 to taxi past, and then continue onto the taxiway once they were clear.

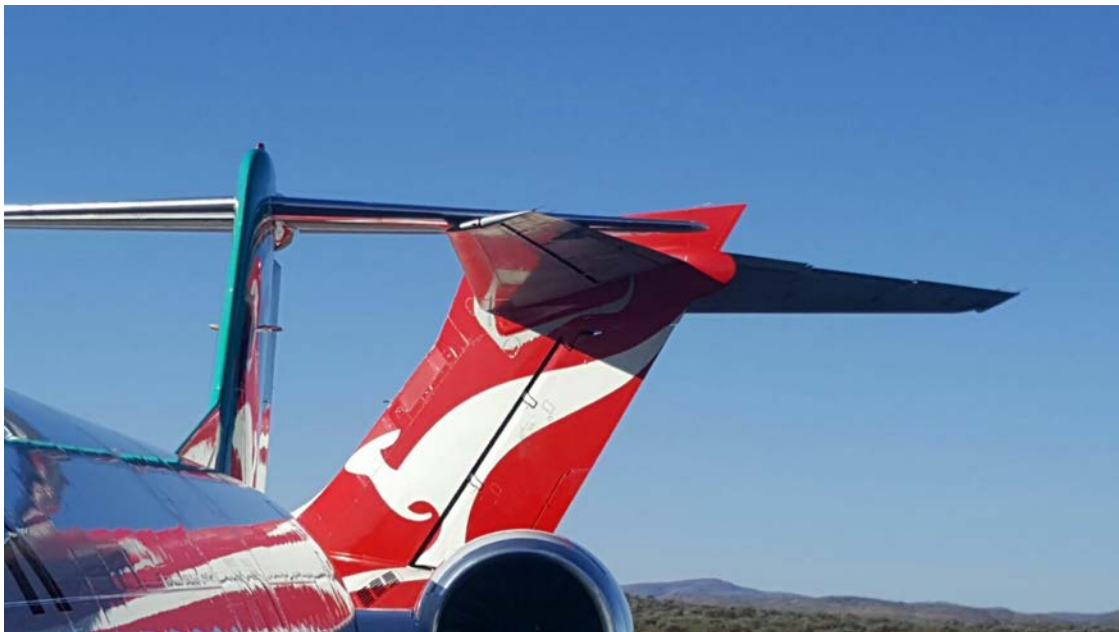
The engineer had expected NXN to taxi towards the runway rather than turning around the back of the F100. The engineer immediately assessed that the horizontal stabilisers of the two aircraft may collide, and tried to signal the captain to stop, but was near the wing of the aircraft and no longer in the captain's sight. The engineer ran towards the front of the aircraft and waved to the captain to stop. The captain braked heavily. The crew did not feel a collision. Some hours later, it was determined that the horizontal stabiliser of NXN had slid under that of NHF, scraping the surface, and both aircraft sustained minor damage (Figure 2). The passengers and crew of NXN were not injured and no one was on board NHF.

**Figure 2: Horizontal stabiliser of NXN under that of NHF**

By the time the engineer assessed that there was insufficient clearance between the horizontal stabilisers of the two aircraft, they were no longer in sight of the captain. The horizontal stabiliser of NXN slid under that of the F100 before the engineer was able to signal the captain to stop.
