Runway incursion involving Fokker F28 MK 100, and vehicle

Perth Airport, Western Australia on 19 October 2016

ATSB Transport Safety Report
Aviation Occurrence Investigation
AO-2016-140
Final – 24 March 2017

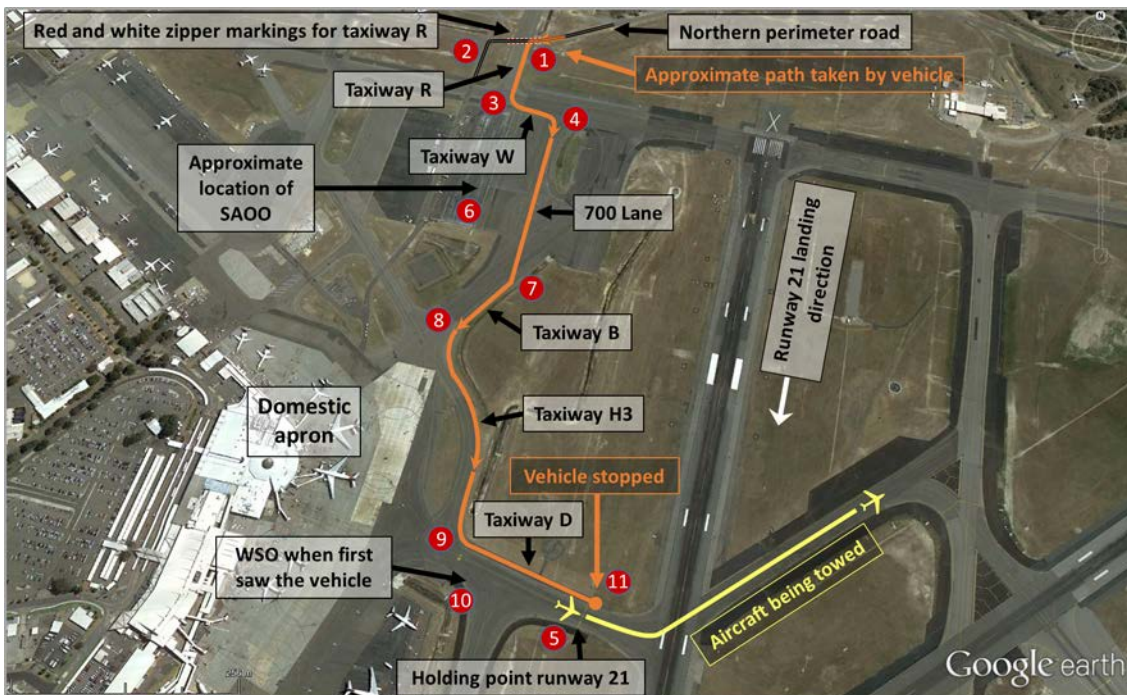
Figure 1: Airport map showing the path of the vehicle

As they drove towards the domestic apron, an area unfamiliar to the driver, the driver observed the aircraft that they were to meet, stationary in a position different to what was expected. They thought the aircraft was on the domestic apron, and instead of continuing along the northern perimeter road to the domestic apron, the driver turned left (Figure 1 item 1) and crossed the red and white zipper markings¹ that denote the road is crossing taxiway R (Figure 2). About another 50 m past taxiway R, was a left turn (item 2) for vehicles to access the domestic apron.

Rather than being parked as assumed by the driver, the aircraft was actually being towed in company with two safety vehicles and was stationary at taxiway D holding point, waiting for clearance to cross-runway 21. The vehicle then turned left onto taxiway W (item 3) and then right onto the 700 lane (item 4). At about 1038, the surface movement controller (SMC) cleared the aircraft that was being towed (item 5), to cross runway 21. At about the same time, a senior airport operations officer (SAOO), who was in a vehicle and parked near the 700 lane (item 6), noticed the vehicle traveling along the 700 lane but was not able to identify it. The vehicle turned right onto taxiway B (item 7) and then left onto taxiway H3 (item 8).

At about the same time, the SAOO contacted the SMC to determine the identity of the vehicle that was just turning onto taxiway D (item 9). The SMC advised that they assumed that the vehicle was associated with works being conducted at the intersection of taxiways A and D. The vehicle was not fitted with a transponder. A transponder was not required for operating in the non-maneuvring area of the airport, but the vehicle was displayed intermittently on the surface movement control system.²

A work safety officer (WSO), who was supervising a work site at the intersection of taxiways A and D heard this exchange and observed the vehicle in the rear-view mirror (item 10). They turned their vehicle around, and followed the unidentified vehicle that was traveling along the paved edge of taxiway D, towards the runway 21 holding point. As the vehicle should not have been there and did not appear to be stopping, the WSO used their vehicle's siren, horn and loudspeaker to alert the driver, and informed them that they were about to enter the runway and to stop immediately.

The vehicle passed over the holding point for runway 21 before it stopped. The vehicle stopped about two to three car lengths past the holding point (item 11). The WSO stopped about 5 m before the holding point and over the loudspeaker instructed the driver to go no further and to turn around. The WSO also advised the SMC that they were talking with the driver. The vehicle had stopped about 20 m before the white gable markers that denote the runway strip. The vehicle did

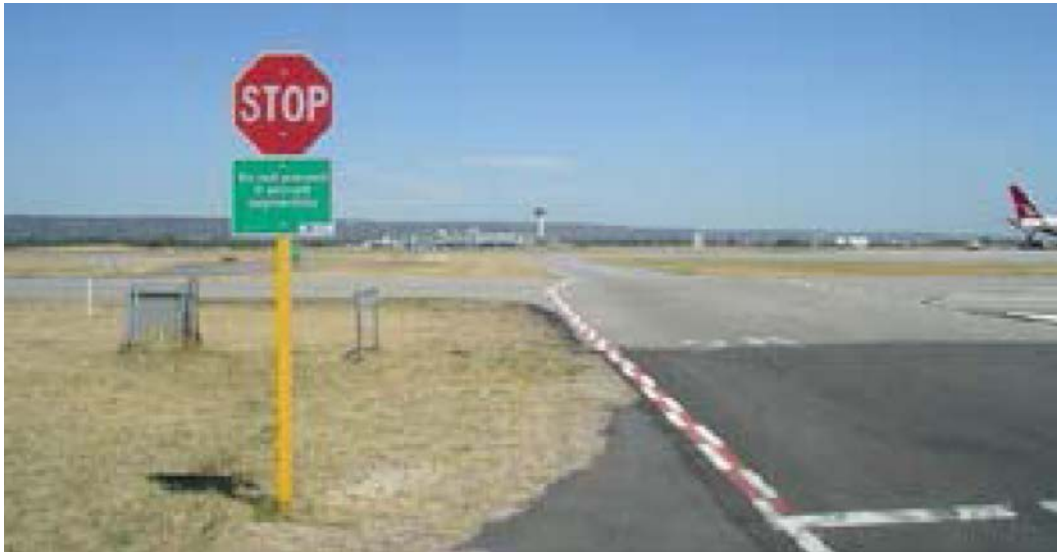
¹ Unless directly involved in the servicing of an aircraft on a bay, vehicles must use the marked roadways for traversing the apron. Where white edge lines of the road turn into red and white chequered markings (referred to as zippers), denotes an active taxiway. The driver must stay clear of this part of the roadway when aircraft are using the taxiway. At taxiway R there were stop signs where vehicles must stop and check for aircraft before proceeding across the taxiway following the road.

Figure 2: Photo showing stop sign and red and white zipper markings that denote a taxiway like that for taxiway R

- A review of the zipper markings will be conducted in areas where taxiways cross roadways to provide an enhanced level of identification to airside drivers.
- The incident and lessons regarding airfield familiarity, lost procedures and general situational awareness will be communicated in an incident alert.
- Explore the option to implement an authority to drive airside (ADA) 'zoning system', to include a review of all organisations and their requirement to access different areas of the airport.
- Review the system of ADA categories to determine if there is scope to implement a system that controls the access of particular organisations to prevent them from entering areas that they do not have a requirement to regularly access.
