Loading related event involving Airbus A320, VH-VQC

Gold Coast Airport, Queensland, 29 October 2016

ATSB Transport Safety Report
Aviation Occurrence Investigation
AO-2016-145
Final – 24 March 2017

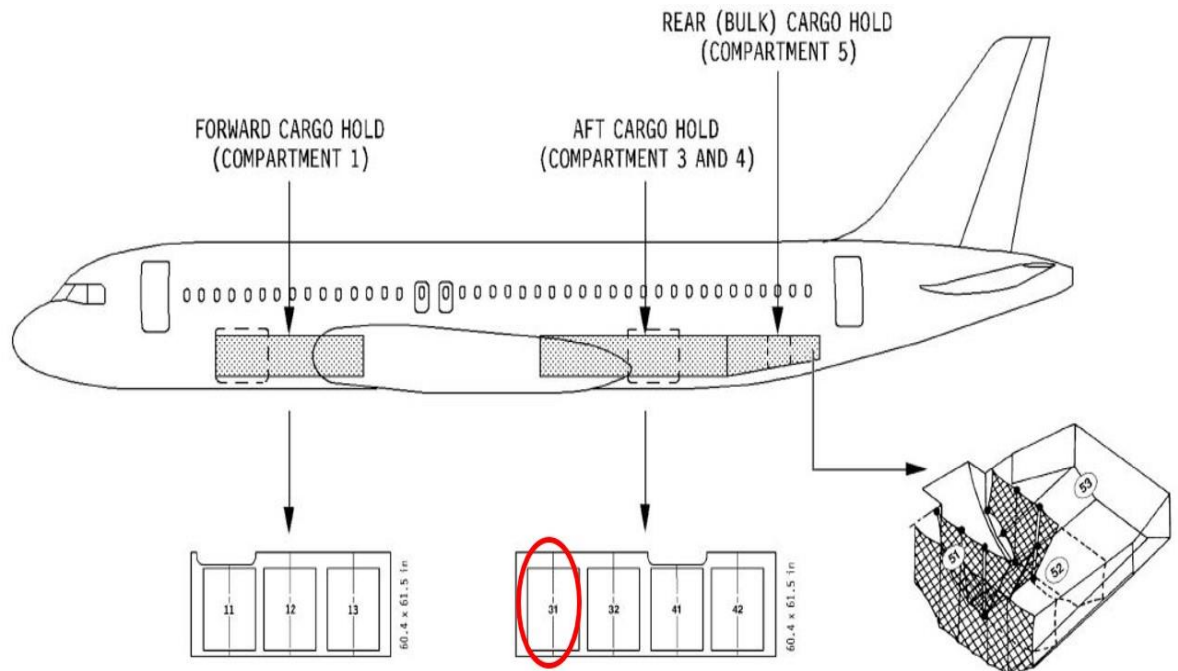
Figure 1: Aircraft hold positions (with position 31 highlighted)

Once the aircraft arrived, the leading hand estimated the unloading would require three dollies² and retrieved the dollies to unload the aircraft. Loader operator 1 unloaded containers from positions 41, 42, and 32 (Figure 1). Both loader operator 1 and the leading hand assumed only three containers needed to be unloaded.

After unloading, the loading procedures require a check of the aircraft hold to confirm if there are any containers remaining in the hold. The loader operator 1 reported checking the hold, however as they were walking towards the hold door, watching their footing, they did not detect a container in position 31. The leading hand witnessed loader operator 1 checking the aircraft hold and assumed all containers had been unloaded.

After unloading, all compartments are to be checked and confirmed as empty. Loader operator 1 did check the hold, but did not see the container in position 31. The leading hand witnessed loader operator 1 checking the hold, but did not check the hold themselves.

When a position is identified as empty on the ULA, the loader operator and leading hand are to check the position is empty and initial it on the yellow copy. The loader operator 1 had commenced the loading process but did not complete the process, nor did they check all the containers once they had been loaded. The leading hand also did not check position 31 though it was marked as empty.

- The lack of loading documentation received at the Gold Coast resulted in the ground crew not knowing the number of containers to be off-loaded from the aircraft. Loader operator 1 did not detect the container in position 31 as they checked to ensure the hold was empty.
- The loader operator and leading hand did not adequately check the containers during the loading process, leading to the container in position 31 not being noticed.
- The individual conducting the loader operator role changed during the loading of the aircraft, which likely led to a misunderstanding of how much of the loading had been completed.
- The ground crew had additional tasks to complete during the unloading and a smaller ground team than normal, which led to the hold not being checked adequately.

- Physically touch each bulkhead wall after unloading is completed, to ensure no containers are left inside the aircraft.
- If there is no leading hand present, then no movement by the loader machine including unloading/loading will be undertaken.
- If there is no yellow ULA, then no loading is to be completed.
- Yellow ULA must be completed as each container is loaded
- Yellow ULA must be handed to the leading hand for cross checking before the white ULA is taken to the crew.
- Standardised communication between loader operators and leading hand to confirm that all containers have been unloaded.
- The leading hand is to conduct a mandatory visual check to ensure unloading has been completed before any loading commences for the new outbound flight.
