Engine shut down involving British Aerospace Jetstream 32, VH-OTQ

60 km WNW of Newcastle (Williamtown) Airport, NSW, 14 December 2016

ATSB Transport Safety Report
Aviation Occurrence Investigation
AO-2016-171
Final – 27 April 2017

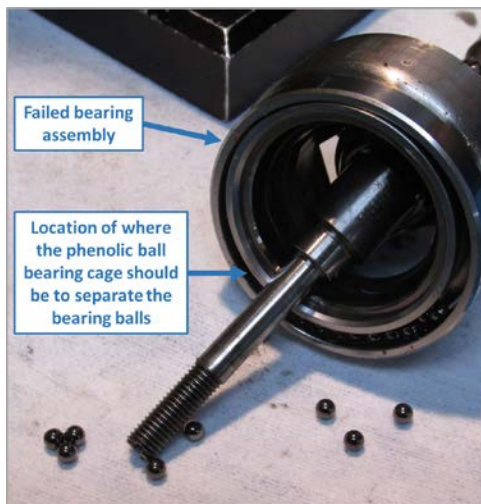
Figure 1: Failed bearing assembly

Aircraft maintenance personnel inspected the right engine after the flight and found that the engine's fuel control unit⁵ was at fault. An examination of the fuel control unit at a component overhaul facility found that the input drive shaft was not free to move. The fuel control unit was inspected and a bearing was found to have failed (Figure 1). The phenolic bearing cage⁶ that separates the bearings was found broken (Figure 2) with many small fragments found to be interfering with the operation of the fuel control unit in that area.

- The engine issue related to a failed fuel control unit bearing, where fragments of the bearing cage interfered with the unit's operation.

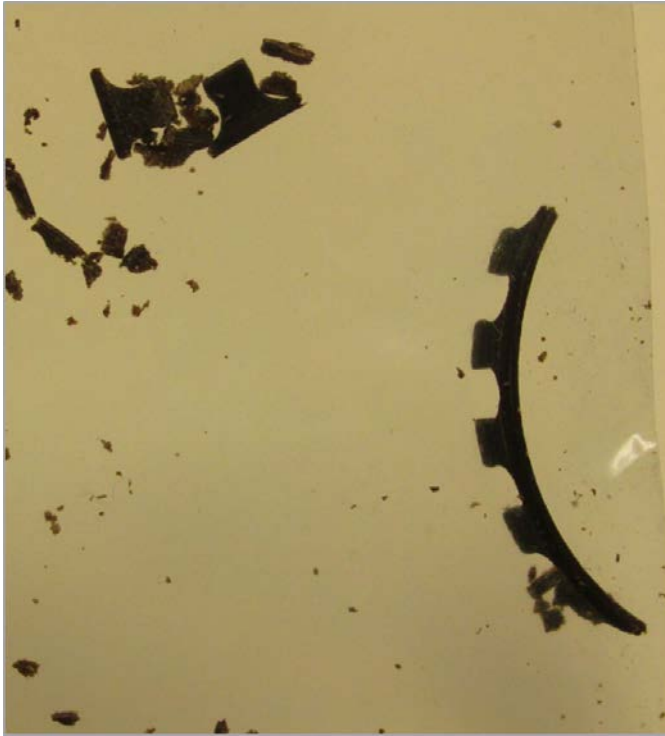
Figure 2: Pieces of the failed phenolic bearing cage

⁶ The phenolic bearing cage is manufactured from fibre-reinforced phenolic resin. The cage retains the ball bearings, to maintain a specific separation between all the bearing assembly parts.
