Landing accident involving Van's RV-6A, VH-TJM

Starke Field ALA, Queensland, 2 January 2017

ATSB Transport Safety Report
Aviation Occurrence Investigation
AO-2017-001
Final – 27 April 2017

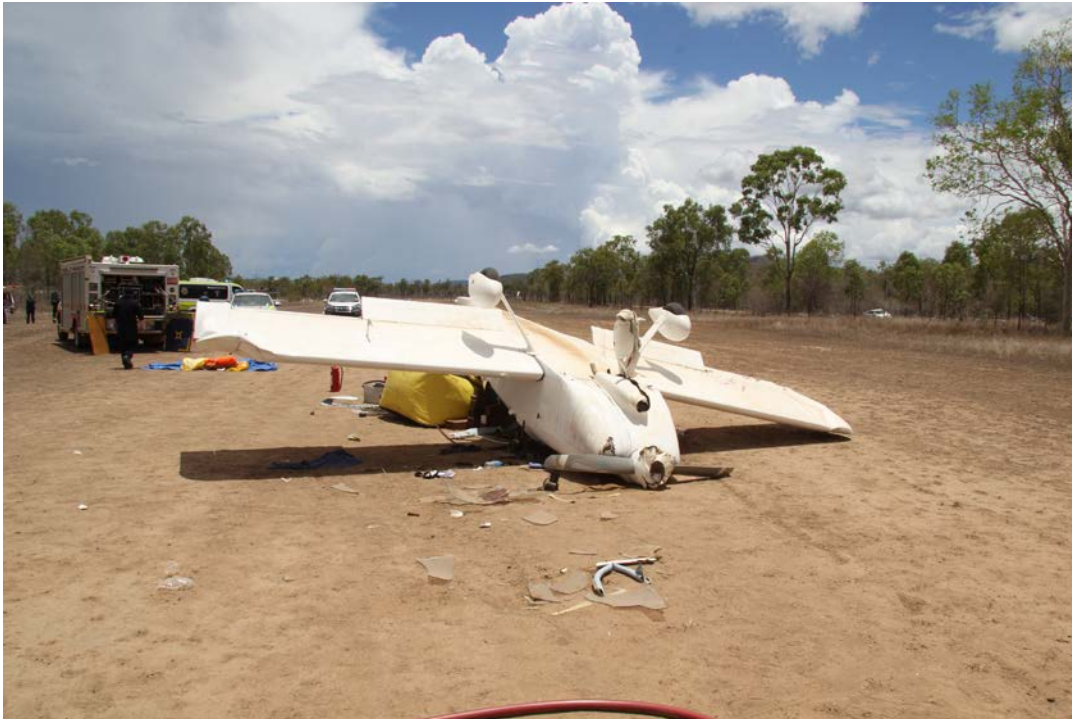
Figure 1: Accident site showing damage to VH-TJM

On 2 January 2017, the pilot of a Van's RV-6A aircraft, registered VH-TJM, conducted a private local flight from Starke Field aircraft landing area (ALA), Queensland. At about 1029 Eastern Standard Time (EST), after a flight of about 85 minutes, the aircraft approached to land at the ALA on runway 15. The aircraft landed heavily, bounced back into the air, and as it contacted the ground again, the nose landing gear collapsed. The propeller struck the runway and the aircraft nosed over and came to rest inverted. The pilot and passenger were seriously injured and the aircraft sustained substantial damage (Figure 1).

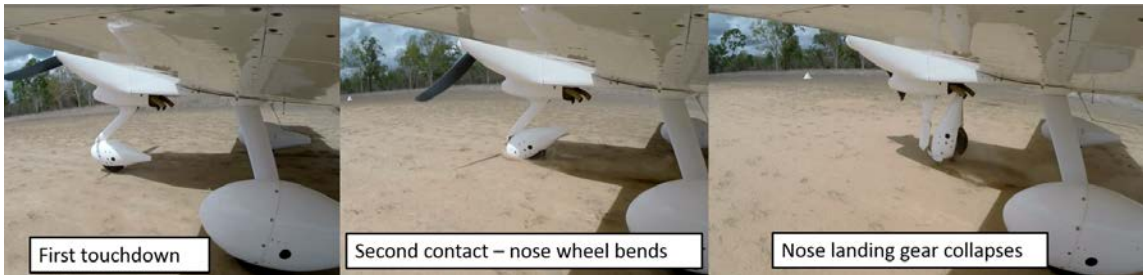
Figure 2: Landing sequence with collapse of nose landing gear

Footage from a video recording device, mounted on the underside of the aircraft's fuselage, showed that the aircraft landed heavily on the initial touchdown. The nose wheel touched very soon after the main wheels and started to vibrate (or shimmy). The aircraft then bounced back into the air and the nose landing gear was still vibrating fore and aft. The nose landing gear was aft of its neutral position when it contacted the ground the second time, just before the main wheels touched again. With that impact, the nose landing gear fork bent and the nose landing gear folded under itself. The aircraft then nosed over.

- The aircraft landed heavily at a high rate of descent and groundspeed, with the nose wheel touching down very soon after the main wheels. This probably led to the nose landing gear collapsing.

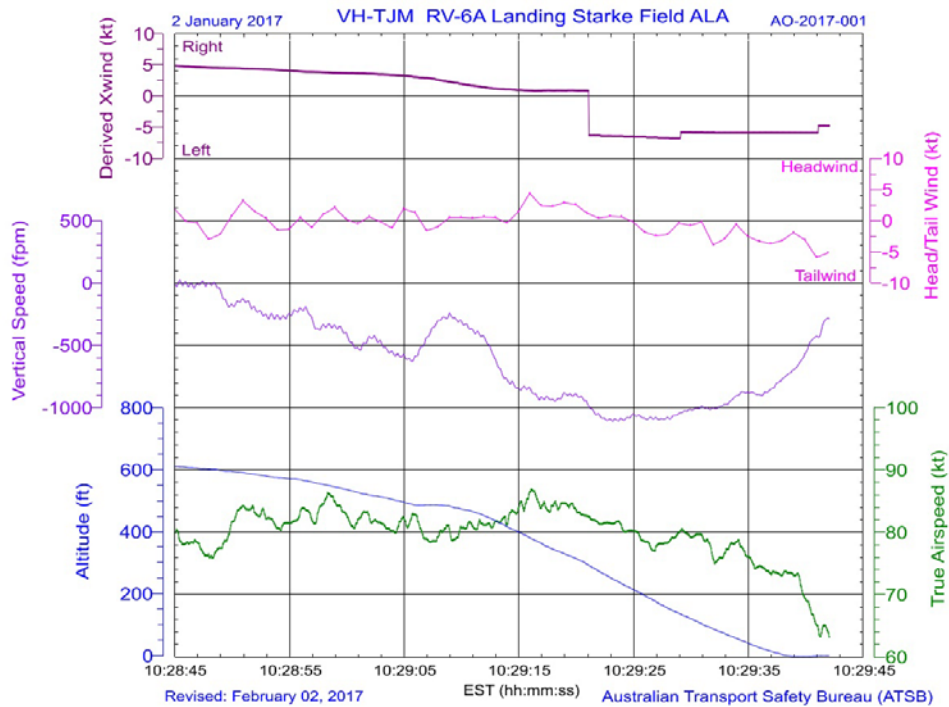
Figure 3: Flight data extract

The ATSB analysed the recorded flight data from the aircraft's avionics system for the incident flight. Figure 3 shows the final minute of the flight as the aircraft descended from about 600 ft above ground level. At 1029:21, the wind changed from 335° at 5 kt to 098° at 7 kt, the aircraft encountered a crosswind of 6 kt and the tailwind, which had been about 4 kt reduced to about 1 kt. The vertical speed at that time was about 1,100 ft per minute.

At 1029:38, the aircraft first contacted the ground, at an airspeed of about 75 kt, with a tailwind of 2 kt and descending at about 700 ft per minute.

The aircraft had a stall speed¹ of 48 kt without flaps and 43 kt with 40 degrees of flap, therefore the aircraft landed at about 1.6 times the published stall speed. The normal approach speed for an aircraft is about 1.3 times the stall speed in the landing configuration. The high rate of descent and speed relative to the ground at landing probably contributed to the nose landing gear collapse.
