Landing on the left side of the runway strip involving British Aerospace AVRO 146, VH-NJW

Darlot Airport, Western Australia, 20 January 2017

ATSB Transport Safety Report
Aviation Occurrence Investigation
AO-2017-014
Final – 24 May 2017

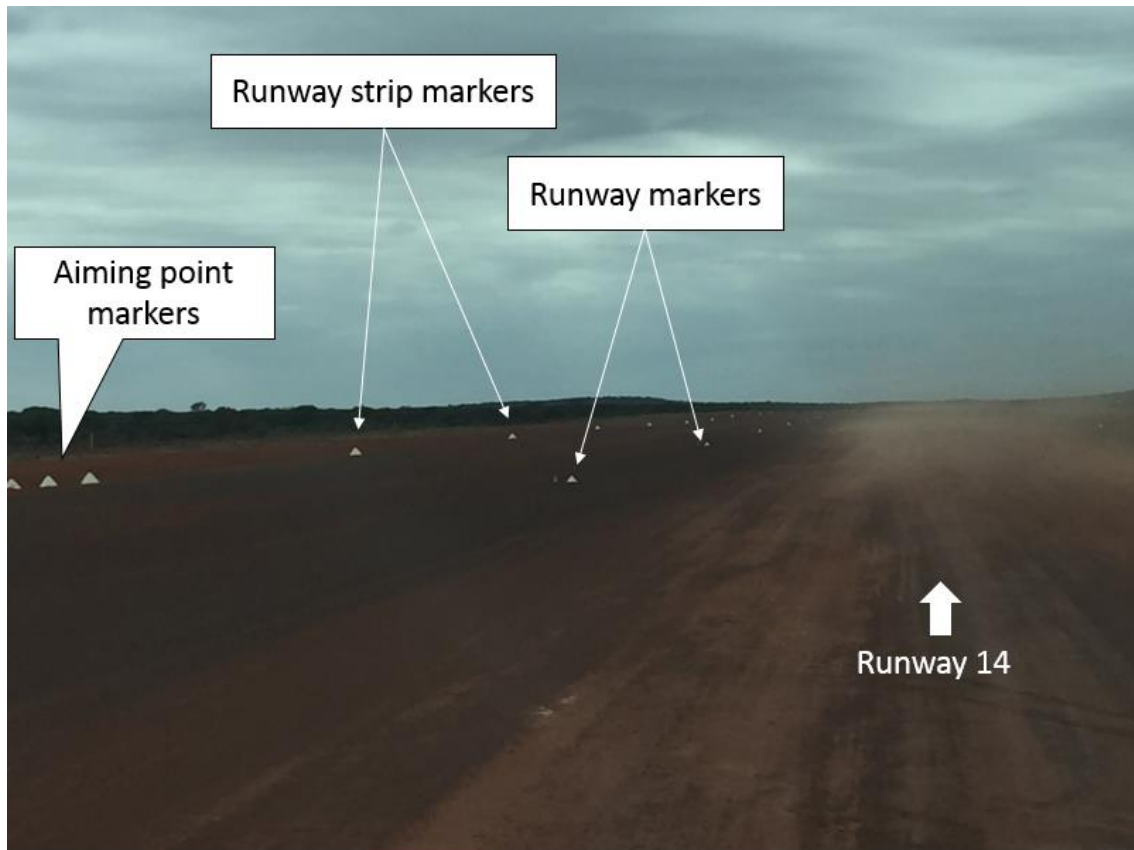
Figure 1: Darlot Airport runway 14

Source: Pilot, annotated by ATSB. Image depicts Darlot Airport runway 14 and left side of runway strip as viewed from the right seat of the aircraft with white frangible cones used as markers. Raised dust extends from the centre of the runway across the southern side of the runway strip.

Where aiming point markers are not required, such as on unsealed runways, the airport operator can elect to ‘implement an aiming point marking by providing an appropriate marking.’ Darlot Airport used three frangible white cones, either side of the runway on the edge of the runway strip, as aiming point markers (Figure 1).

runway strip markers as the left runway markers because the right runway and runway strip markers were obscured by the raised dust. This was confirmed in their mind by the presence of the aiming point markers on the left side of the runway strip. The PF was seated in the left seat and therefore used the aiming point markers on the left side as their visual guidance cue for the aircraft landing.

- The PF landed the aircraft in the runway strip to the left of the runway due to raised dust obscuring the markers on the right side of the runway and runway strip.
- Aiming point markers were employed in a non-standard manner at the unsealed runways used by the operator, which may have contributed to the PF landing the aircraft left of the runway.

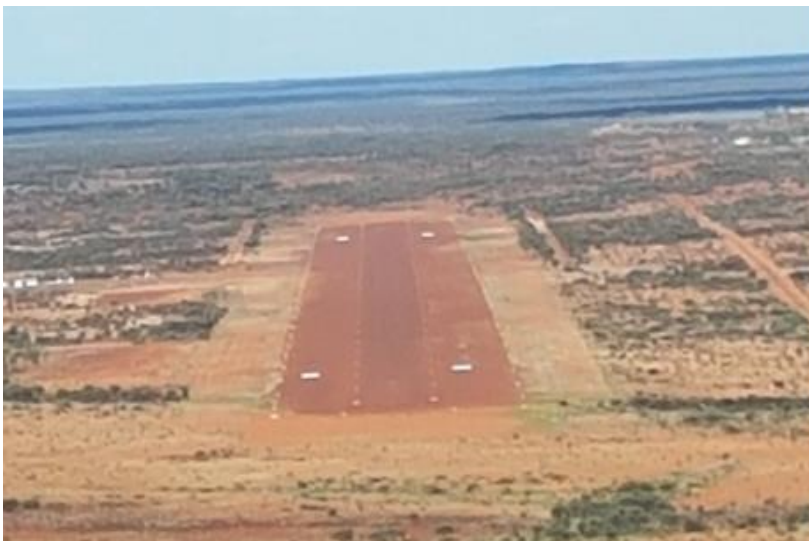
Figure 2: Gable aiming point markers within the runway strip (different airport used by the operator)

The aircraft operator provided services to three other airports with unsealed runways. Following this incident, the operator reviewed the other airports and found that at two airports the aiming point markers were located inside the runway strip (one used gable markers and the other cones), either side of the runway (Figure 2), and at the third airport the aiming point markers had been removed. Therefore, the aiming point markings were inconsistent between all four airports.

The siting of aiming point markers at airports with unsealed runways used by the aircraft operator was not standardised with respect to the type of markers used or the position of the markers relative to the runway. The pilot had experience, from operating into other unsealed runways, of aiming point markers positioned in the runway strip next to the runway. Therefore, the position of the aiming point markers on the left side of the runway strip markers was not recognised by the PF as an indicator that the aircraft was landing to the left of the runway.

The operator submitted a discussion paper to the Civil Aviation Safety Authority on the provision of aiming point markers for unsealed runways. The paper proposes the standardisation of aiming

point markers in accordance with the system previously tested by the United States Federal Aviation Administration.
