Fuel starvation and forced landing involving Piper PA-31-350, VH-HJE

11 km south of Archerfield Airport, Queensland, on 7 April 2023

ATSB Transport Safety Report

AO-2023-017

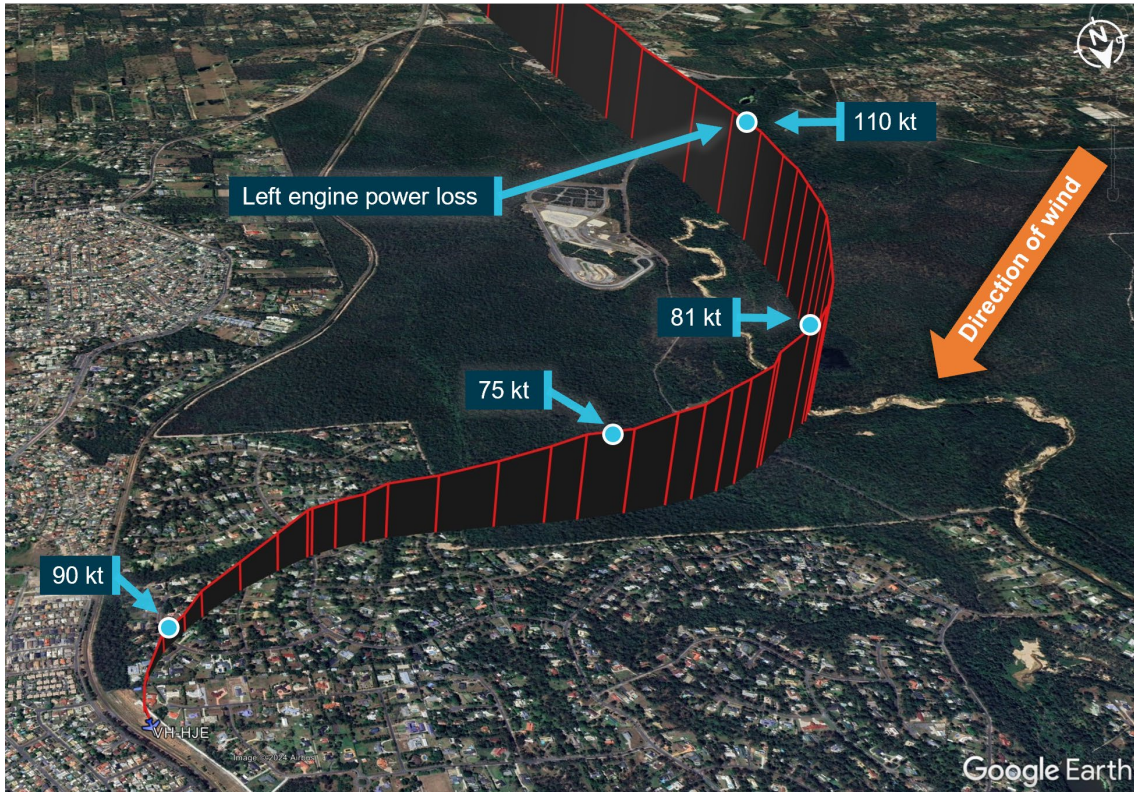
Figure 1: Flight profile showing recorded groundspeed

groundspeed fluctuated from 110 kt to a low of 75 kt. It was calculated that in the prevailing wind, this would have provided an approximate indicated airspeed of 71 kt; equal to the aircraft's clean configuration stall speed.⁶

The pilot declared an emergency and advised ATC that they were unable to make Archerfield Airport and would be conducting an off-airport forced landing. With very limited suitable landing areas available (Figure 1), the pilot elected to leave the flaps and gear retracted to minimise drag to ensure they would be able to make the selected landing area.

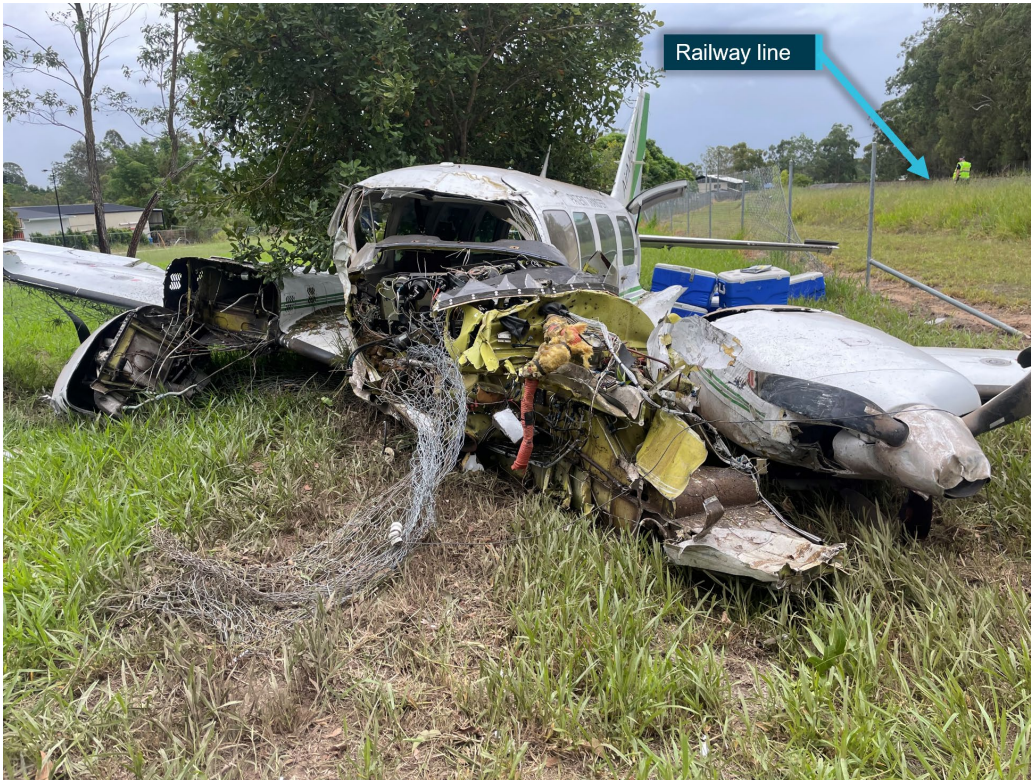
Figure 2: Accident site

At about 0605, the aircraft touched down in a rail corridor beside the railway line, and the aircraft's left wing struck a wire fence. The aircraft hit several trees, sustaining substantial damage to the fuselage and wings (Figure 2). The pilot received only minor injuries in the accident and was able to exit through the rear door of the aircraft.

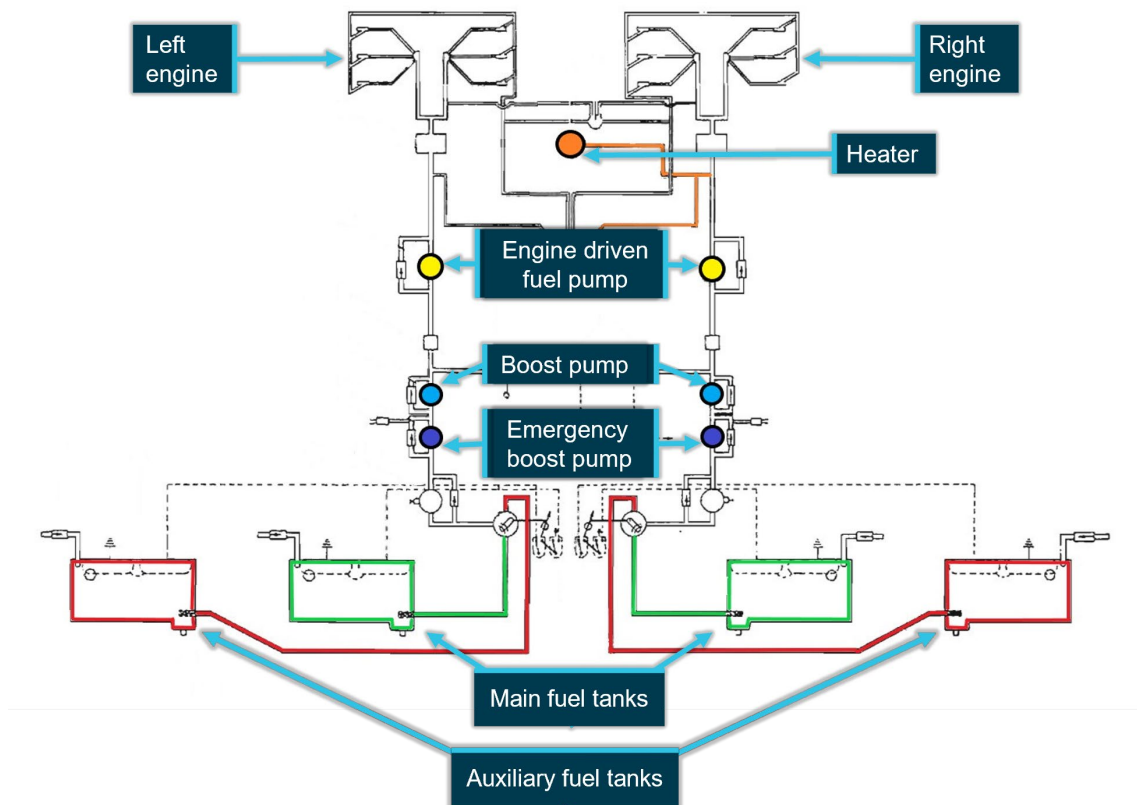
Figure 3: PA-31-350 Fuel system schematic

The fuel controls in the cockpit controlled the left and right fuel tanks' supply to their respective engines. Figure 3 shows the layout of the standard fuel system installed in the aircraft.

The pilot operating handbook contained operating instructions for the selection of tanks during various phases of flight. Due to the shape of the tanks and the location of the fuel outlet at the rear of the tanks, certain manoeuvres may cause the fuel to move away from the outlet increasing the likelihood of fuel flow interruption. To avoid this, the manufacturer published guidance around minimum quantities of fuel to be retained in each tank when manoeuvring. Further to this, inboard main tanks were required to be selected for take-off, climb and descent, with the auxiliary tanks only to be used during level co-ordinated flight in cruise. The operator adhered to the manufacturer's guidance with the checklist in Figure 4 serving as a prompt to the pilot to ensure the inboard tanks were selected for descent.

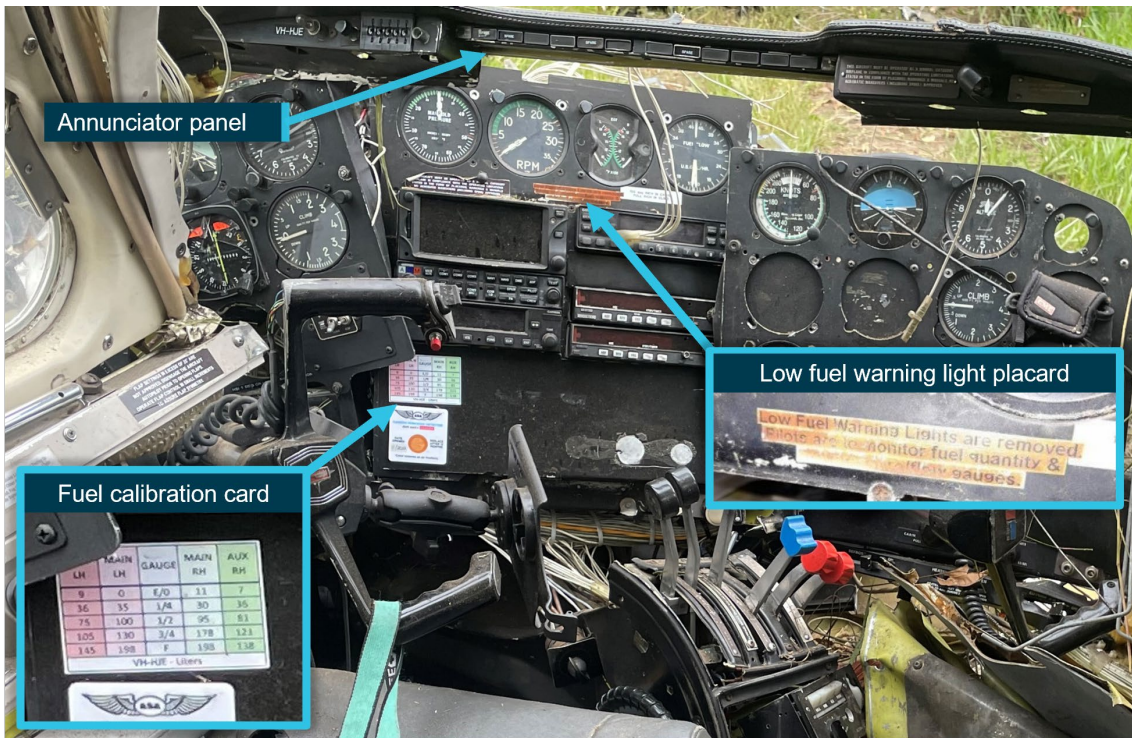
Figure 5: Cockpit

At the time of the accident, the warning system had not been reinstalled and a worn placard was installed in the aircraft (Figure 5).

Image shows the low fuel warning light placard below the engine instruments, the annunciator panel that houses the light it refers to and the fuel calibration card on the instrument panel.
Source: Operator, annotated by the ATSB

The ATSB noted that the low fuel warning light system had been removed from the aircraft. This system is essentially a low fuel quantity indication for each main tank and would not have provided a warning for low fuel flow from the auxiliary tanks. Given the substantial quantity of fuel found in the main tanks, the absence of this system was not a factor in this occurrence.
