# Collision with terrain involving Cessna 172S, VH-CPQ

3.5 km west of Camden Airport, New South Wales on 24 January 2024

AO-2024-002

Final – 23 July 2024

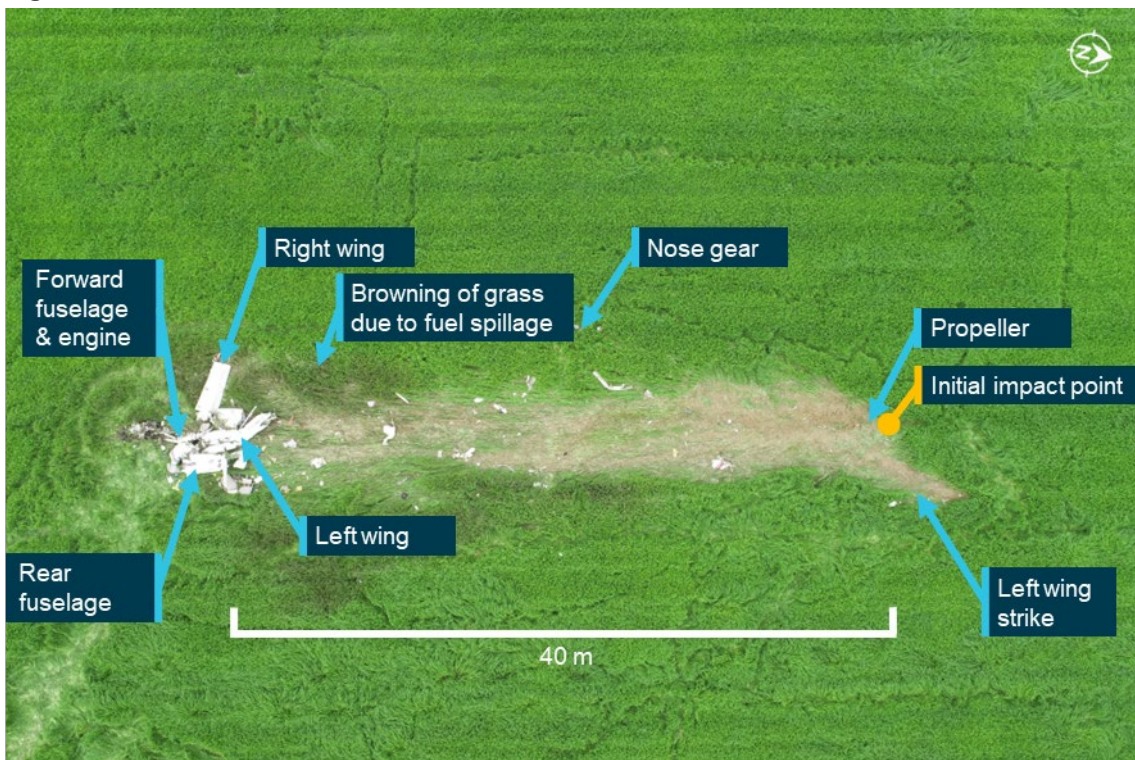
**Figure 3: Overview of VH-CPQ accident site**

The accident site was approximately 1.6 NM west of the runway 06 threshold, in a paddock. The wreckage trail extended in a direction consistent with the flight path on the downwind leg of a circuit, about 40 m from the initial impact point to where the main wreckage, including the wings, empennage, and engine had come to rest (Figure 3). The propeller detached and was embedded in the soil at the point of initial impact. All components necessary for flight, including all major sections of the aircraft's structure and control surfaces, were accounted for at the accident site.

Ground impact marks and damage to the airframe indicated that the aircraft impacted the terrain in a slightly left wing-low, steep nose-down attitude at high speed. The airframe was heavily disrupted. Pre-impact flight control continuity was established and wing flaps<sup>11</sup> were assessed to have been extended but set at less than 10° at the time of impact. There was no evidence of an in-flight break-up or other pre-impact airframe or control defects.

On-site examination of the engine did not reveal any pre-impact mechanical issues, while damage to the propeller and marks in the soil at the impact indicated that the engine was producing power at impact. The engine control positions were unable to be confirmed due to the extensive damage.

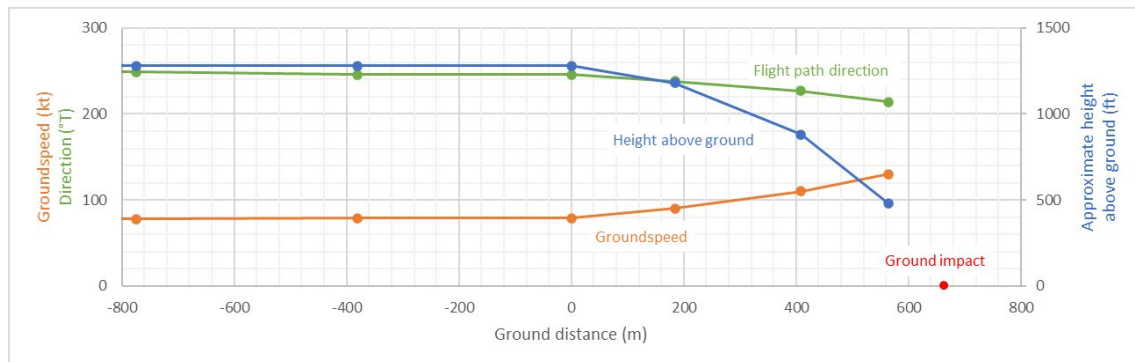
**Figure 4: Recorded ADS-B data for the descent**

Recorded ADS-B data, which was validated by the ATSB, showed the aircraft travelling at 90 kt just prior to the descent. The data showed a steepening descent, consistent with the ground impact location, and groundspeed increasing to 130 kt before impact and a very high descent rate (about 10,500 ft/min).<sup>12</sup> Accounting for wind speed and descent angle, the airspeed was almost certainly above 150 kt. The descent from level flight lasted approximately 6 seconds until impact.

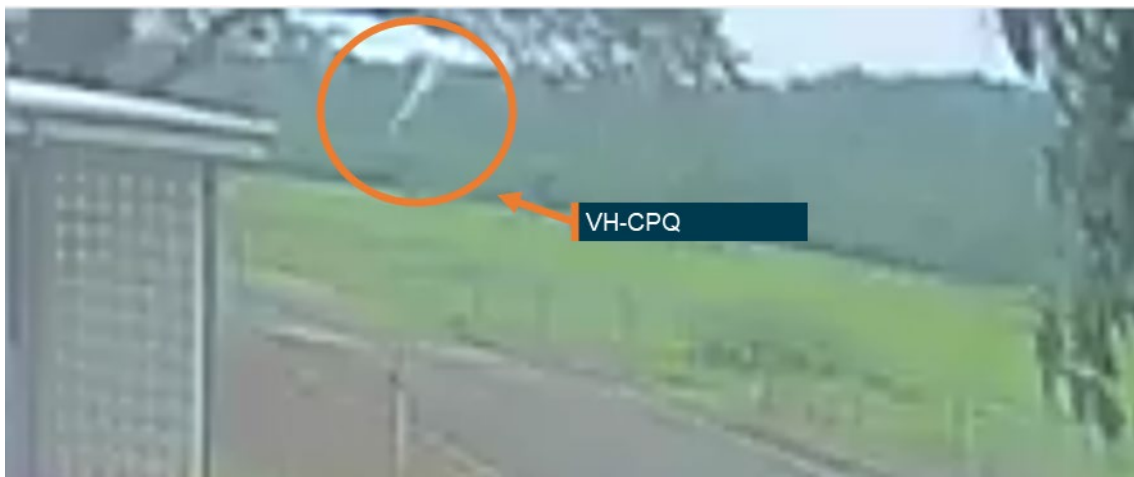
**Figure 7: Camera A**

Camera A faced southwest and captured the collision with terrain in a small part of the background. The footage indicated the aircraft was in a steep, nose-down descent on impact.

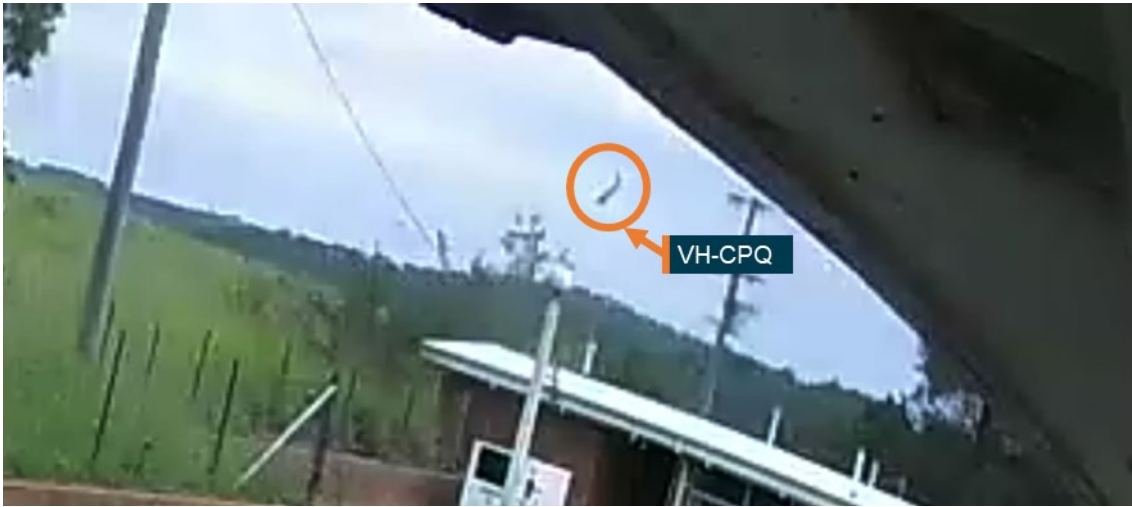
**Figure 8: Camera B**

Camera B faced west-southwest and captured the descent of the aircraft over 7 frames (at 25 frames/sec) before losing sight of the aircraft behind terrain. The aircraft was in a steep descent, with the flight path being about 60° from level, with the aircraft's nose about 60° down and wings approximately level.

Analysis of the CCTV recordings from the 2 cameras resulted in an estimated airspeed above 150 kt and a descent impact angle of approximately 60°. There was no evidence of a spin or loss of control.
