Collision with terrain involving Air Tractor AT-502, VH-AQW

17 km north-west of Bourke Airport, New South Wales on 10 February 2024

ATSB Transport Safety Report
Aviation Occurrence Investigation
AO-2024-005
Preliminary – 17 July 2024

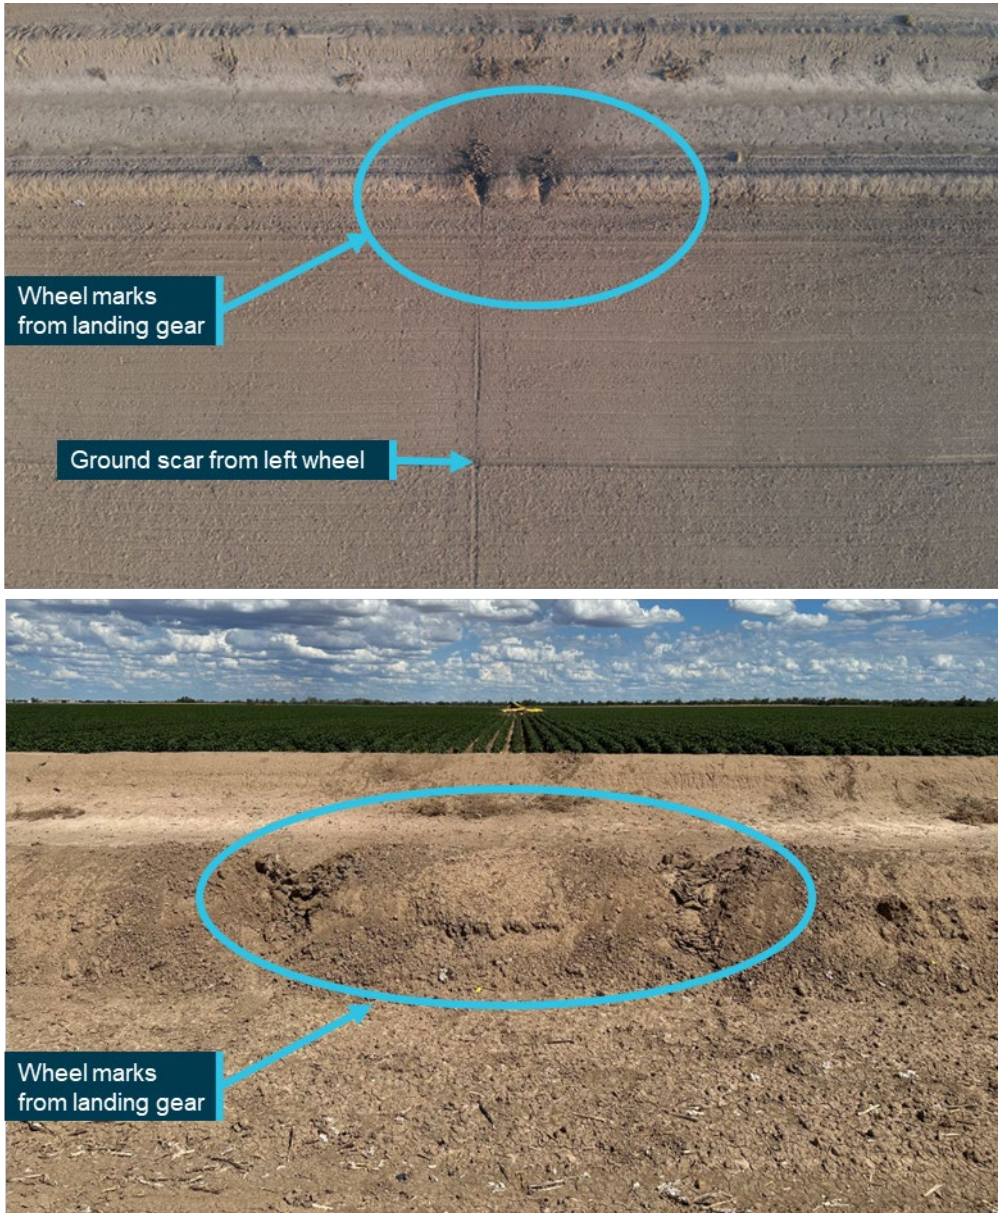
Figure 2: Wheel marks in the paddock and levee

The ATSB's site examination found that the aircraft had impacted an irrigation levee adjacent to the southernmost field to be sprayed. A ground scar about 27 m long from the aircraft's left main wheel was found in the paddock just before the levee. Two more wheel marks were found where the main landing gear struck the levee (Figure 2).

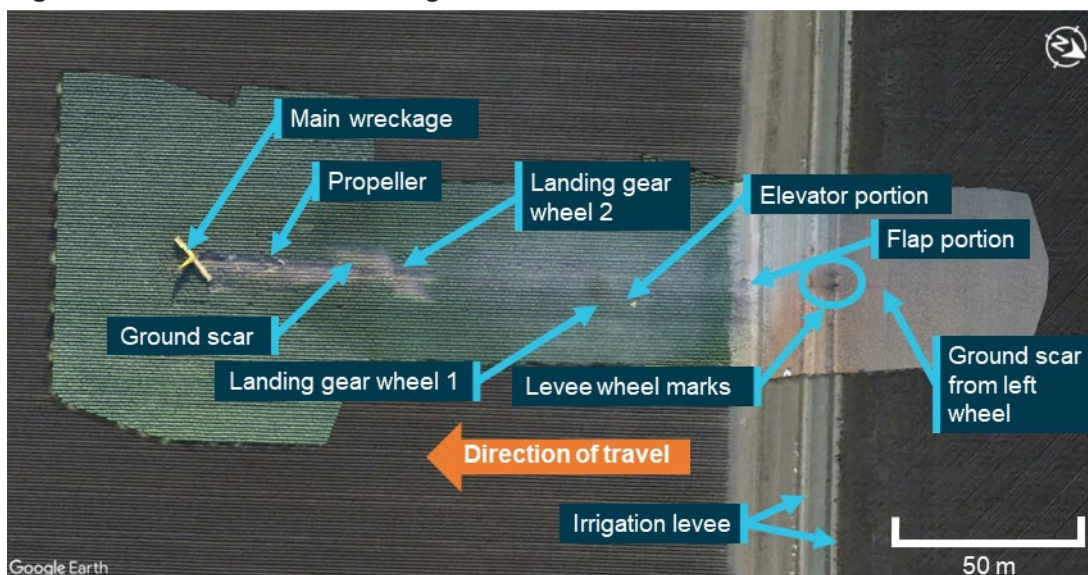
Figure 3: Overview of the wreckage distribution

A larger ground scar was found in an adjacent cotton field where additional debris, including the elevator, flap, and parts of the landing gear and the main wreckage was found. The propeller and parts of the engine were found in the large ground scar, indicating the aircraft collided with terrain nose down initially, then came to rest inverted (Figure 3). The ground scars and main wreckage were aligned with the final data point recorded on a track of about 150° magnetic and perpendicular to the levee at the site of the main wheel impact.

All the aircraft's major components were present at the accident site with no evidence of an in-flight break-up. There were no pre-impact defects identified that affected the airframe or flight controls. Examination of the propeller and engine indicated that the engine was delivering power at the time of the impact. Fuel and chemical product residues were also found at the accident site, but there was no post-impact fire.
