# Grounding of *World Diana*

Port of Bunbury, Western Australia on 22 April 2023

**ATSB Transport Safety Report**

MO-2023-001

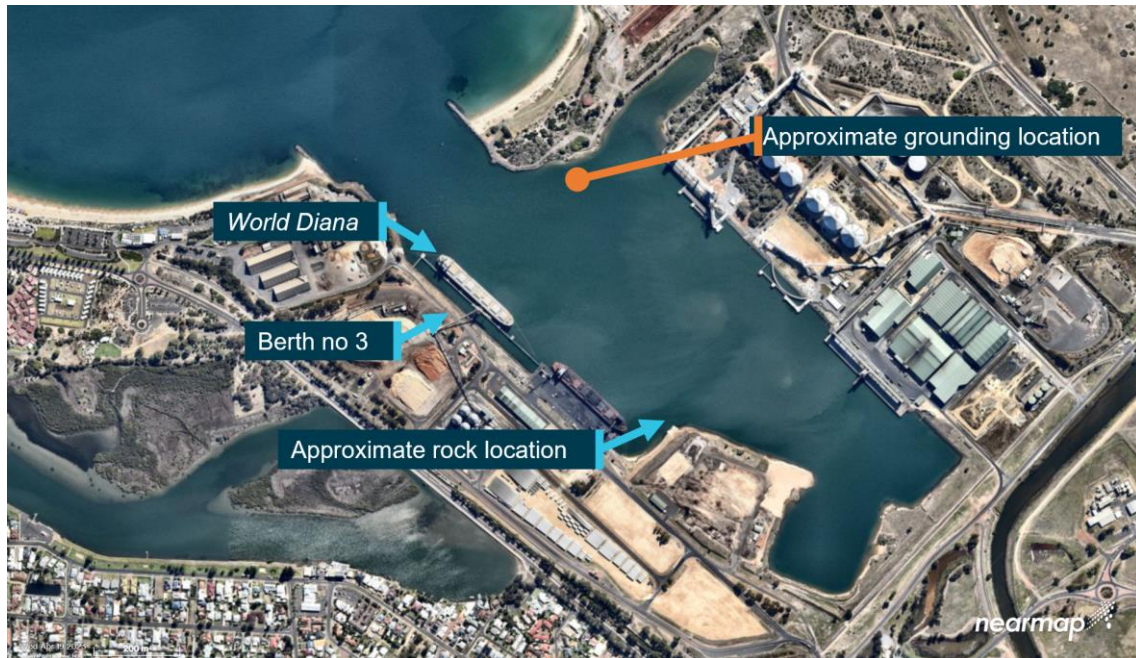
**Figure 1: Overview of Bunbury inner harbour with *World Diana* at berth no 3**

On the morning of 22 April 2023, the bulk carrier *World Diana* was scheduled to depart the Port of Bunbury, Western Australia under the conduct of a harbour pilot. The ship was berthed starboard side alongside at berth no 3 (head-in) and needed to be manoeuvred into the inner harbour turning basin and then turned to port towards the harbour entrance (Figure 1). The ship was nearly fully laden with a cargo of grain and had a draught of 11.65 m forward and 11.69 m aft (a deep draught for the port).

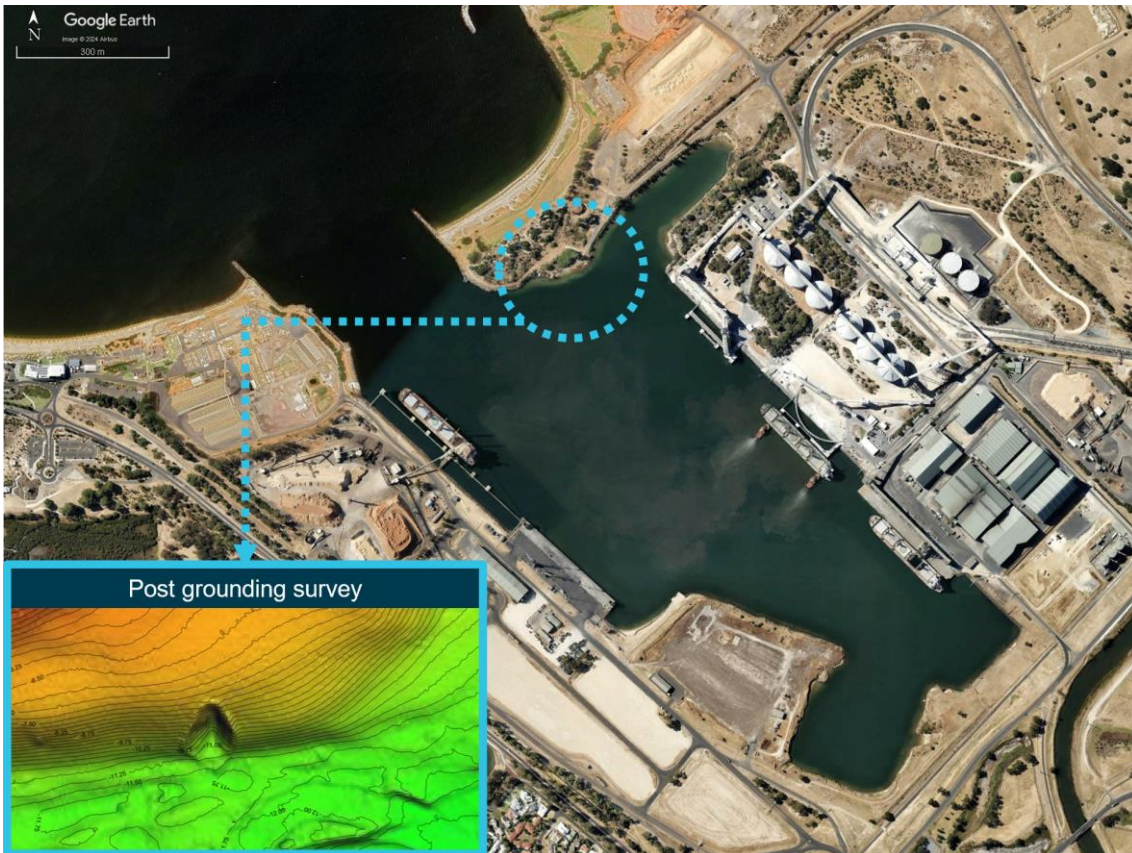
**Figure 2: Post incident survey imagery of shallow water (circled)**

Two days later, the pilot reported the incident as a near miss. A subsequent review of incident data indicated a grounding, and a survey of the seabed in the incident location was arranged. The survey identified an indentation in the soft seabed where *World Diana's* bow had grounded (Figure 2).

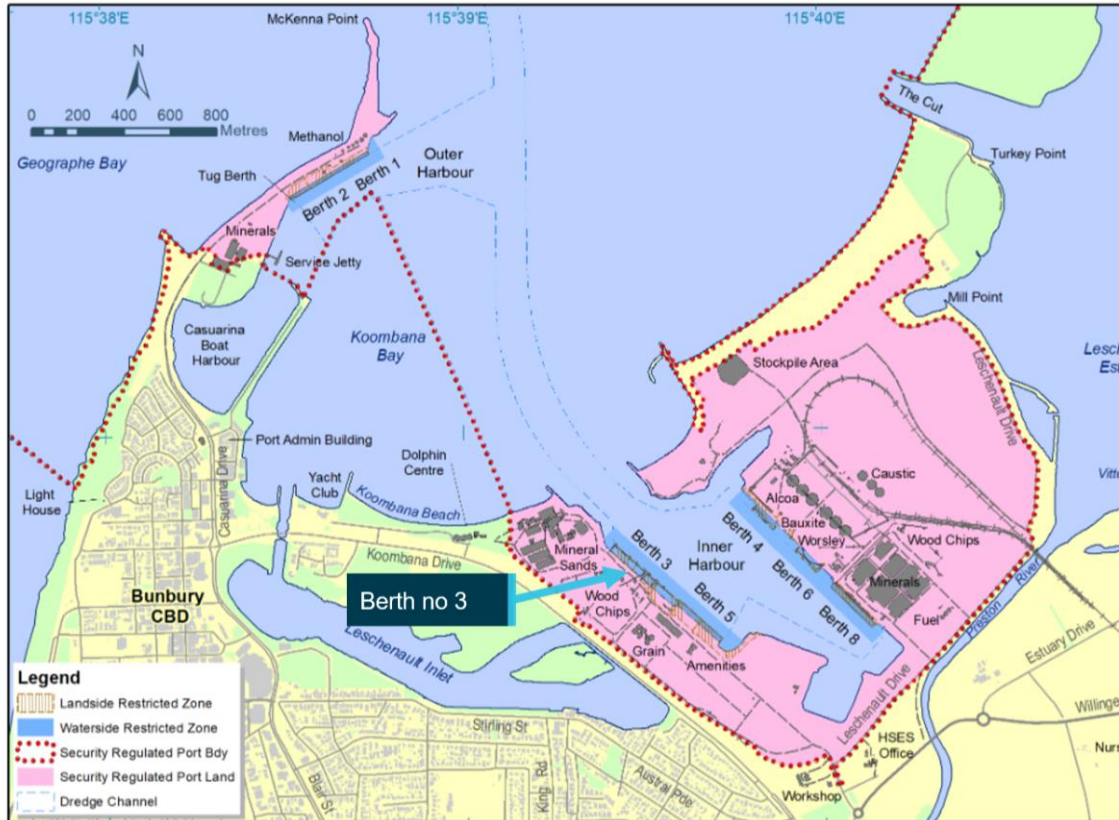
Figure 3: Bunbury harbour berth layout

The entrance to the inner harbour of the Port of Bunbury is about 150 m wide (Figure 3). The inner harbour has 5 berths, and a submerged rock is located within the 9 m charted depths off berth no 5 (Figure 6).

Berth no 3 is located on the western side, closest to the entrance. It is a specialised grain and woodchip loading berth, which started being used to load Panamax bulk carriers in September 2022. This larger size of ship had to be berthed starboard side alongside the berth to allow the cargo loaders to access all the ship's cargo holds. *World Diana* was the 10th ship exceeding 210 m that had berthed starboard side alongside at the berth.

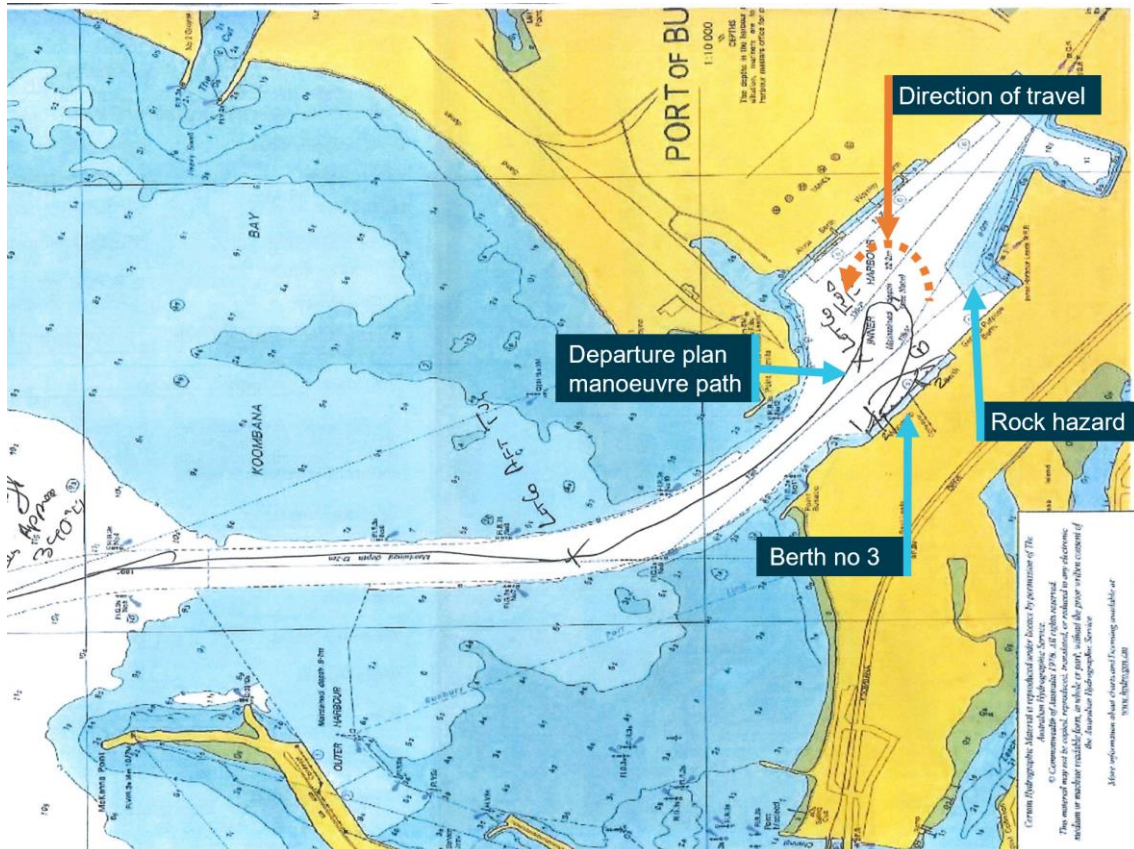
Figure 4: Departure plan diagram

Bridge resource management (BRM)<sup>5</sup> for *World Diana*'s pilotage started with a master-pilot information exchange during which the pilot presented the departure plan (Figure 4). A hand-drawn line on the plan indicated the approximate direction of travel, including the turn to port and the locations where the tugs would be cast off. It included the calculated static under keel clearance (1.82 m), but did not include any specific information such as ship's speed, rate of turn and clearing distances or associated limits. There was no bridge audio data available, therefore there was no record of what was discussed during the exchange.

The pilot reported having asked the ship master and bridge team to voice any concerns they had about the planned manoeuvre. They also stated that as the ship master was unfamiliar with the port, it was unlikely that deviations from the plan would be recognised.

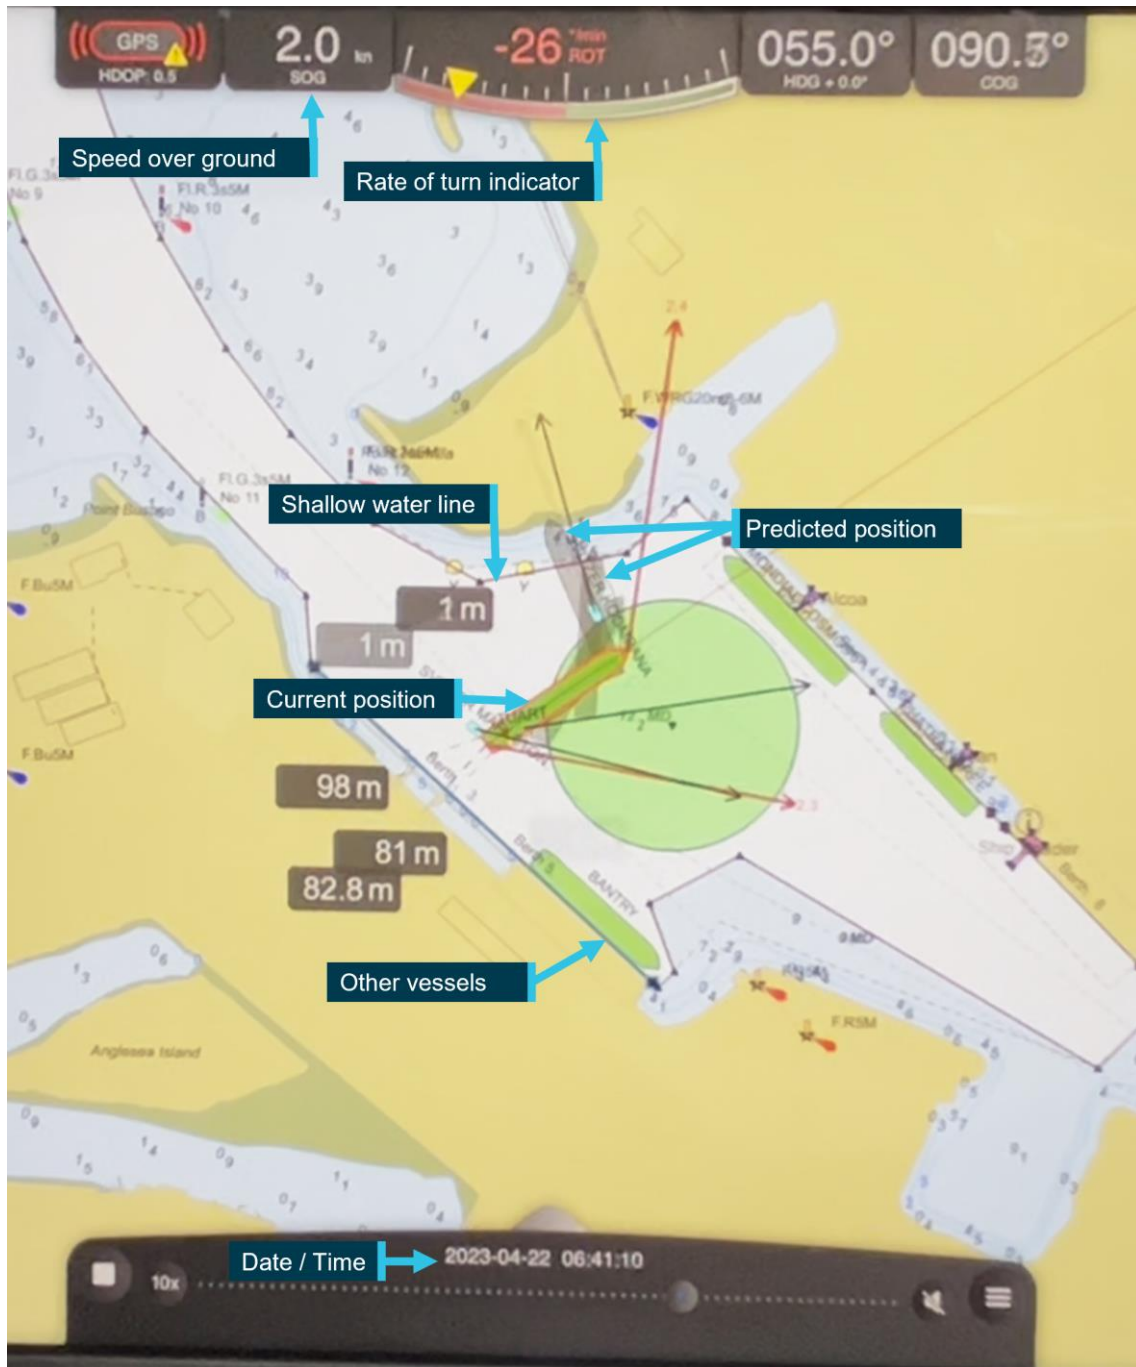
Figure 5: Portable pilot unit display at 0641

The involved pilot advised that they preferred to conduct pilotages largely by sight, using visual cues based on local knowledge and experience, and used the PPU mostly to check ship speed and rate of turn. A review of the recorded data by the ATSB identified that the PPU was showing the ship’s trajectory throughout the manoeuvring and had predicted that it was going to ground in the minutes before it occurred (Figure 5). It also showed the ship speed was 1.9 kt just prior to grounding.

The pilot's portable pilot unit (PPU) was accurately displaying the ship's position and progress in real time and indicating useful data, such as speed and rate of turn, to safely complete the turn. At 0641, the PPU predicted that the ship would ground. However, neither the pilot nor others on the bridge were using the PPU or paying attention to its display. Additionally, the forward tug's master

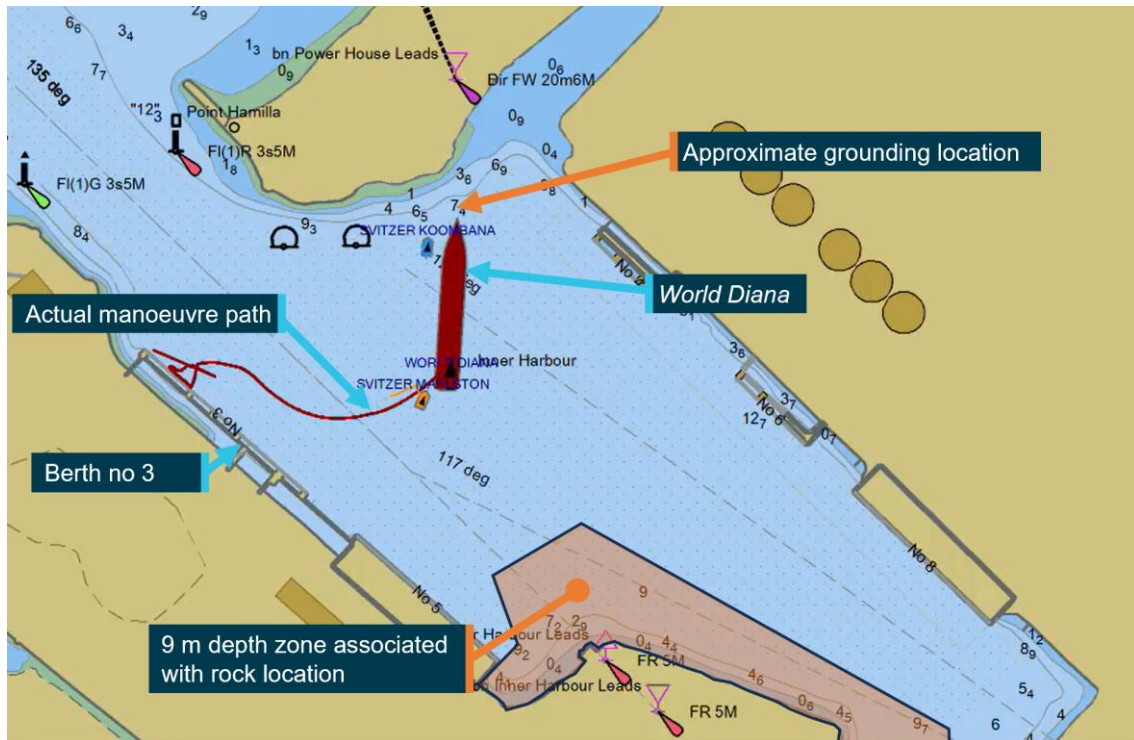
Figure 6: Actual manoeuvre path

The pilot portable unit data was used to recreate the ship's path (Figure 6).

According to the pilot, the turn was started early to keep clear of the submerged rock near berth no 5. The pilot stated that the plan was to have the aft tug push and then pull the ship back into position, but the ship's speed unexpectedly increased. The pilot attributed this to the aft tug pushing at full power at a slight angle, increasing the ship's headway. The pilot attempted counteracting this by running the ship's engine half astern and reported that as the rate of turn was 22°/minute and increasing, the propeller was ineffective in arresting the headway. The pilot then resorted to using the forward tug to push at full power, but the tug had run out of sea room. Subsequently, the pilot instructed the tugs to pull back on the tow lines in an unsuccessful attempt to prevent the grounding.

At approximately 0632, shortly after the ship had left the berth, the pilot began turning the ship to port earlier than planned using both tugs, the ship's main engine and steering. According to the pilot, the turn was started early to keep clear of the submerged rock near berth no 5. However, the rock was located off the farthest end of berth no 5, over a ship length ahead of the ship's bow. Significantly, starting the turn early also reduced the sea room available to turn.

By 0636, use of the ship's main engine had resulted in developing slight headway (0.3 kt). Four minutes later, the speed had increased to 1.5 kt and the ship was turning rapidly towards the shallow waters to the east of harbour entrance. In response to the developing situation, the pilot reversed the main engine (half astern) and instructed the aft tug to push at full power on the port side to turn the ship in the limited sea room. After a couple of minutes, the pilot realised that the turn could not be made in time to avoid the shoals and attempted to arrest the turn followed by an attempt to arrest the headway by using the tugs. These measures were unsuccessful, and shortly after 0643, the ship's bow grounded.

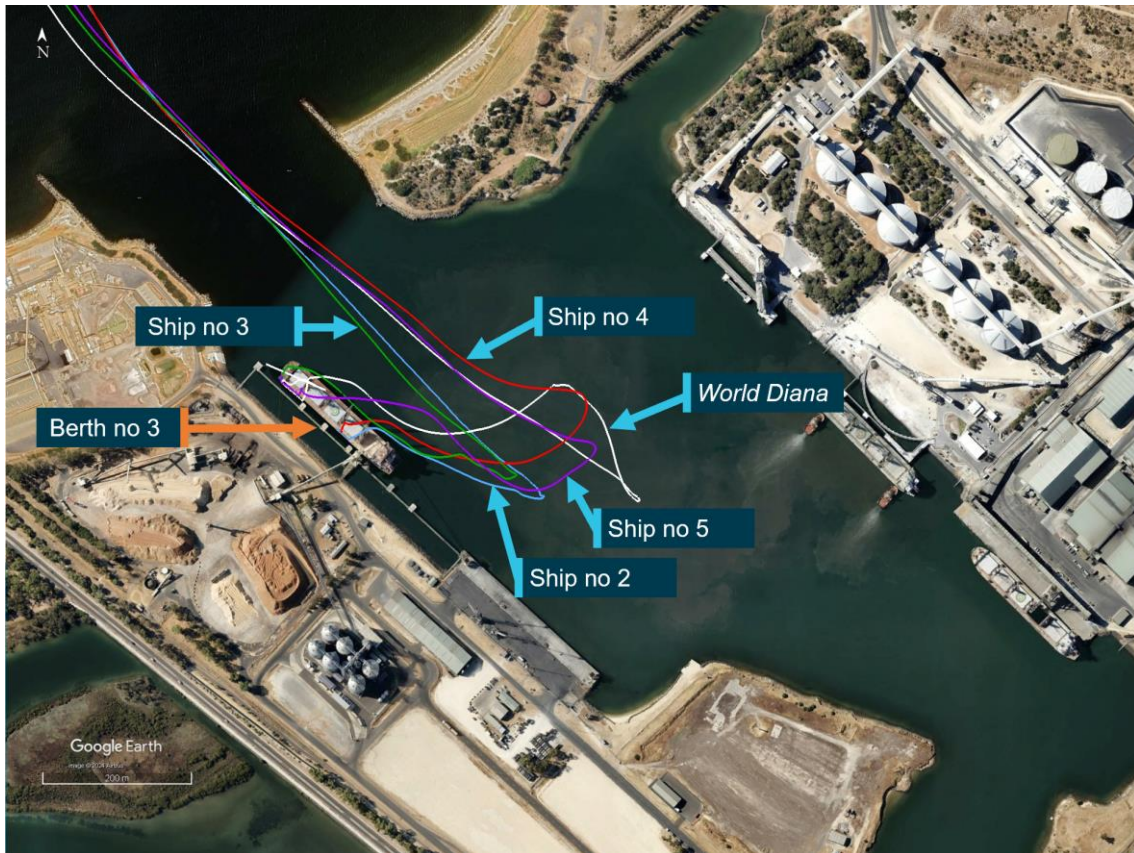
**Figure 7: Ship departure tracks from berth no 3**

The ATSB compared ship track PPU data from 4 of the previous departures from berth no 3 with *World Diana's* track. This showed that the ship's turn was started earlier than the others and that it was later manoeuvred further to the east of the turning basin (Figure 7). The maximum rate of turn achieved during these departures did not indicate wide variations, with *World Diana's* rate of turn similar to the incident-free departures (Table 1).

*Ships referenced in image all have an approximate length of 229 m and show a different starting position due to their movement along berth no 3 used to load different hatches. The PPU data point is taken from a single position at the bridge of the ship. Labels also used as reference for Table 1.*

- standard procedures for departing all berths, including berth no 3 after berthing starboard side alongside.
- a maximum rate of turn for turning ships in the harbour of 20° per minute.

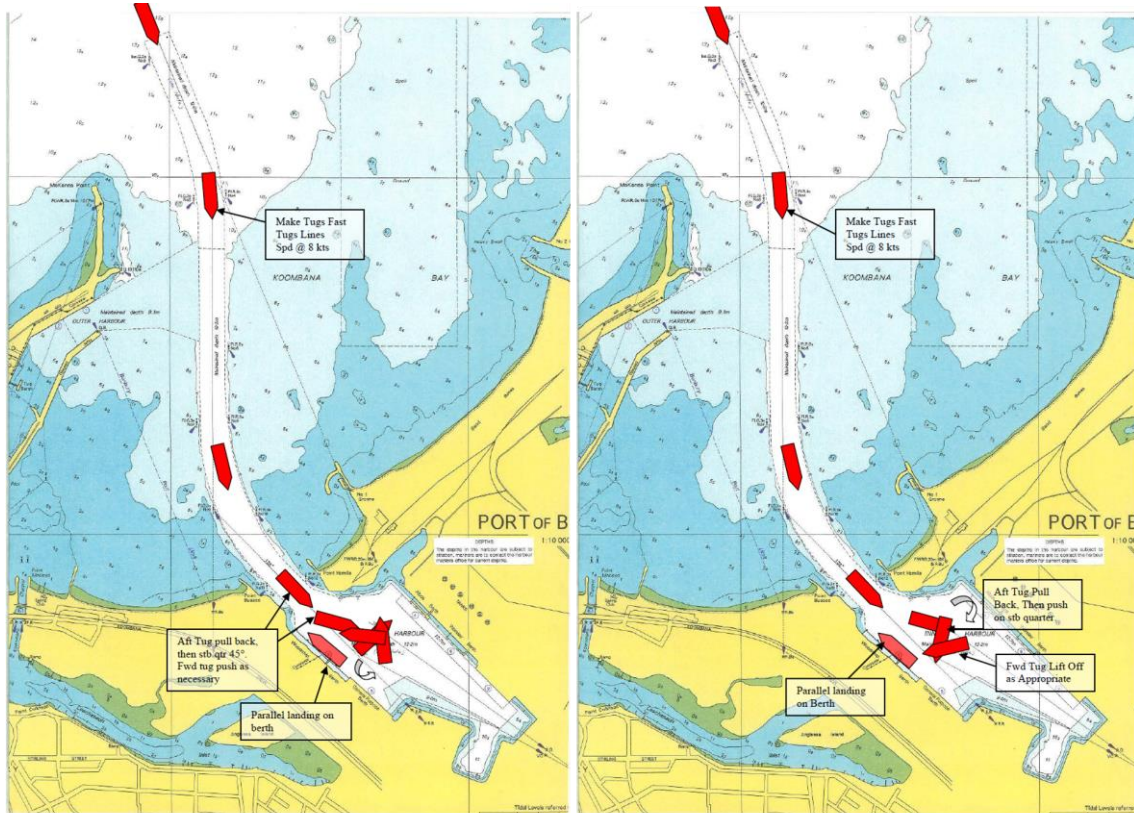
Figure 8: Arrival procedures for berth no 3

The procedures manual provided arrival plans for all berths, including guidance for entering the harbour. These plans indicated berthing the ship head-out (that is, bow facing harbour entrance) by turning the ship either to port or starboard as shown below for berth no 3 (Figure 8). Specific ship-handling guidance such as rate of turn or speed was not provided. The manual did not include a plan to berth a ship starboard side alongside berth no 3. No departure procedure or plan was provided for any berth. In their departure plans, pilots used a copy of the chart to hand-draw a plan, such as in this case (Figure 4).

The investigation identified that no procedures had been developed that included arrival and departure plans for larger ships that were required to berth starboard side alongside berth no 3. This reduced the information available to pilots for these ship movements and to share with bridge teams and tug masters to ensure a common understanding of how manoeuvring would be conducted.

The Southern Port Authority has updated its Marine Pilotage Standards and Procedures Manual to include:
