Level crossing collision between freight train 7SP5 and a truck

Barrier Highway level crossing near Cutana, South Australia, 31 December 2023

Rail Occurrence Investigation

RO-2023-009

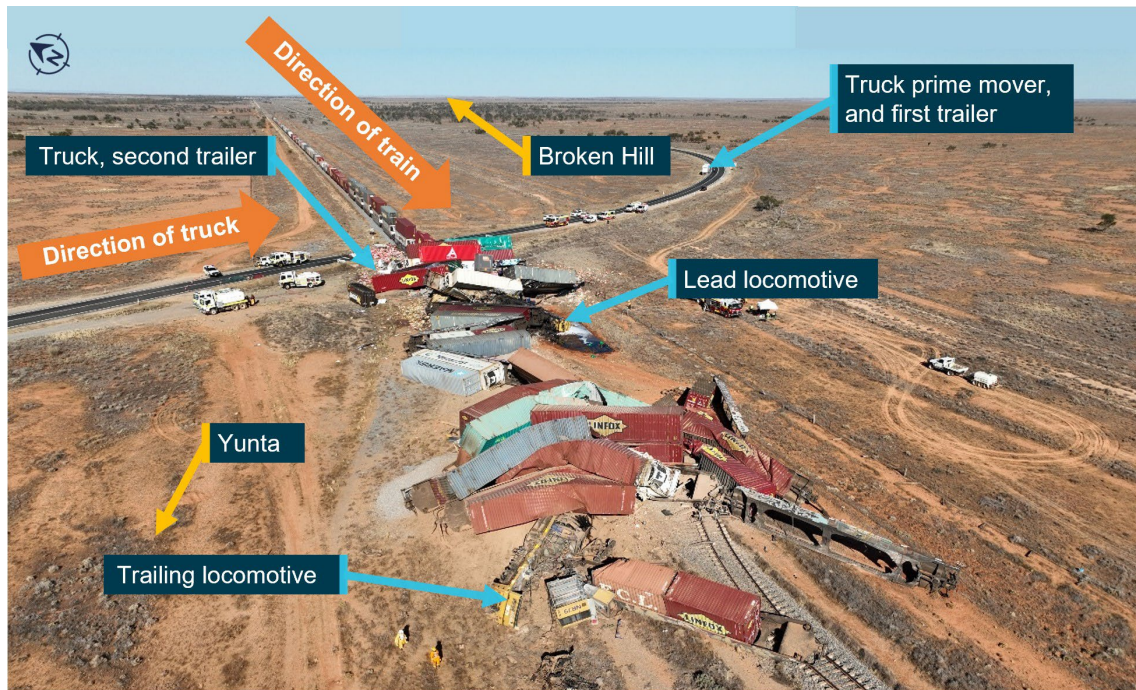
Figure 2: Overhead image of the accident site

At approximately 1015 the truck, travelling at about 90 km/h, entered the activated level crossing into the path of Pacific National train 7SP5. The train, travelling at about 84 km/h, collided with the trailers of the truck, resulting in the derailment of both locomotives and 6 multi-platform 5-pack⁵ wagons. The second trailer of the truck, both locomotives and several wagons were destroyed in the collision as well as substantial damage to the track and signal infrastructure, and active level crossing traffic controls (Figure 2). The train drivers received fatal injuries and no injuries were reported for the truck driver.

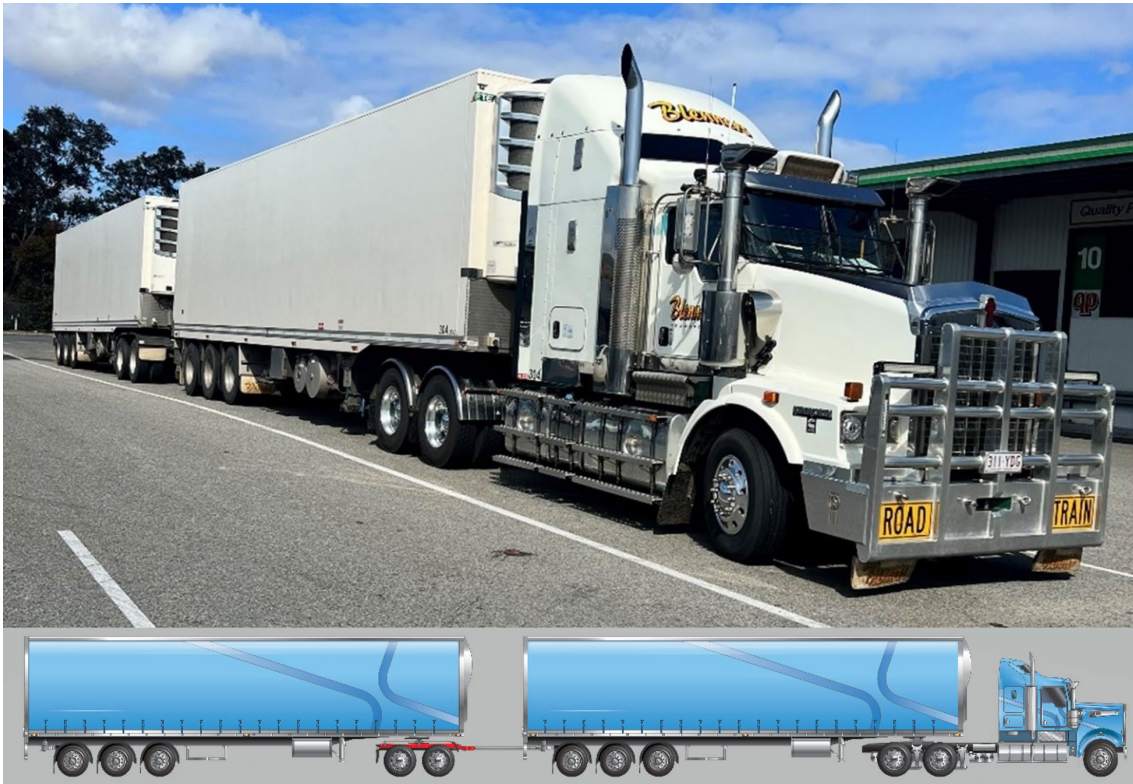
Figure 3: Truck configuration prior to collision

The truck was a 2018 Kenworth T659 prime mover, coupled to 2 FTE3A model refrigerated semi-trailers in an A-double road train configuration (Figure 3). The combined unloaded weight of the truck and trailer was about 35 t. At the time of the collision, the truck was loaded with avocados and was on a return trip from Perth, Western Australia. The estimated weight of the loaded truck trailer combination was 78 t.

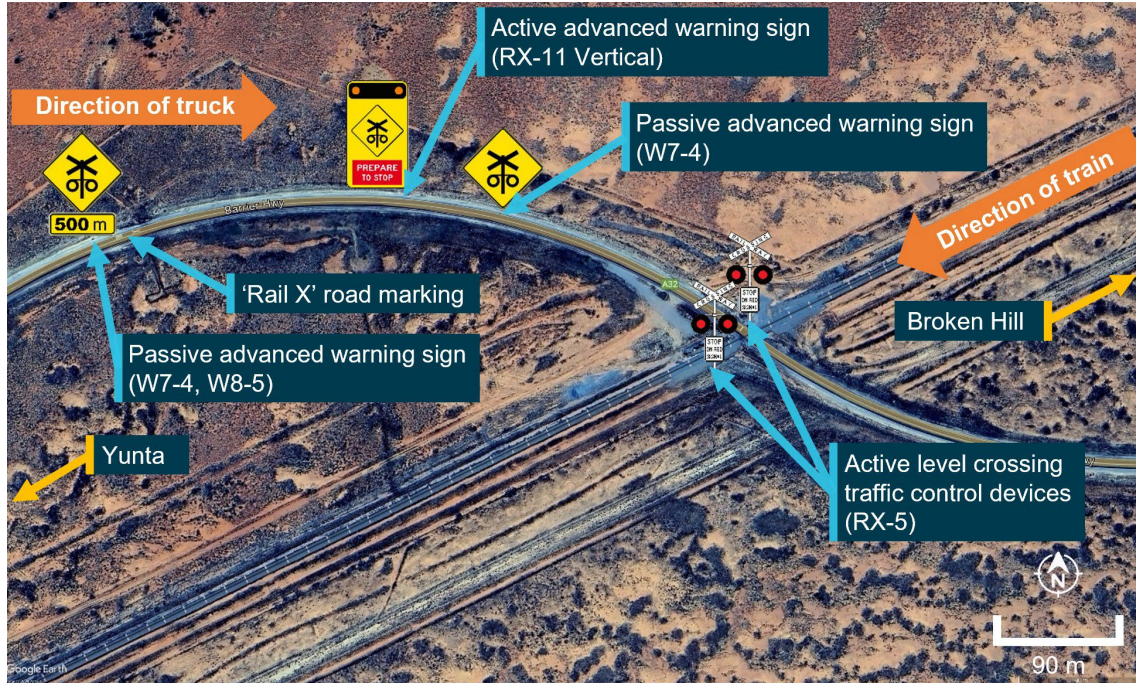
Figure 4: Aerial view of the level crossing approach and road alignment

The Barrier Highway at the location of the level crossing is oriented in a north-east to south-west direction before curving right immediately prior to the level crossing. On the other side of the level crossing, the road returned to a north-east to south-west orientation (Figure 4). The maximum speed limit for road-trains was 90 km/h.

The level crossing approaches were fitted with passive road markings, passive advanced warning signs and active advanced warning signs (Figure 4). The placement of these signs from the level crossing, in the direction the truck approached the crossing, was about:

- 500 m for the first passive advanced warning sign (sign type W7-4 and W8-5)
- 485 m for the 'Rail X' road marking
- 267 m for the active advanced warning sign (sign type RX-11 vertical)
- 193 m for the last advanced warning sign (sign type W7-4).
