Loss of control and collision with terrain, Cessna 150, VH-RXU

270 km SE Alice Springs, Northern Territory | 12 July 2016

ATSB Transport Safety Report
Aviation Occurrence Investigation
AO-2016-074
Final – 28 July 2017

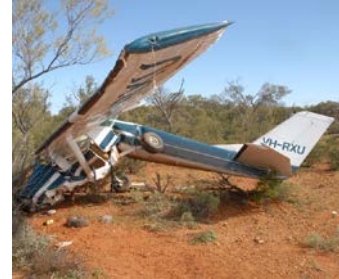
Aircraft wreckage

For reasons that could not be determined, the pilot lost control of the aircraft and was unable to arrest the descent before the aircraft impacted the ground heavily. The pilot was the sole occupant on-board the aircraft and was fatally injured. The aircraft sustained significant damage.

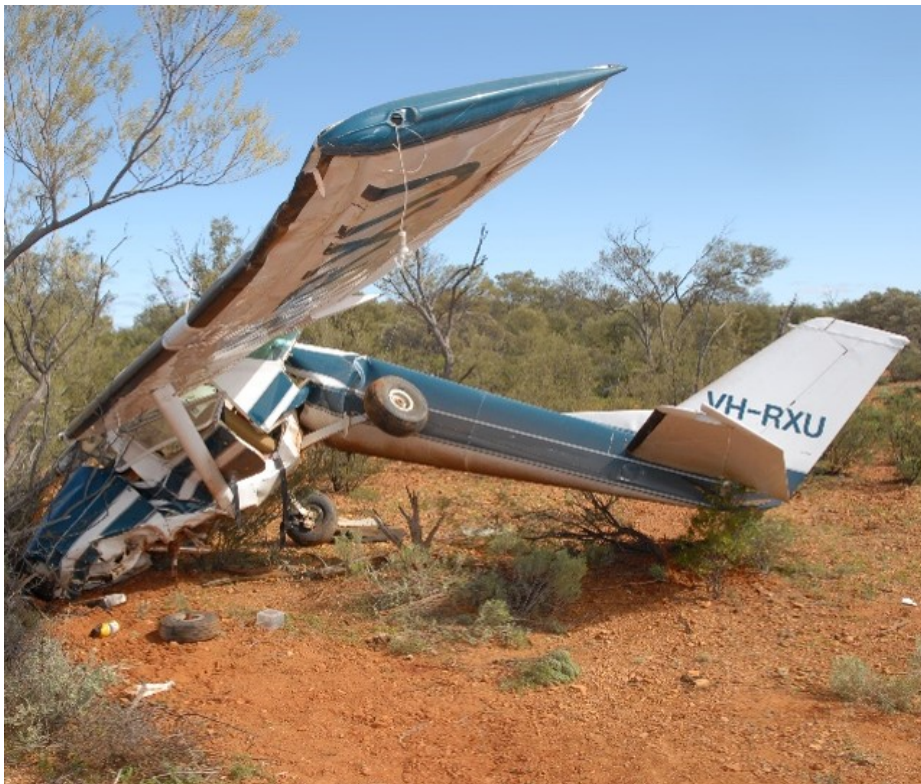
Figure 2: Photograph showing the accident site terrain and impact damage to the aircraft.

Photographic evidence provided to the ATSB indicated that the aircraft impacted the ground and slid approximately six meters before coming to rest upright, with the right wing tip resting on the ground, and the left wing in the air. Despite significant damage, all major components remained attached to the aircraft, and the wreckage was not subjected to a post impact fire (Figure 2).

Ground marks consistent with a left wheel and left wing impact and sliding, was observed to the left of the wreckage. As a result of the ground impact, the pilot who was the sole occupant sustained fatal injuries.

There was no evidence of upward movement of the tailplane as would have been expected had the impact angle been steep. This indicates the aircraft's nose impact angle was low (less than 45 degrees).

The left wing displayed a high level of impact damage to the lower outboard surface of the leading edge from the wing tip to approximately 1/3 its length (Figure 2). Crumpling and upward bending of the wing was evident behind the leading edge impact area and toward the wing root. It was probable that the left wing was part of the initial impact sequence of the aircraft. The right wing displayed significantly less damage, which was limited to the wingtip. Both wing fuel caps were in place and fuel seepage was observed from around the over-wing refill points.

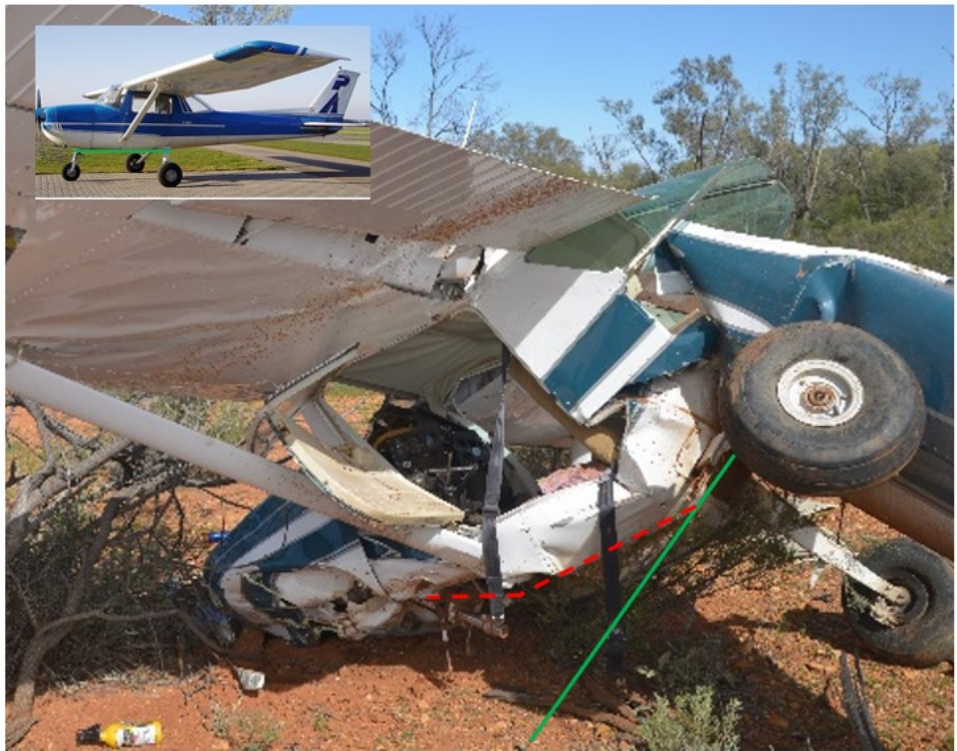
Figure 3: Crush damage to accident aircraft compared to exemplar Cessna 150

From photographs obtained of the wreckage, the occupied cabin area within the fuselage was compromised by the impact sequence. Figure 3 shows how the forward floor of the cabin under the instrument panel was crushed when the nose gear collapsed. The impact had buckled the floor under the seats, and the fuselage was breached behind the rear cabin bulkhead. The instrument panels had become dislodged and pushed rearward as a result of the nose impacting the ground. The cabin roof and wings had moved forward as a result of the nose section of the aircraft impacting the ground, reducing the cabin height. All of this damage reduced the survivable space within the cabin area.
