Australian Government

Australian Transport Safety Bureau

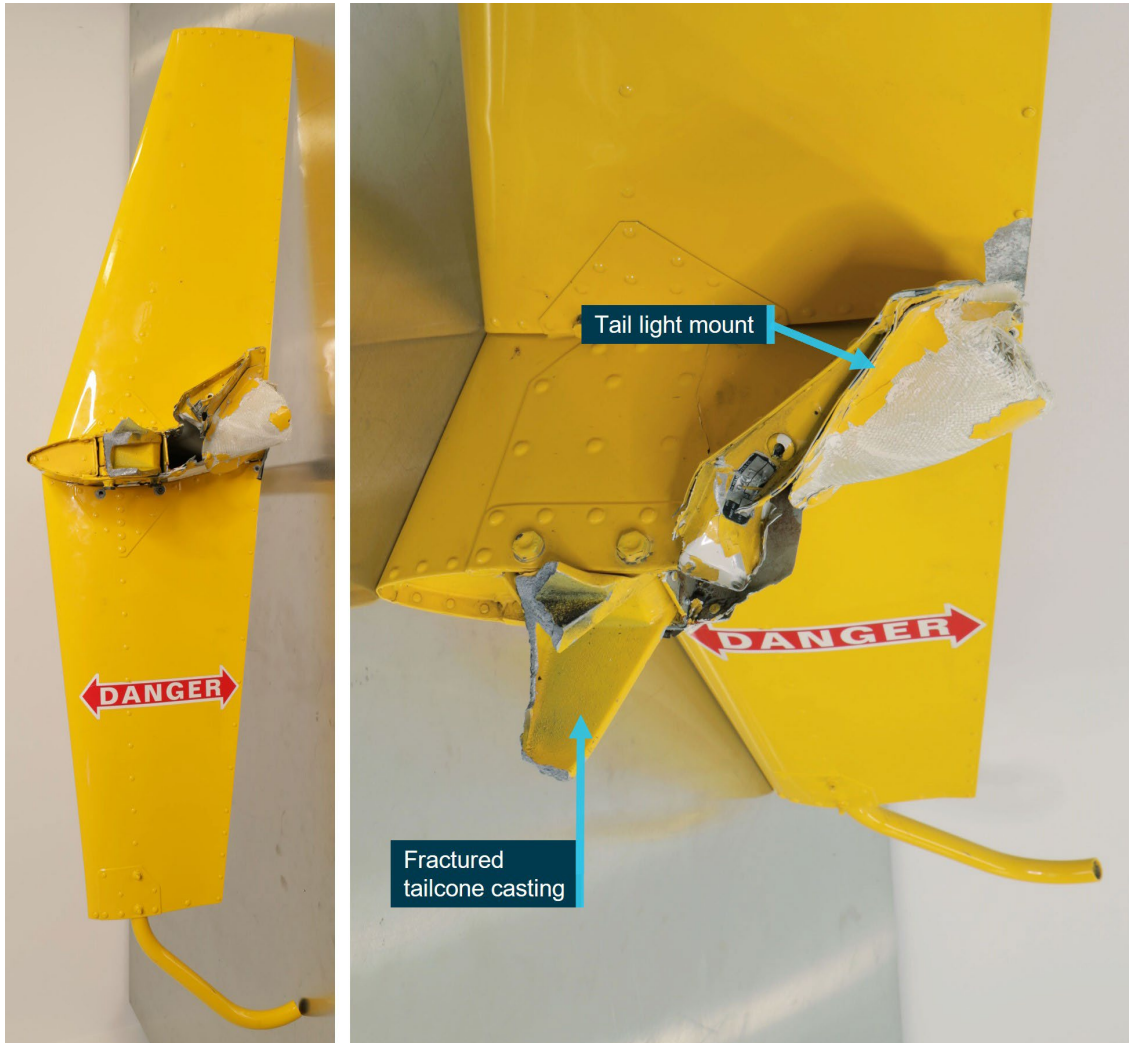
Figure 3: Empennage overview and damage

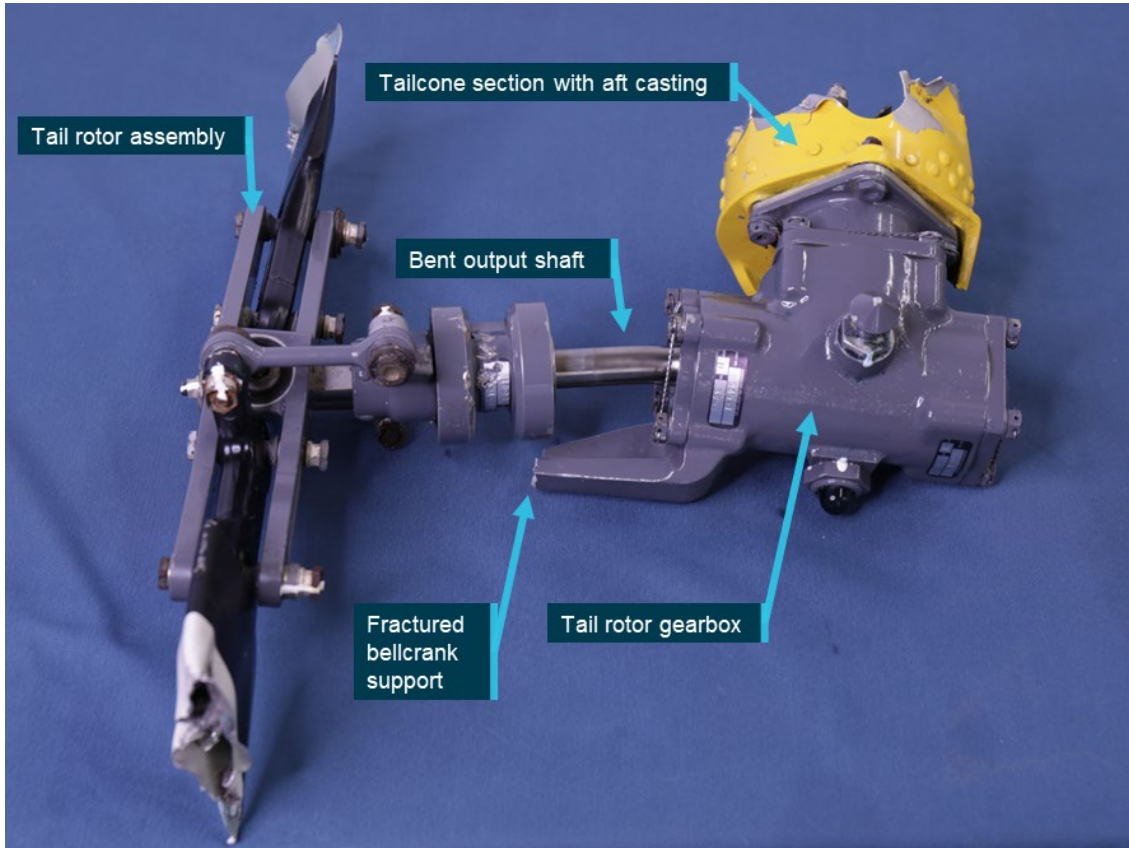
Figure 4: Tail rotor gearbox assembly as recovered

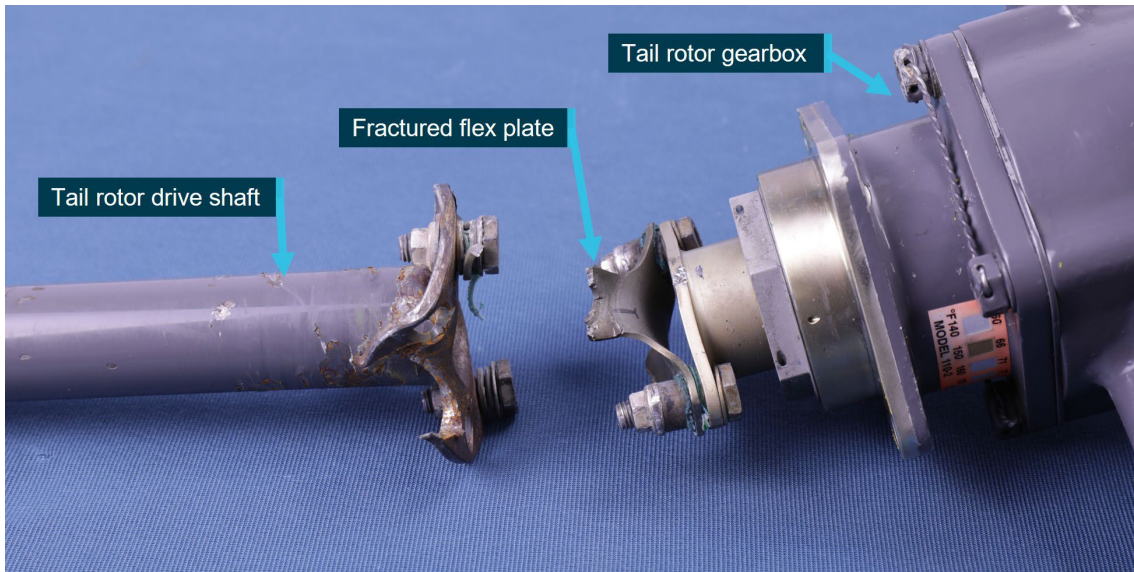
Figure 5: Fractured tail rotor aft flex coupling

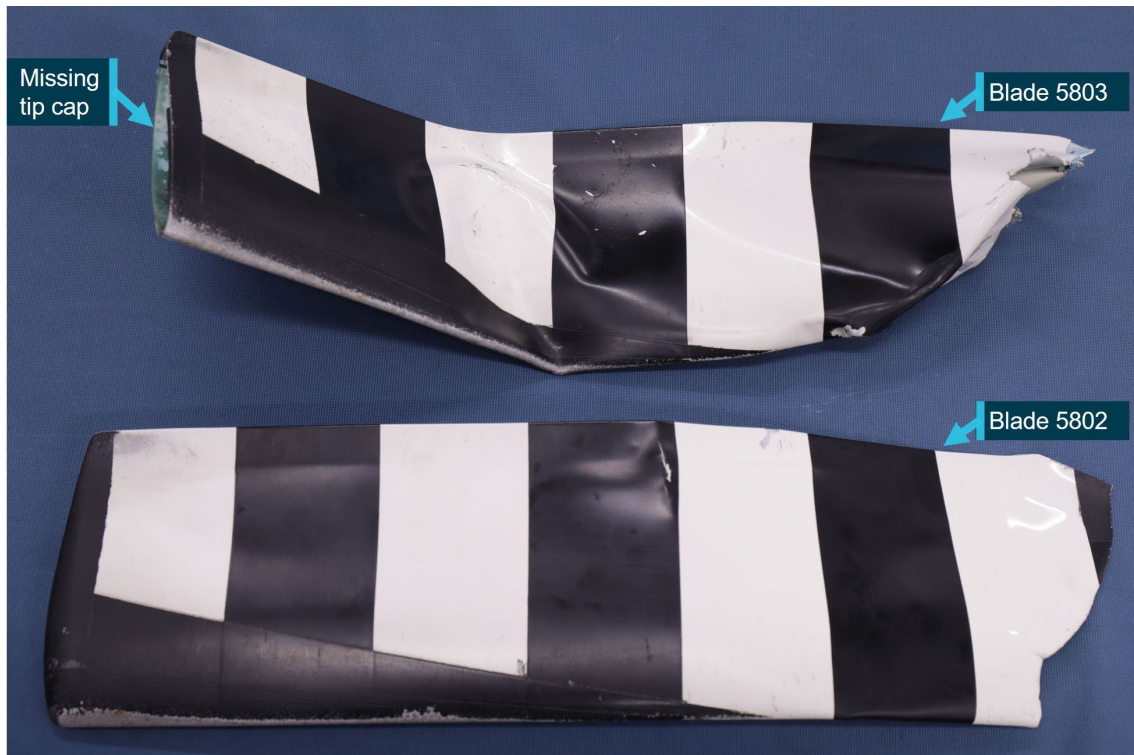
Figure 6: Tail rotor blades SN 5802 and SN 5803

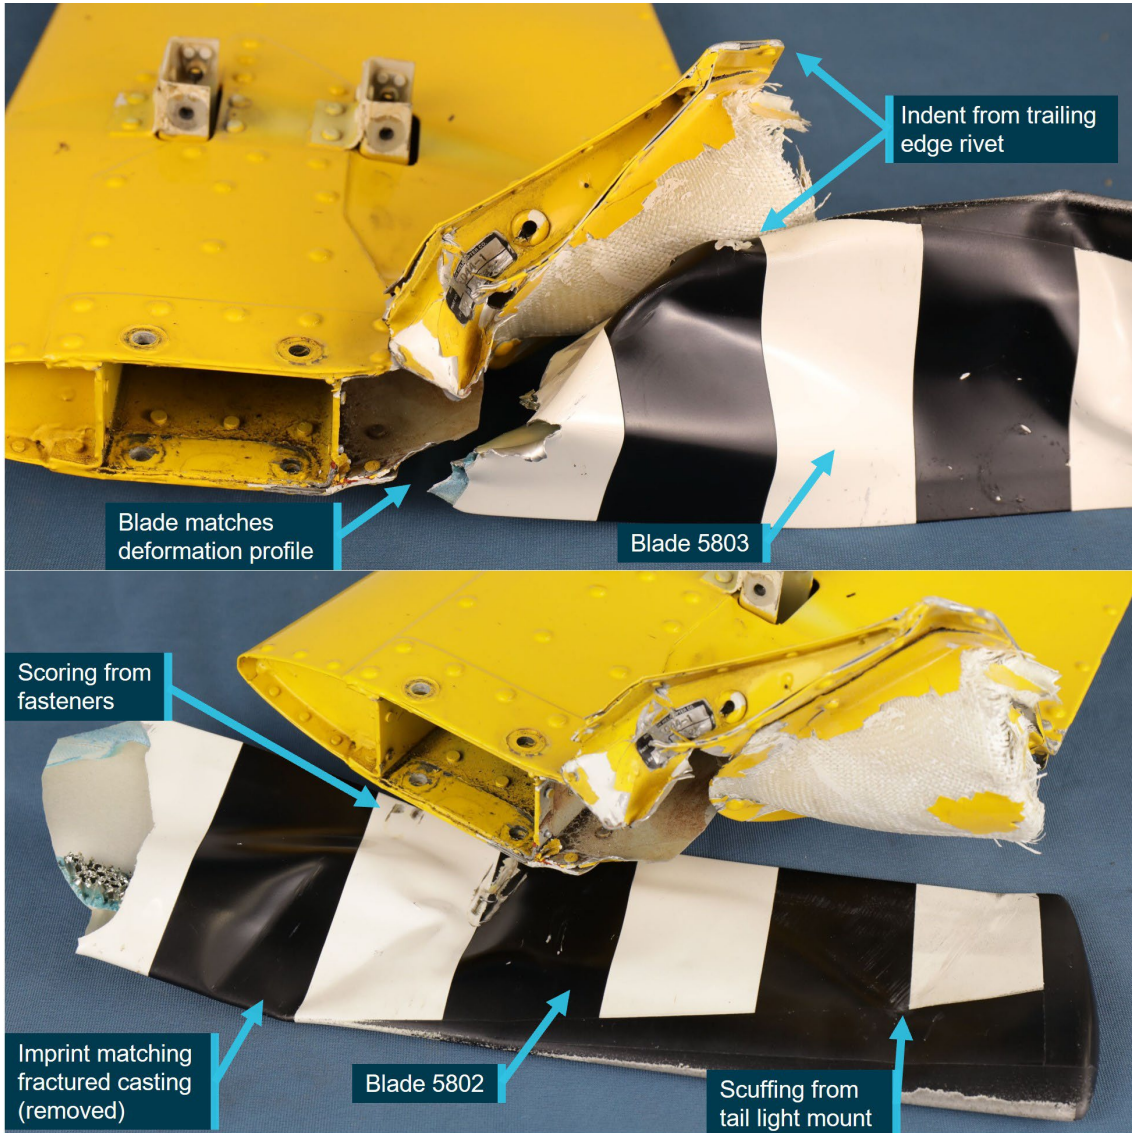
Figure 7: Rotor blade contact with horizontal stabiliser

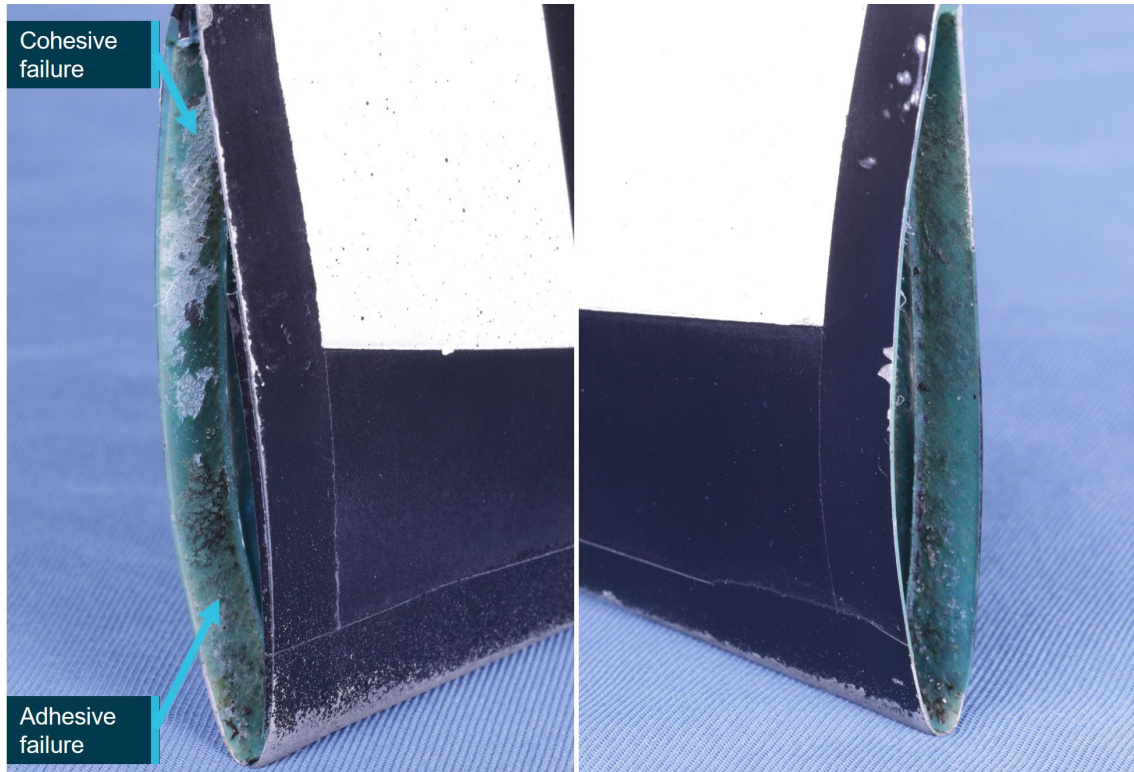
Figure 8: Blade SN 5803 post-occurrence tip cap adhesive condition

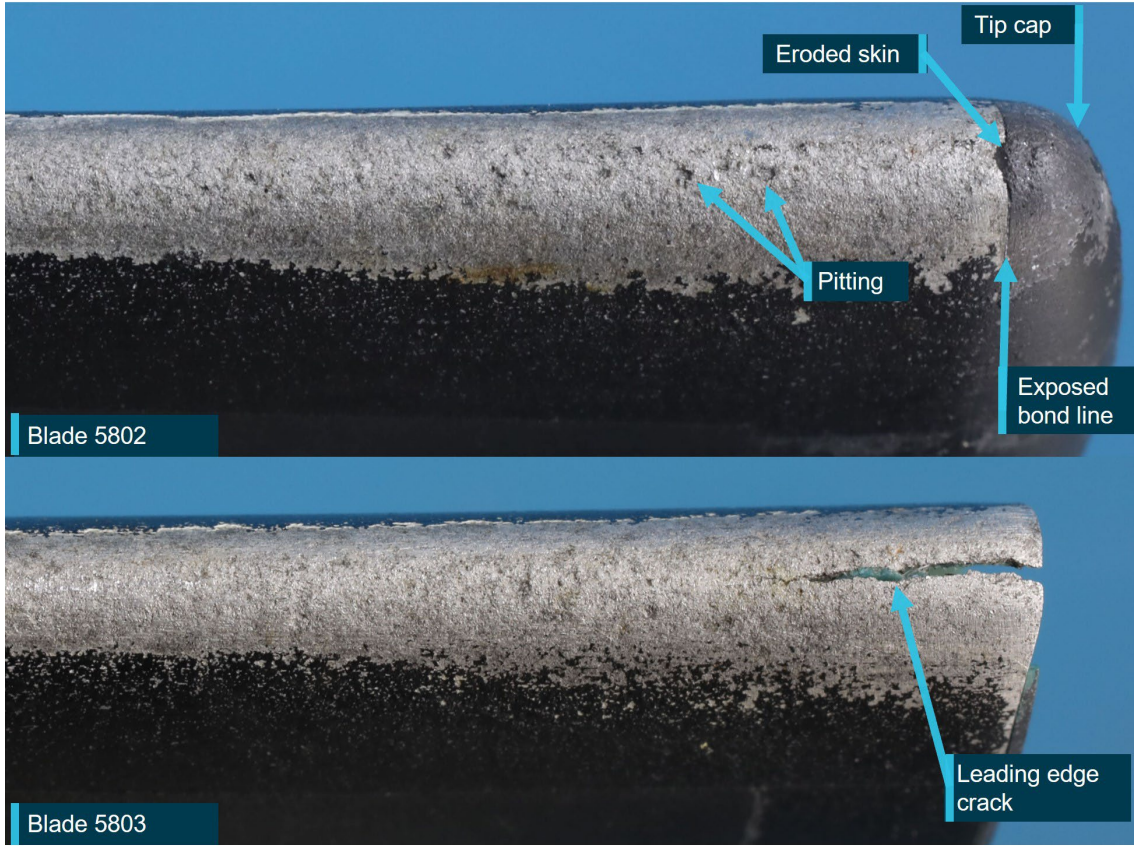
Figure 9: Tail rotor blade leading edges, showing paint loss, erosion and skin cracking

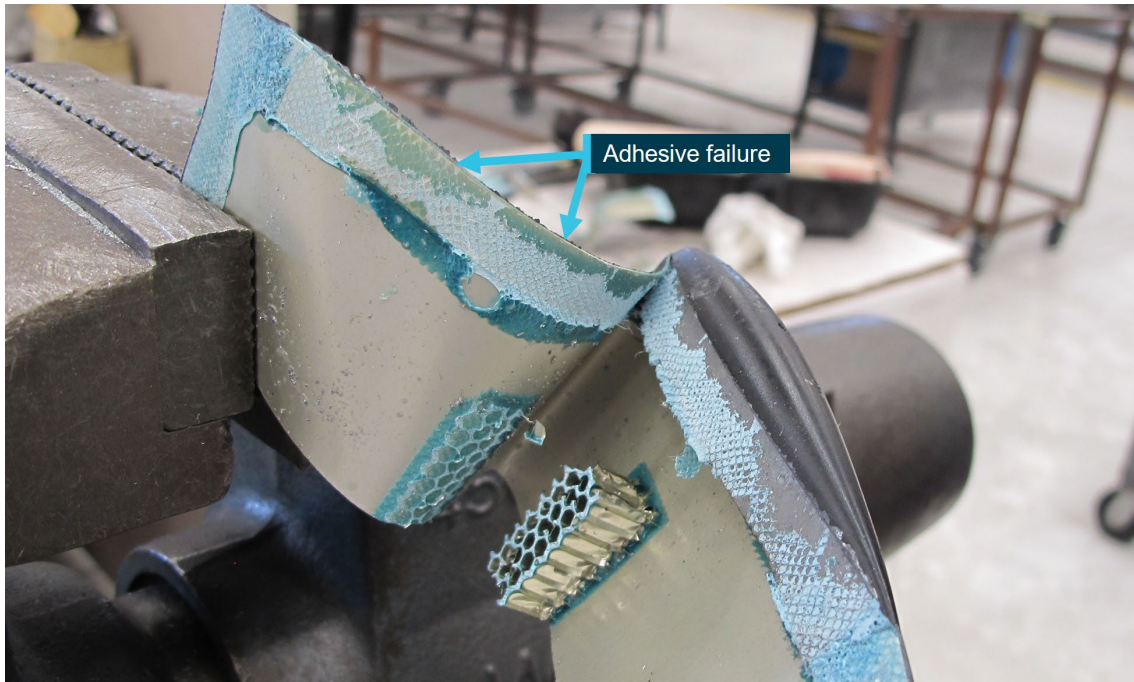
The other side of the bond exhibited similar visual characteristics.
Source: Robinson Helicopter Company, annotated by the ATSB

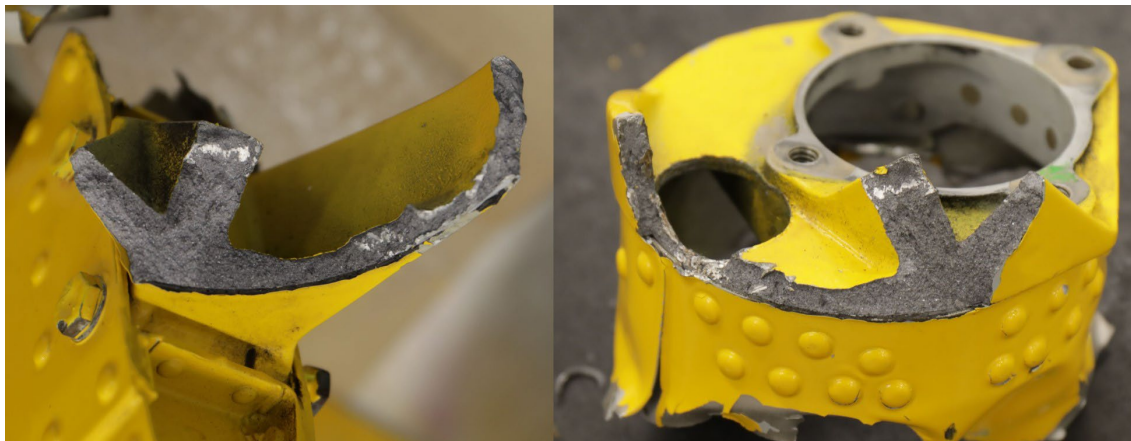
Darkened regions on the fracture surface were considered to be due to gearbox oil migration.
Source: ATSB

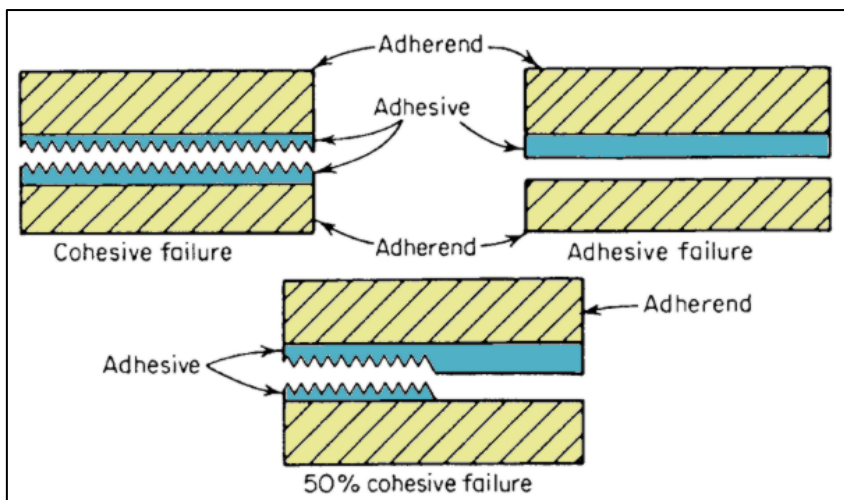
Source: Petrie (2000), modified by the ATSB

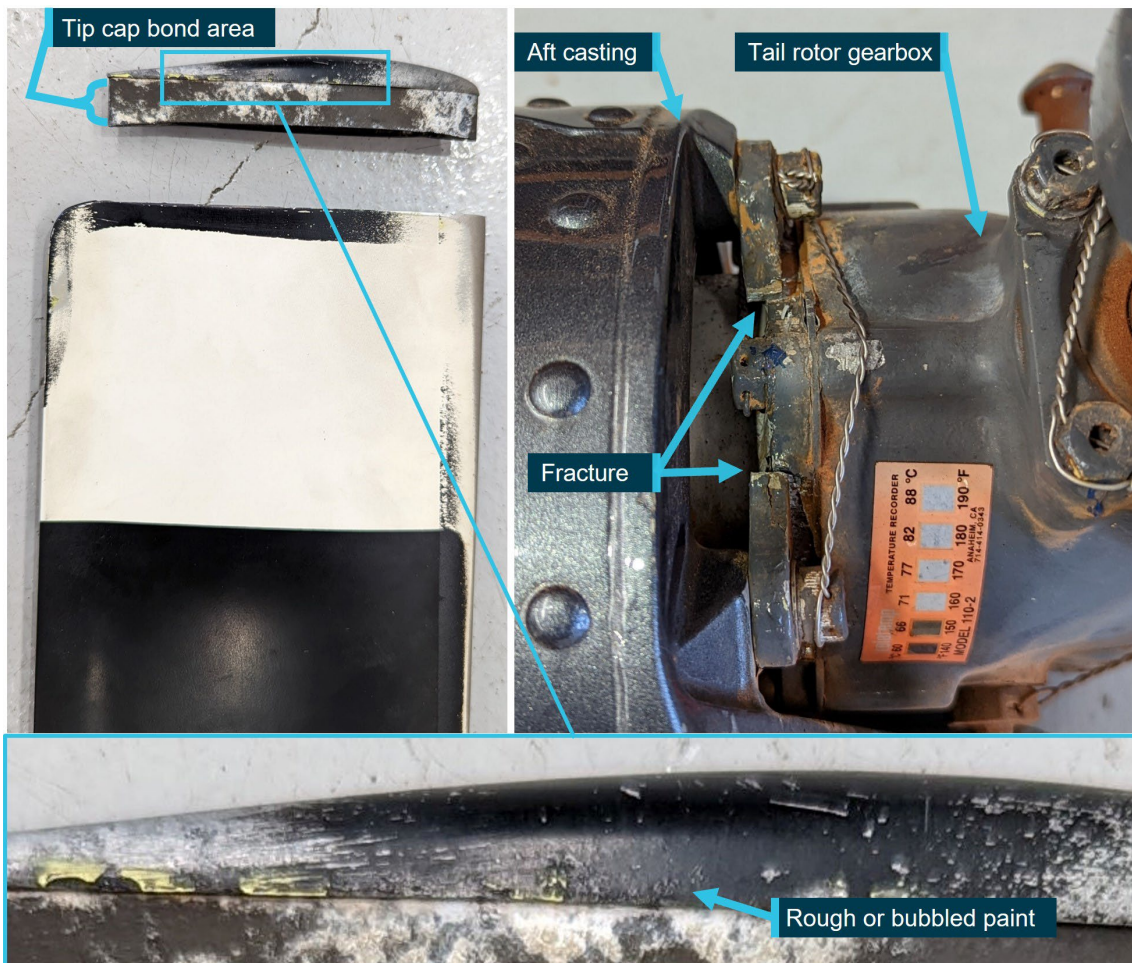
Source: Civil Aviation Safety Authority, modified by the ATSB

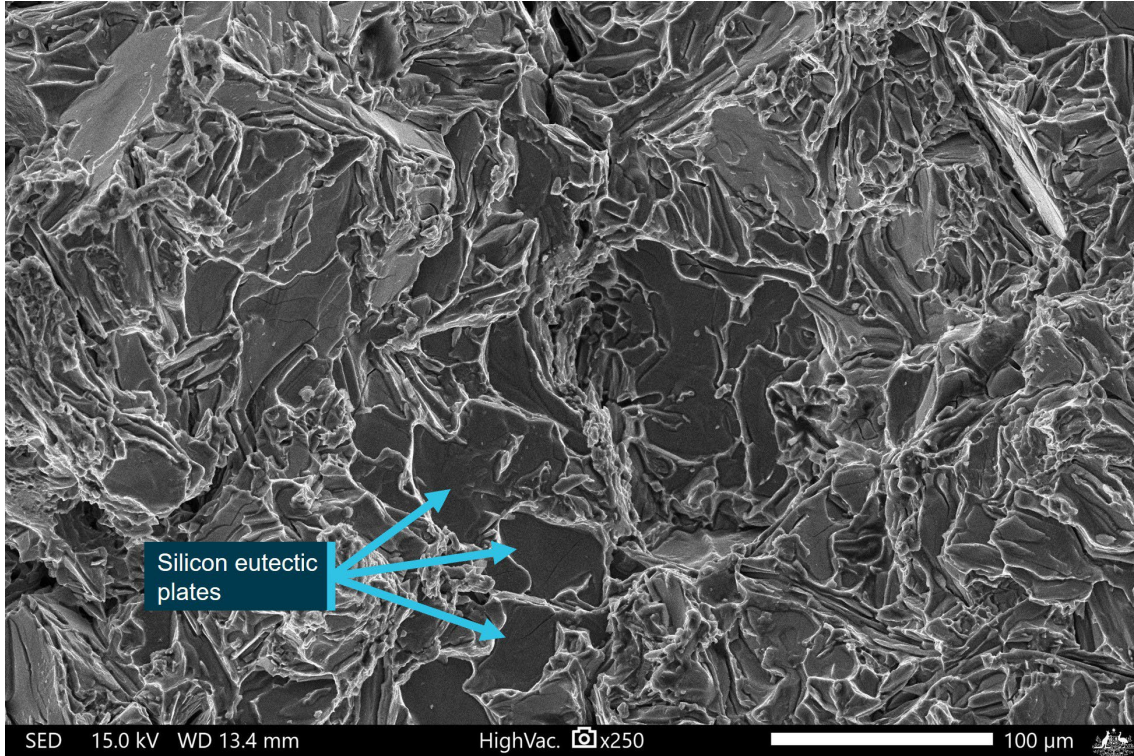
Figure 14: SEM micrograph showing the general casting fracture surface morphology

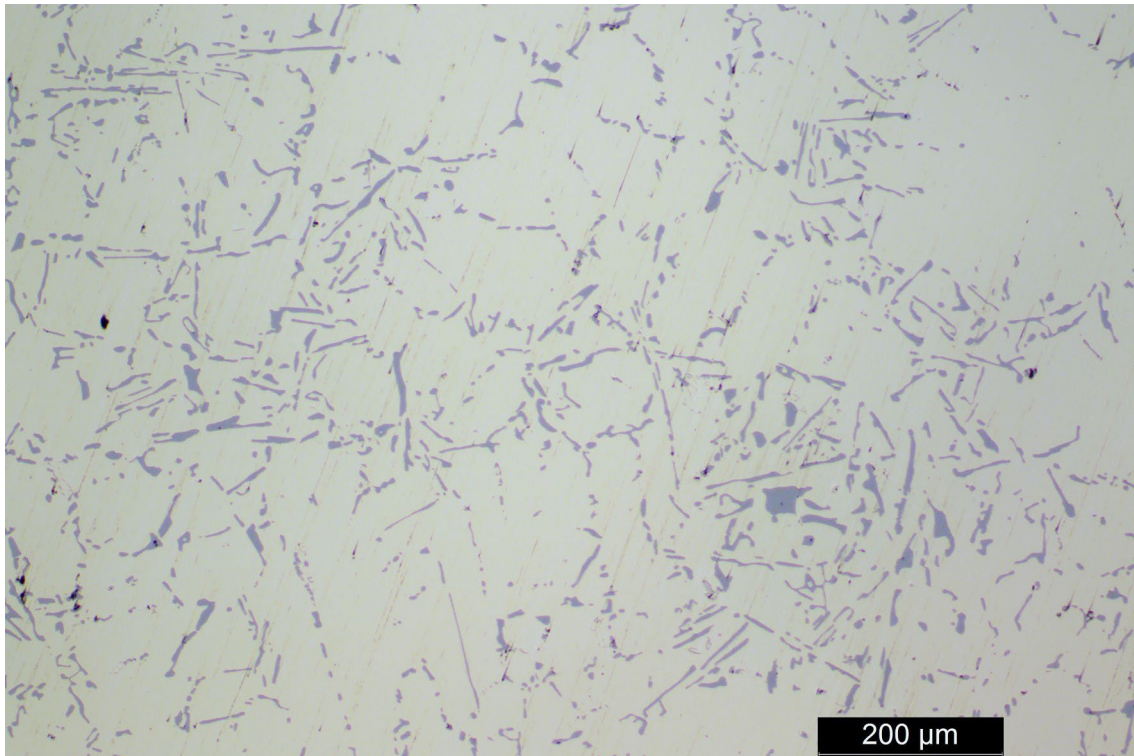
Figure 15: Microstructural cross section of unmodified A356, showing silicon eutectic (grey) in an aluminium matrix (white)

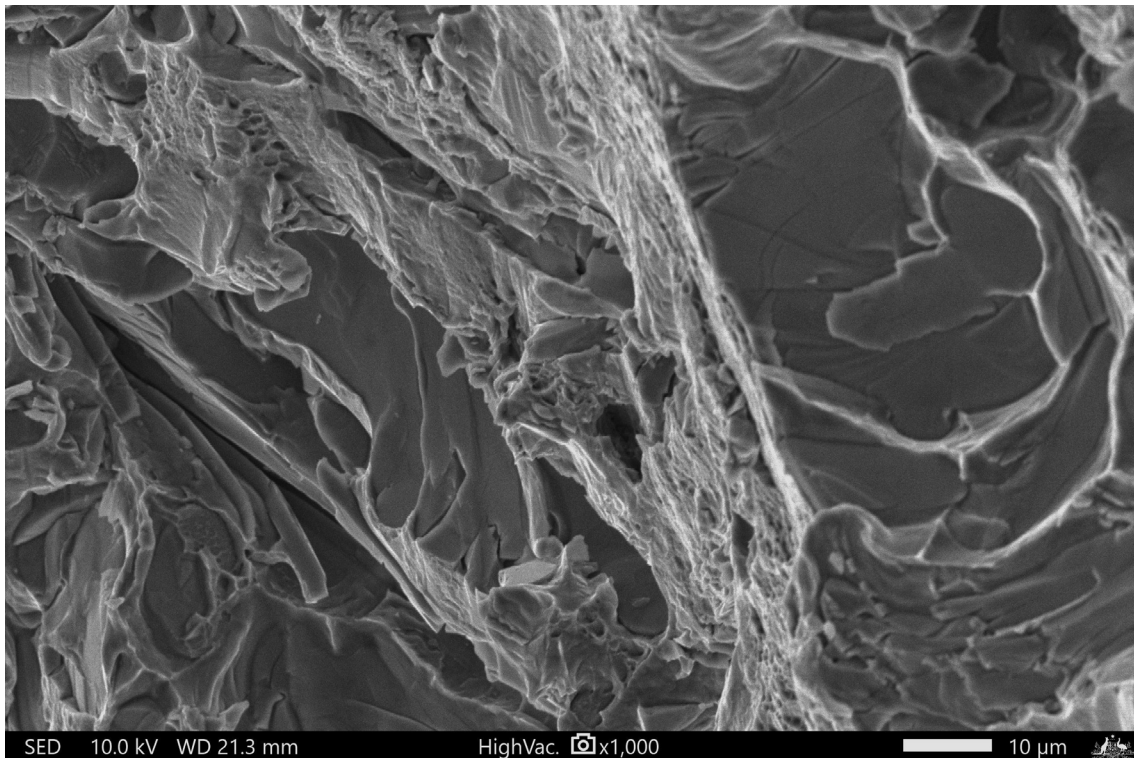
Figure 16: Occurrence fracture surface ‘striated’ matrix

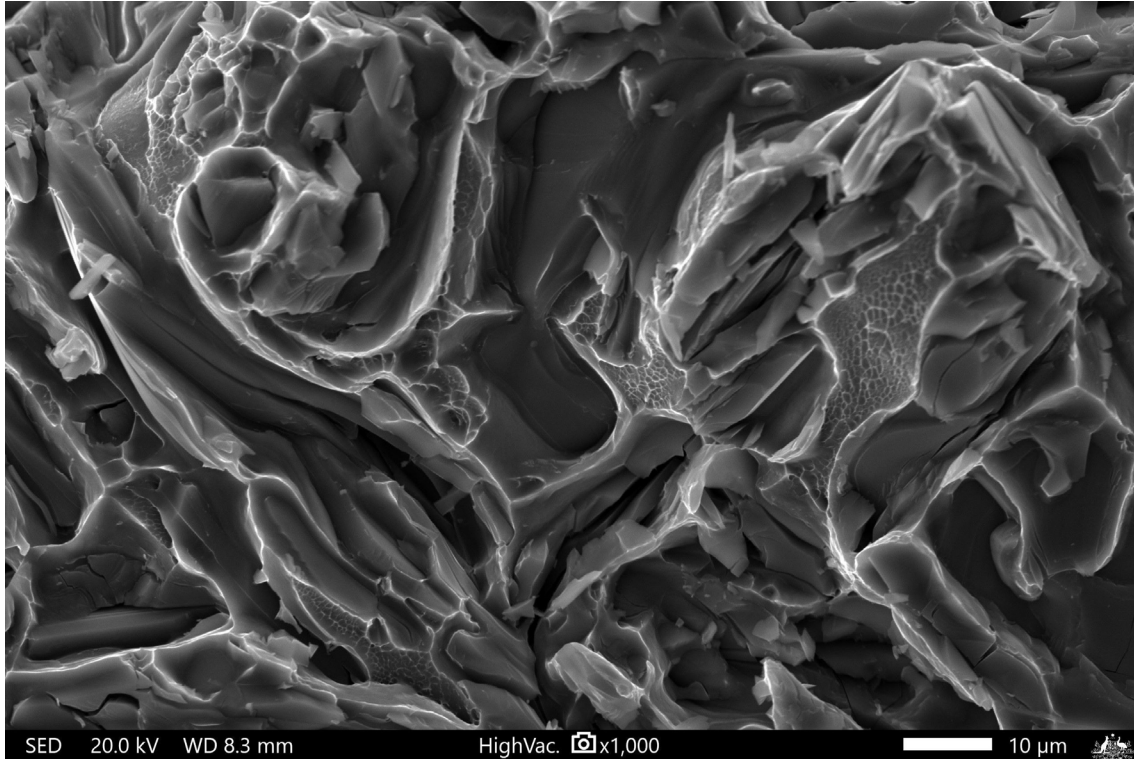
Figure 17: Monotonic fracture surface showing micro-dimpled rupture

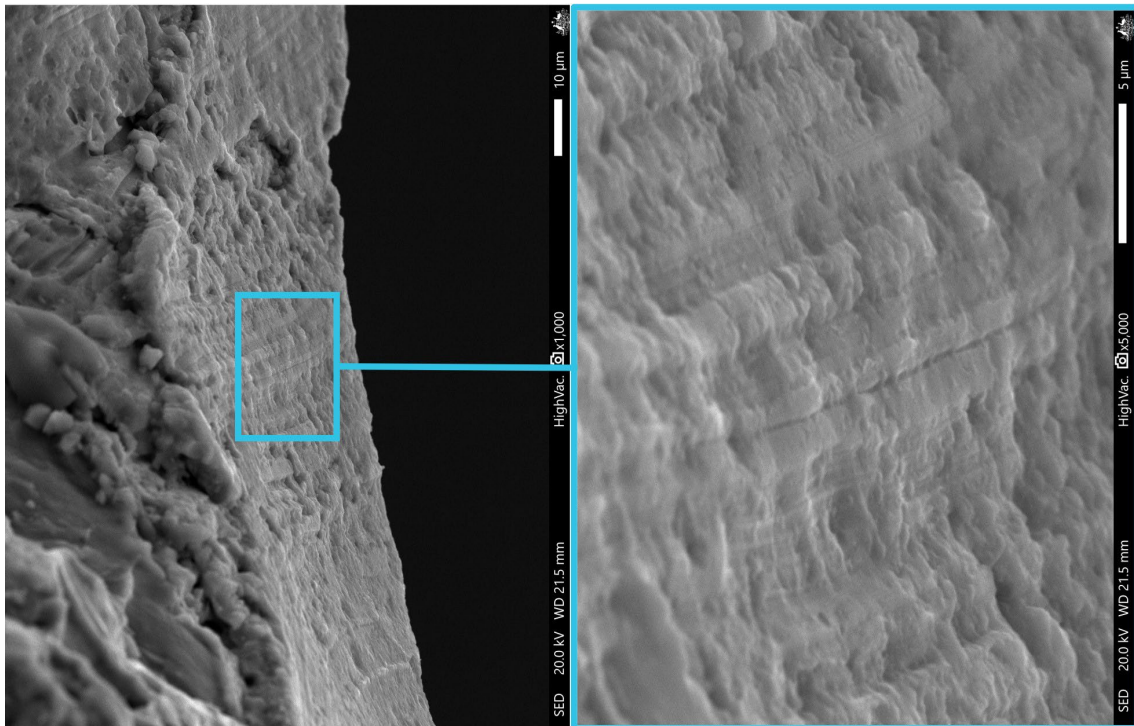
Figure 18: Discrete area of striations identified on the fracture surface

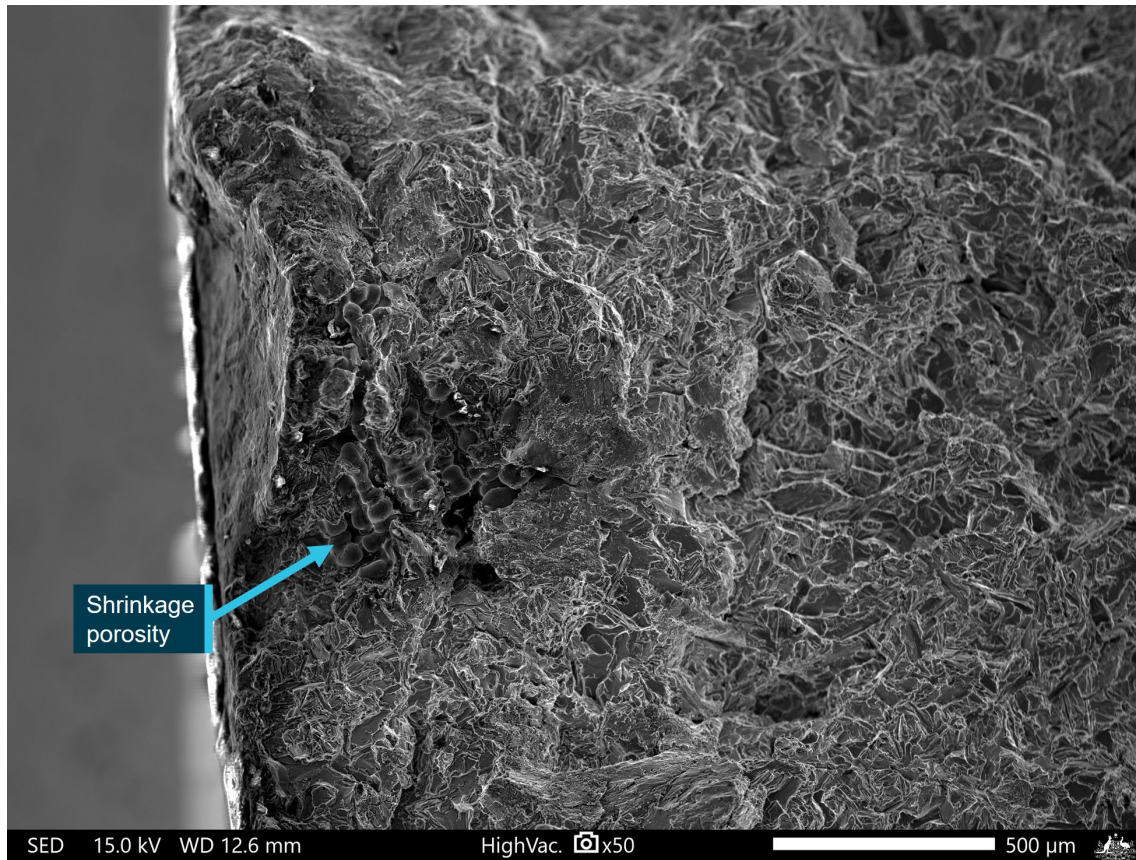
Figure 19: SEM micrograph of an example defect in the aft bulkhead fracture surface where subsurface shrinkage porosity was identified

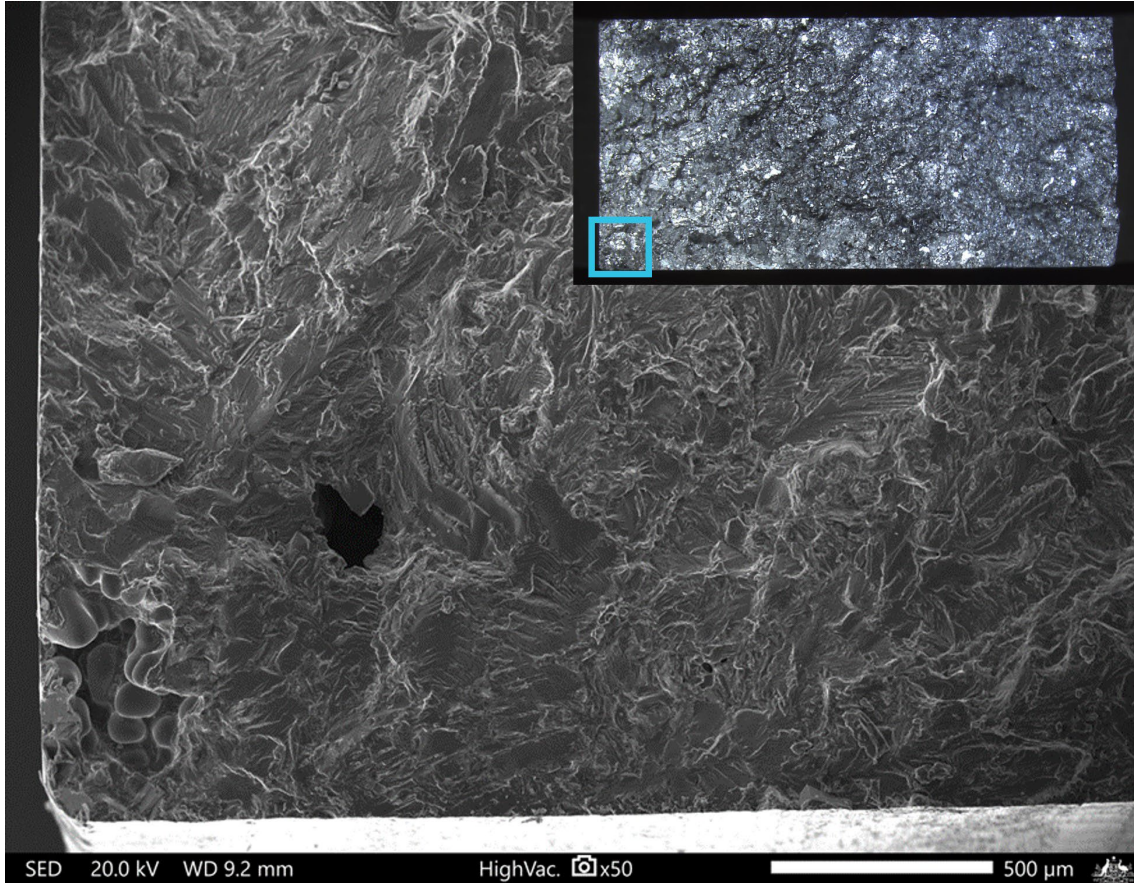
Figure 20: High-cycle fatigue specimen fracture origin
