Partial engine power loss and collision with terrain involving Cessna 210L, VH-FTM

Groote Eylandt Airport, Northern Territory on 16 June 2023

ATSB Transport Safety Report

AO-2023-028

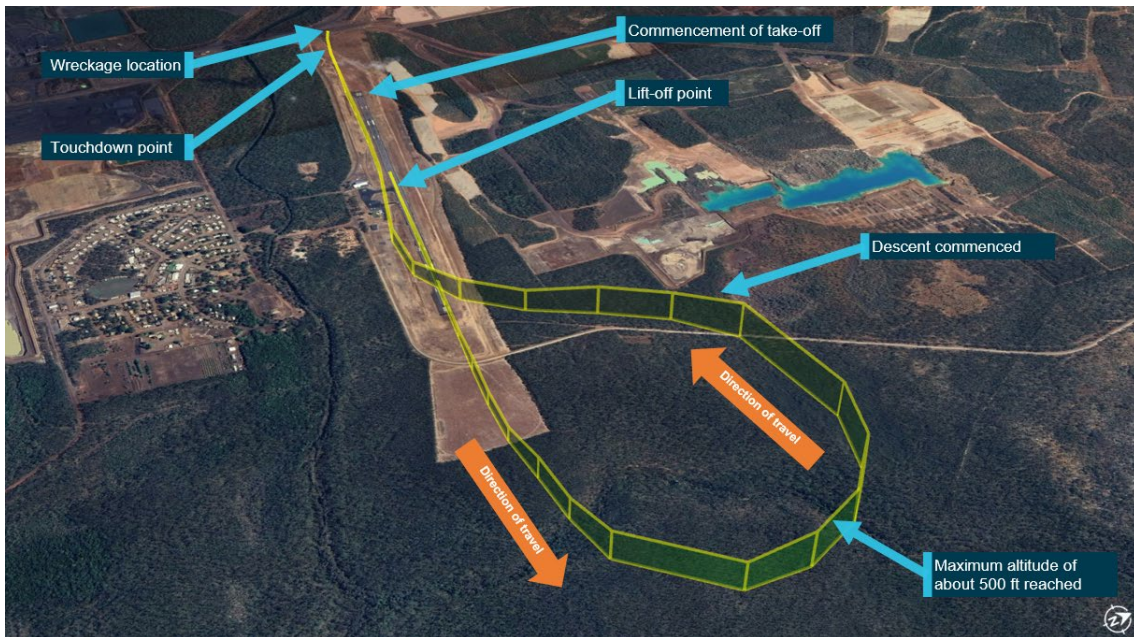
Figure 1: Flight path overview

Recorded data showed that the aircraft became airborne at about the midway point of the 1,903-metre runway (Figure 1). Shortly after becoming airborne, at an altitude of about 100 ft, the pilot noted engine surging accompanied by fuel flow fluctuations. The pilot assessed that there was insufficient runway remaining ahead of the aircraft to attempt a landing and elected to continue to climb the aircraft straight ahead with a perceived partial power loss. At this time, the recorded groundspeed was about 84 kt (accounting for wind, airspeed was about 89 kt), and the rate of climb was about 500 ft per minute.

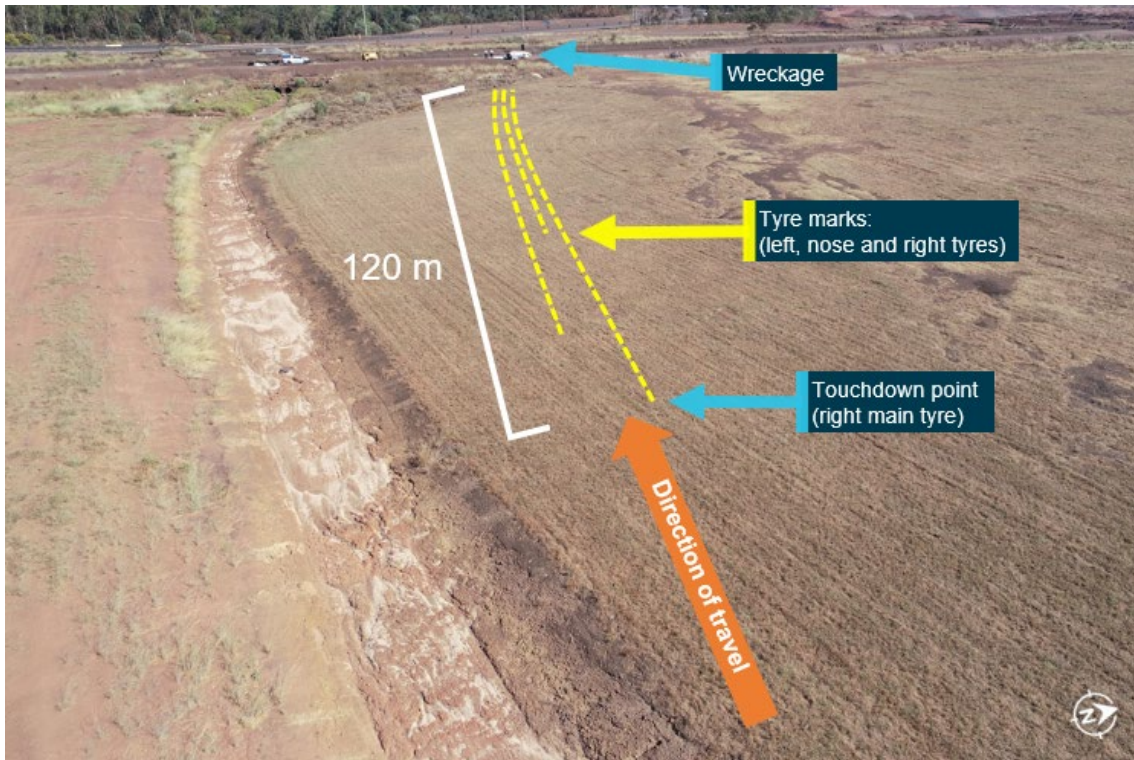
Figure 2: Touchdown point overview

The aircraft was recorded by a second security camera as it touched down in the clear grassed area. The aircraft continued along the ground for about 120 m and collided with an embankment on the eastern side of a culvert, outside of the aerodrome boundary, at about 62 kt (Figure 2). The aircraft traversed the culvert and then struck a larger embankment on the western side, flipped, and came to rest inverted on a service road (Figure 3).

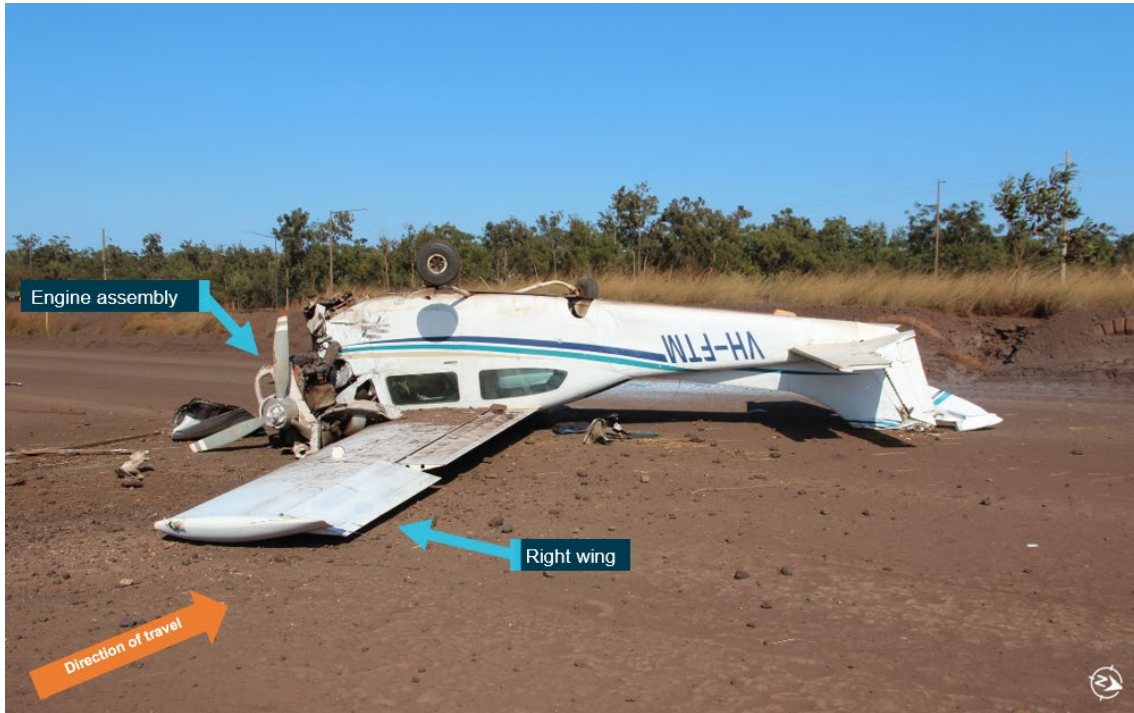
Figure 5: Wreckage of VH-FTM

All major sections of the aircraft's structure were accounted for at the accident site. Flight control continuity was established where possible and the wing flaps¹³ were retracted. The landing gear was extended and propeller damage was indicative of the engine running at low power at the time of impact. Fuel system components were examined and found to be free from contamination or obstruction. The ATSB took fuel samples at various points throughout the aircraft's fuel system that showed no evidence of contamination with water.

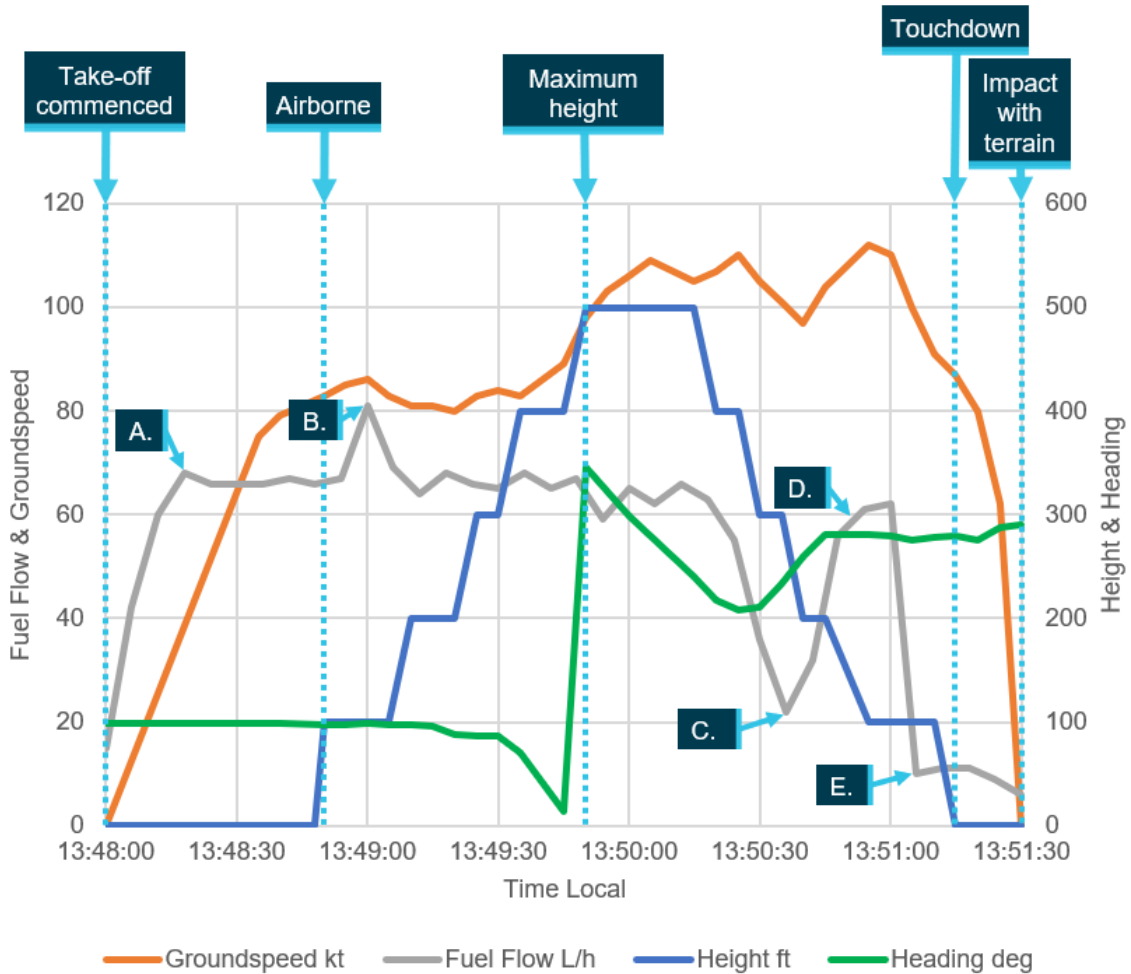
Figure 6: VH-FTM groundspeed, fuel flow, height and heading data

- On application of full throttle by the pilot (A), the fuel flow reached a mean of about 66 L/h (104lb/h), about 33 L/h less than recorded at take-off power on previous flights that day (Figure 7).
- After the aircraft became airborne, the fuel flow increased to about 81 L/h for 1 data point (B) then fluctuated in the range 59-69 L/h, with an average of 66 L/h, before reducing significantly during the first part of the descent (C).
- The fuel flow increased again to the previous level at around 200 ft (D), before being reduced to idle (E) when the aircraft was beside the runway, about 250–500 m from the eastern end.

The EDM-900 engine data management system data is consistent with this scenario and indicated that on application of full throttle, the average fuel flow attained during take-off was about 66 L/h. This was about 33 L/h less than other take-offs that day. The fuel flow indications were consistent with a reduced fuel component of the air-fuel ratio, where less fuel is being delivered to the cylinders, and would have resulted in reduced engine power. The exhaust gas temperatures (EGTs) were also found to be around 48°C hotter than recorded at take-off power on previous flights that day. The hotter EGTs were also consistent with a reduced fuel component of the air-fuel ratio where there is less unburnt (cooling) fuel within the exhaust gas, resulting in increased EGTs.

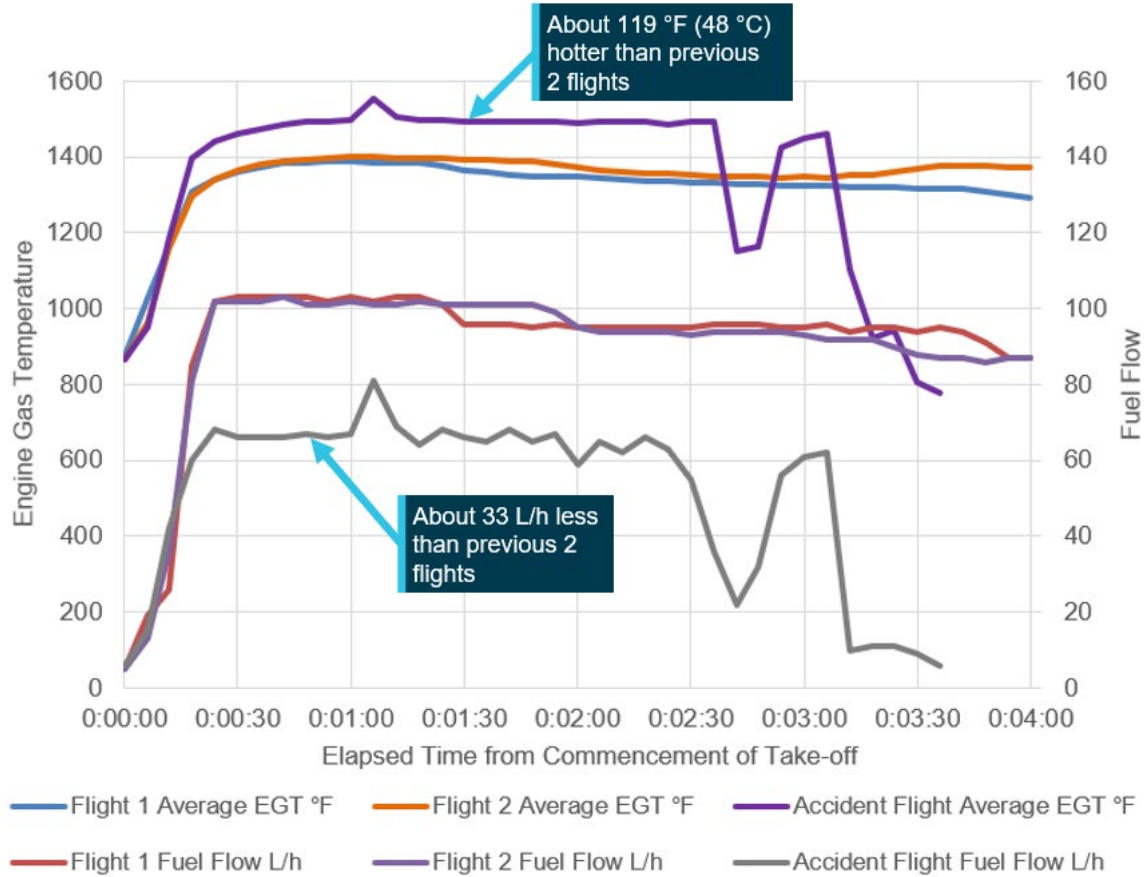
Figure 7: VH-FTM take-off fuel flow and average EGT for flights on 16 June 2023

Engine RPM fluctuated consistently with the EGTs and other parameters. The EGTs on the accident flight were found to be around 119 °F (48 °C) hotter than recorded at take-off power on previous flights that day (Figure 7).
