# Stall warning activation involving Saab 340, VH-TRX

5 km north of Merimbula Airport, New South Wales on 8 June 2023

Aviation Occurrence Investigation (Short)

AO-2023-030

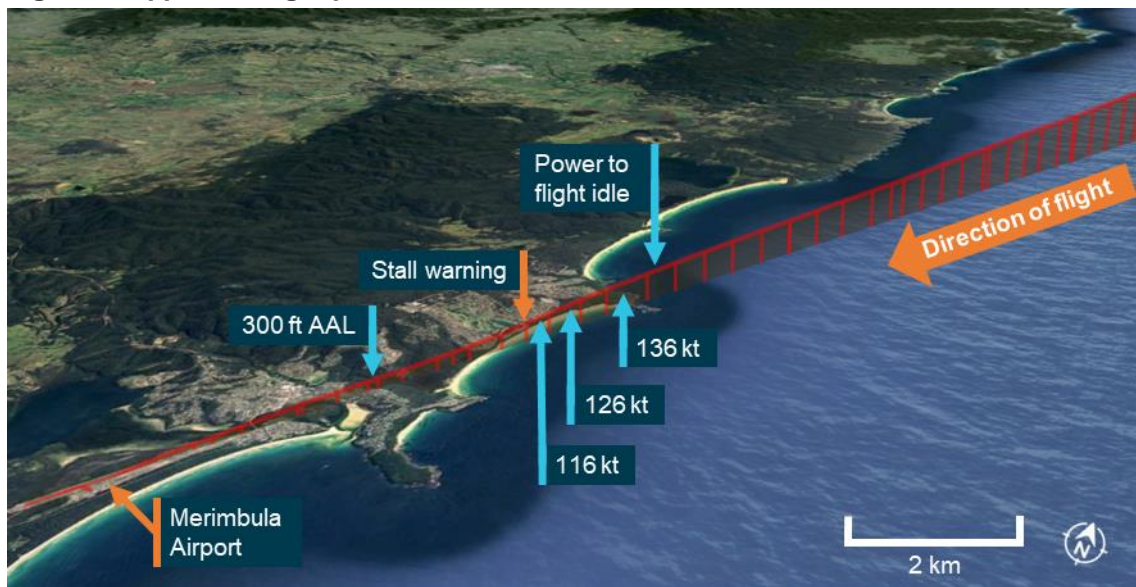
**Figure 2: Approach flight path**

During the approach, at 1517 with the autopilot engaged in the vertical speed mode,<sup>6</sup> the first officer selected flaps to 20° for the landing. At 1518:45, as the aircraft descended below 1,164 ft above mean sea level in turbulent conditions and at a speed of 143 kt, the captain reduced power to flight idle to prevent an inadvertent exceedance of the 165 kt maximum flap speed. A few seconds later, at 1518:54, speed reduced below 136 kt, the minimum speed for that segment of the approach (see the section titled *Approach speeds*).

The power remained at flight idle, and speed continued to reduce as the approach continued (Figure 2) with the engine anti-ice and ice speed systems selected on. The aircraft then entered a rain shower, and the captain asked the first officer to turn on the windscreen wipers. The first officer asked if they should be set to low or high and the captain asked for the high setting. The wiper activation was then delayed as the turbulence prevented the first officer from quickly making the required selection. At about the same time, with power still at flight idle, the aircraft encountered increased turbulence and at 1519:21, at a speed of 109 kt, the stall warning activated.

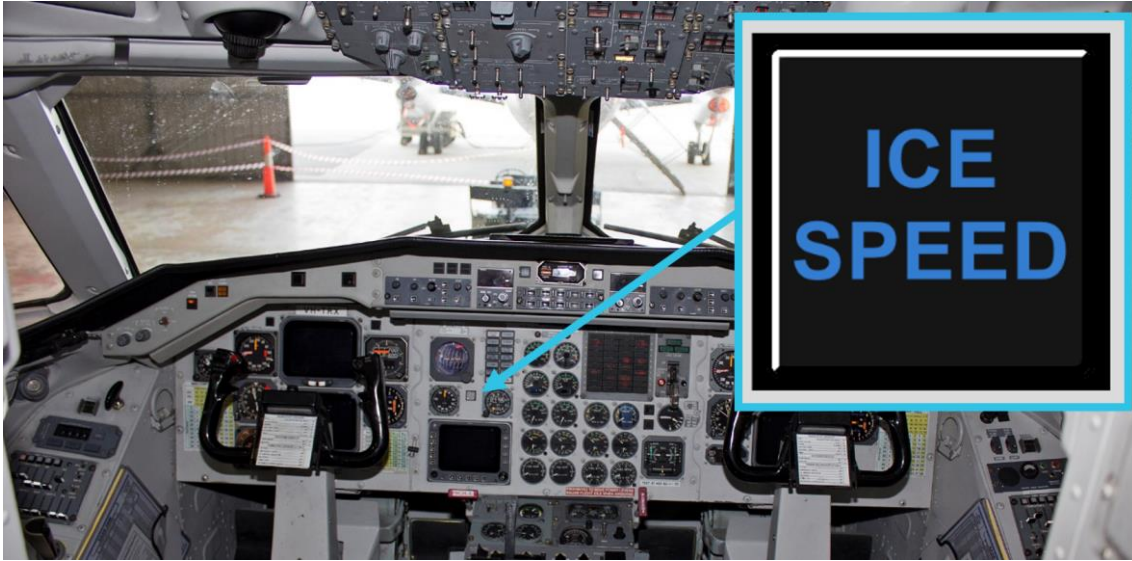
Figure 3: The flight deck of VH-TRX showing the ice speed system indicator

The ice speed system fitted to VH-TRX compensated for possible ice accumulation by lowering the stall warning stick shaker/aural alert activation AOA by about 6°. The visual alert and stick pusher activation AOA remained unchanged.

The system was activated by selecting either (or both) engine anti-ice systems on and was indicated by the illumination of a blue ICE SPEED push button on the instrument panel (Figure 3). Once activated, the ice speed system remained active even if the engine anti-ice system was subsequently selected off and needed to be deselected separately.

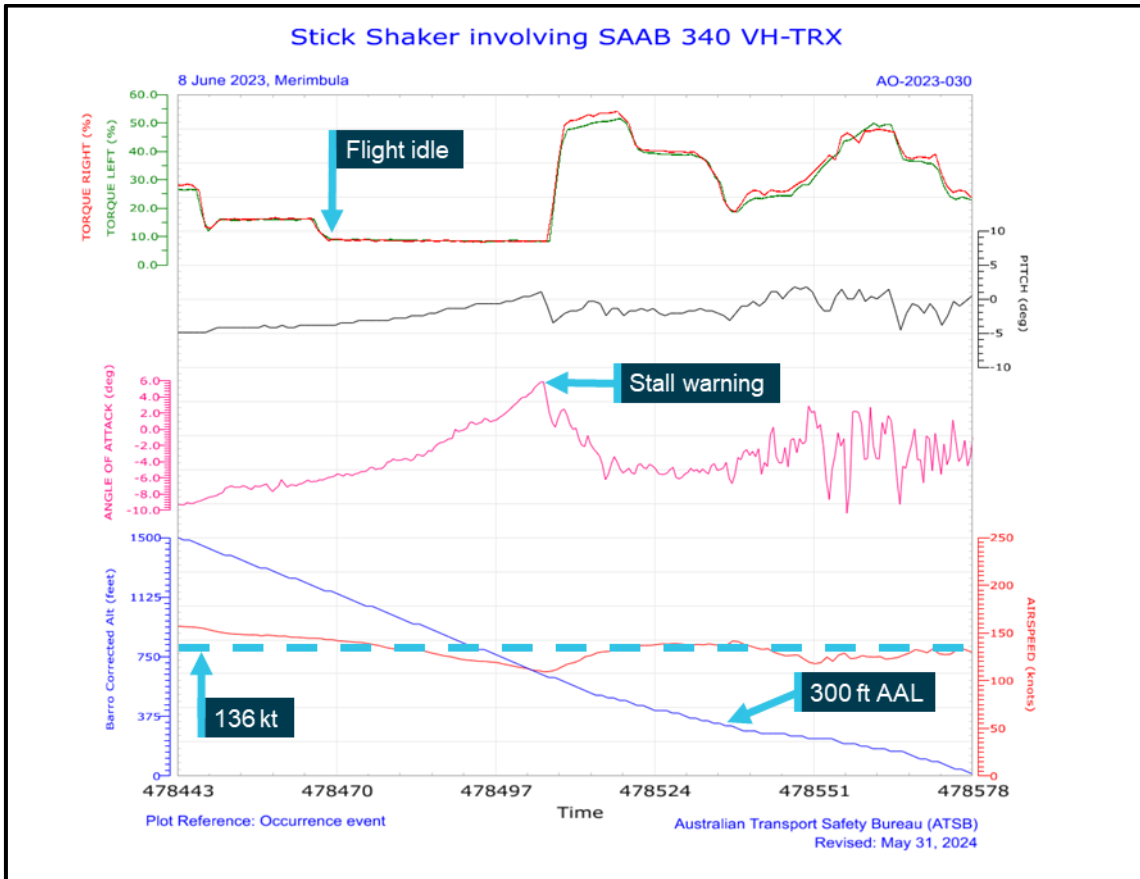
**Figure 4: Graphical representation of recorded flight data**

Analysis of flight data from VH-TRX’s flight data recorder showed that power was reduced to flight idle at 15:18:45, as the aircraft descended through 1,164 ft AMSL. Following the power reduction, the aircraft’s speed began reducing while the autopilot increased the aircraft pitch angle and wing AOA to maintain the selected descent rate. Nine seconds after the power reduction, speed reduced below 136 kt. A further 11 seconds later, speed reduced below 126 kt and 11 seconds after that, at 15:19:16, speed reduced below the base reference speed of 116 kt.

At 15:19:21, while descending through 636 ft AMSL and 34 seconds after power was reduced to flight idle, the speed slowed to 109 kt. The AOA increased to 5.9° and the stall warning activated for 1 second (Figure 4). At the same time the autopilot automatically disconnected.

Following the stall warning, the recorded angle of attack reduced by 5.6° within 2 seconds and power increased to about 50% torque within 4 seconds. At 15:19:35, 14 seconds after the stall warning, the speed increased above 136 kt and power began to be reduced to the normal approach power setting. The recorded data showed the descent rate reduced from the 830 ft per minute rate, recorded before the stall warning activation (with autopilot engaged), to about 450 ft per minute.
