# Flight management occurrence involving Embraer E190, VH-UYN

20 km north-west of Alice Springs, Northern Territory on 24 August 2023

**ATSB Transport Safety Report**

AO-2023-040

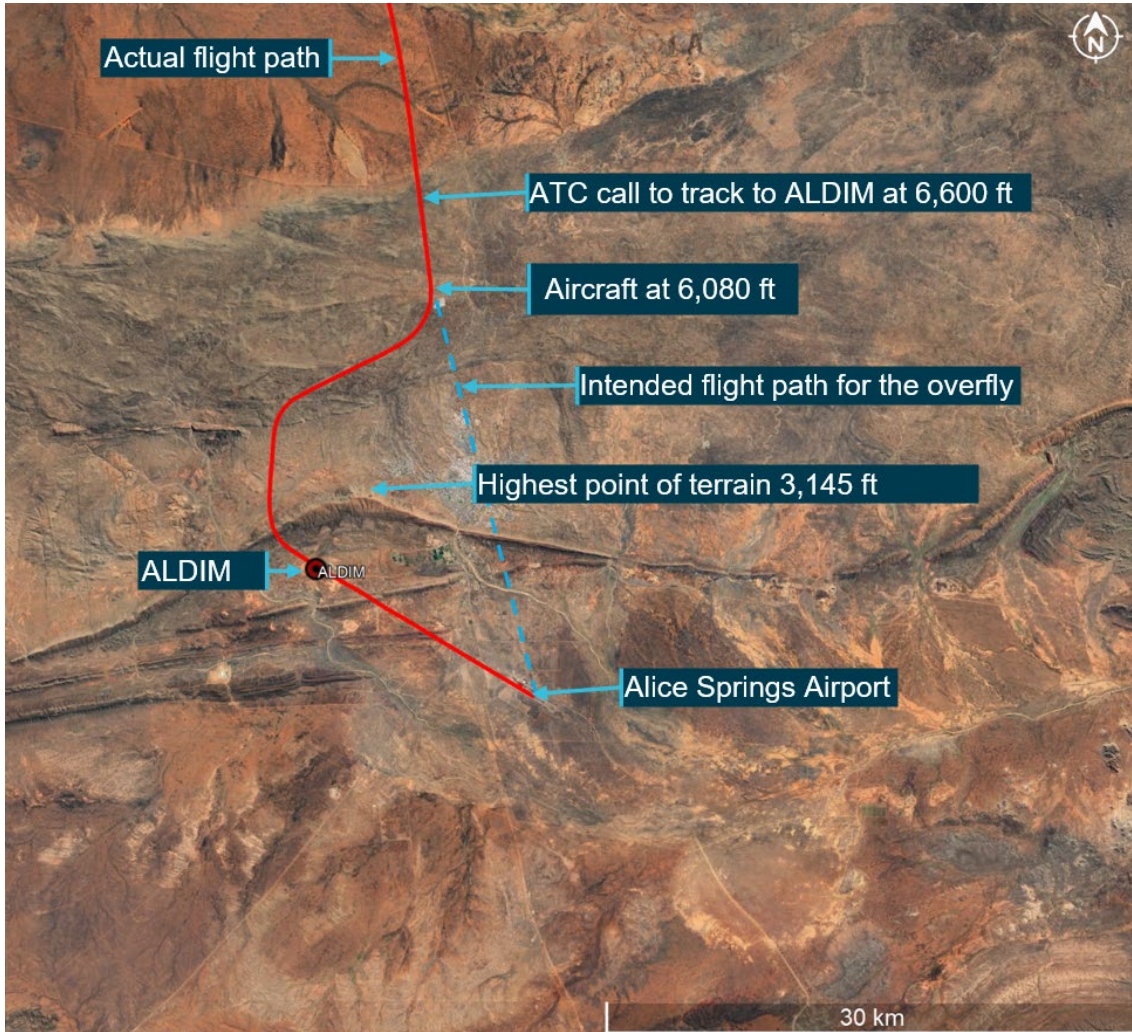
Figure 1: Actual and intended flight paths

At 1621 local time, when the aircraft was passing 6,600 ft AMSL<sup>5</sup> and approximately 12 NM from the airport, the trainee ADC advised the flight crew that a straight-in visual approach was now available and asked if they could track direct to ALDIM, which was around 10 NM south-west of their position (Figure 1).

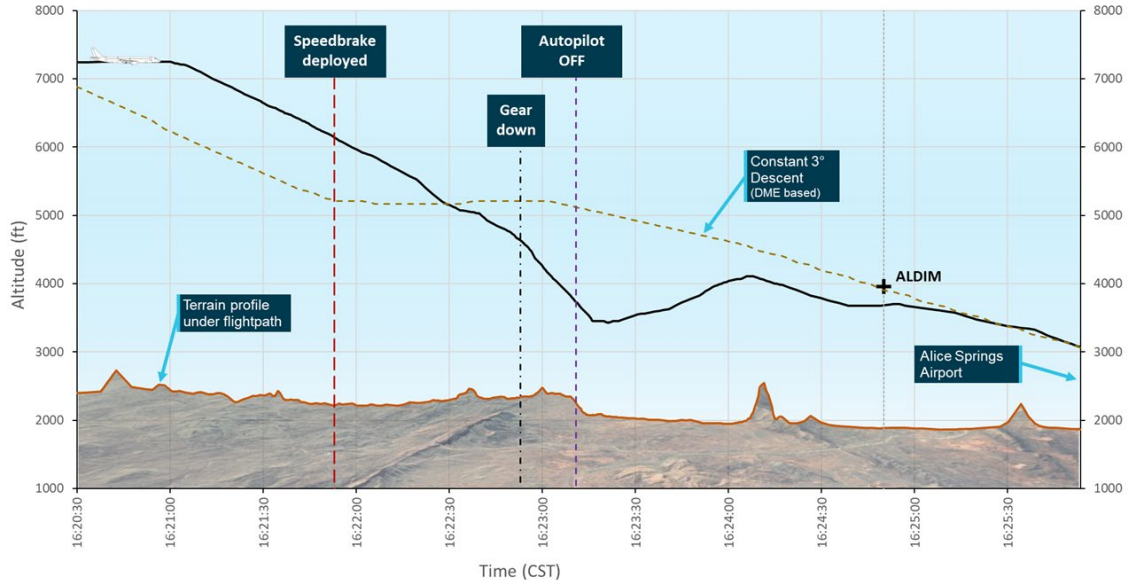
**Figure 2: Flight path over terrain**

The captain later stated that while the approach (Figure 2) was ‘untidy’, they were aware of, and visual with terrain, and did not feel that the flight was in danger at any time.

The representation of a constant 3° approach profile (brown dashed line) is based upon the DME distance from Alice Springs and is not a straight line, as may be expected for a constant 3° approach. Firstly, a 3° approach is a geometric profile, but the horizontal axis of the plot is time, so any variations in speed will distort it from a straight line. Also, the path in Figure 2 follows along the actual flight path, not a straight-in 3° approach. As such, when the aircraft is flying in a south-westerly direction, it is flying roughly tangentially to a circle centred on the DME transmitter, that is, the DME distance is not changing significantly during that period of time, so the 3° approach in Figure 2 flattens out.

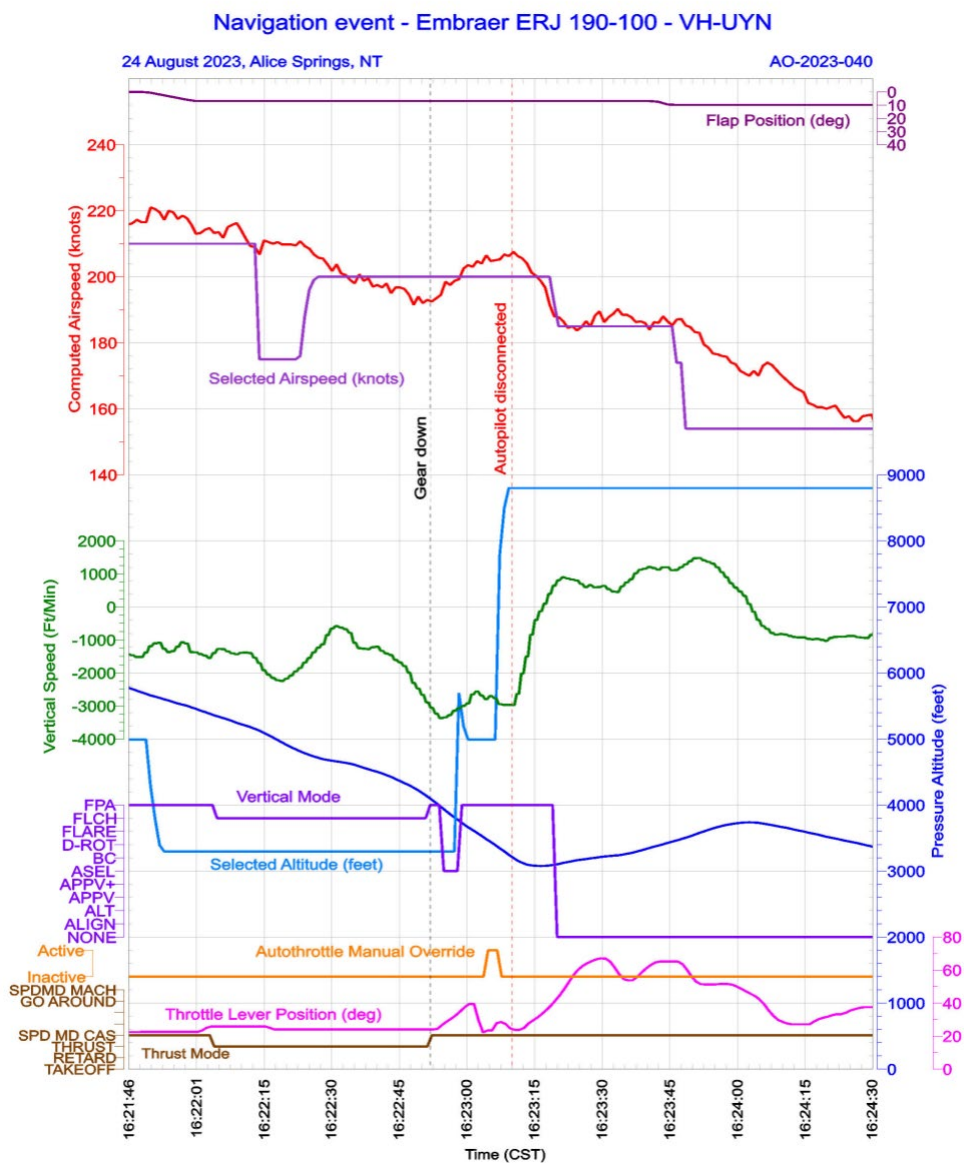
Figure 55: VH-UYN active flight modes on approach

A review of the data identified that between the 2-minutes between 1621:13 and 1623:12 (from when the aircraft turned towards ALDIM until the autopilot was selected off), the aircraft was configured with flap and slats and flight level change (FLCH) mode was selected. Then as the

landing gear locked down, flight path angle (FPA) mode was selected in the flight management system (FMS). The FMS then automatically changed to altitude select (ASEL) mode as the aircraft neared the selected altitude and while this was active, the throttle lever position increased (consistent with normal autothrottle operation) indicating the aircraft was starting to level off. However, prior to this occurring, the selected altitude was manually changed, and the flight mode reverted to FPA, and the throttle lever position automatically reduced.

The data also showed that between the first and second selection of the higher altitude in the altitude selector, the autothrottle override activated for 3 seconds. The autopilot was then intentionally disconnected, and as the speed started to reduce to the selected speed of 200 kt, the autothrottle began to increase the throttle lever angle, reducing the rate of descent. The crew then reduced the selected speed to 185 kt. This resulted in the autothrottle increasing the thrust further and the aircraft started to climb.
