Near grounding of *Rosco Poplar*

Bond Reef, Hydrographers Passage, Queensland on 4 May 2022

ATSB Transport Safety Report

MO-2022-005

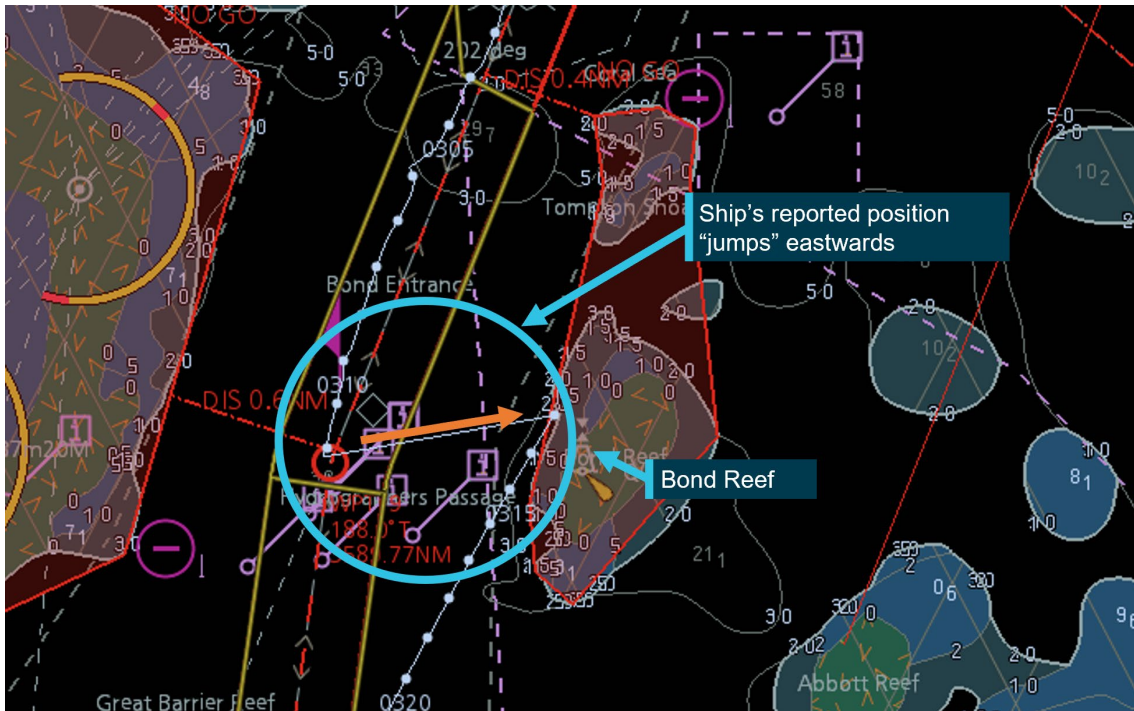
Figure 5: *Rosco Poplar's* track, as displayed on the ship's ECDIS

The pilot noted that the PPU and ECDIS displays both showed that the indicated position had suddenly shifted and said to the master 'captain, your waypoint is off; we were here, now suddenly we are here – that's why we were looking at this light'. While the ship remained on a heading of 205° to return to the planned route, the pilot, master and second mate discussed the error.

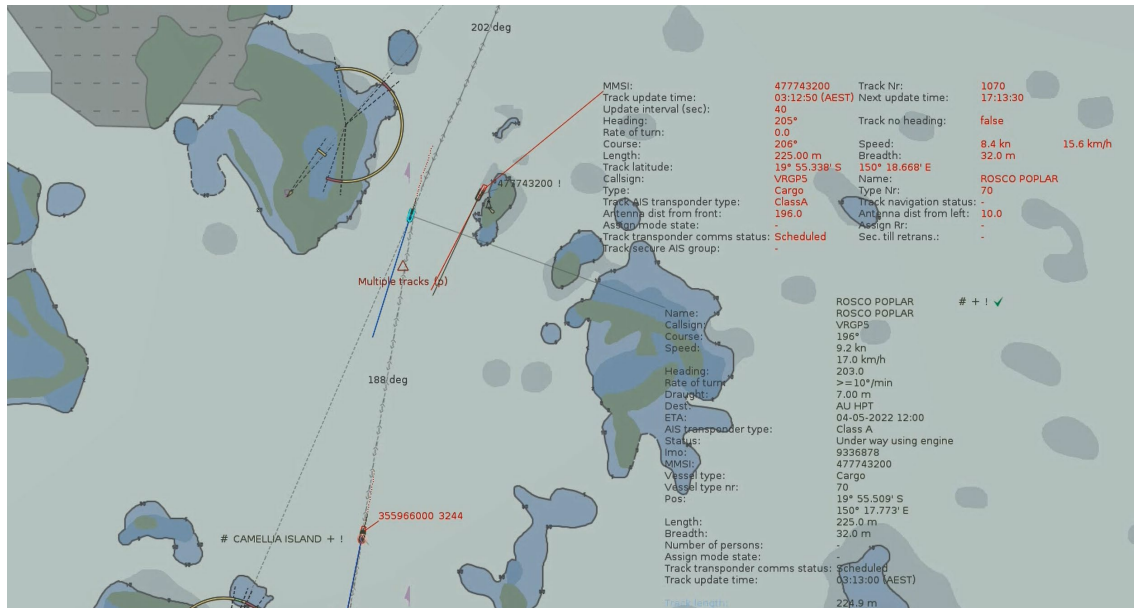
Figure 6: Rosco Poplar's track information at 0313, as displayed at REEFVTS

Meanwhile, at 0313 a series of alerts, including a potential grounding alert, were generated by the REEFVTS decision support tool (DST)⁷. The duty vessel traffic service operator (VTSO) noted that these alerts were associated with multiple dead reckoning (DR) targets for *Rosco Poplar* (Figure 6). The VTSO assumed this was due to a DST system error. The VTSO checked the ship's displayed position and track to determine if intervention was required.

At 0313, the VTSO noted that the ship's position had suddenly shifted close to Bond Reef, after which it had started tracking away from the reef. The VTSO decided against calling the pilot/ship's crew and began investigating the suspected DST system error. From about 0321, the VTSO made several internal calls to Gladstone VTS and others, which seemed to confirm a possible system error. At 0330, the VTSO started calling the ship (on VHF channel 11) but could not establish contact until 0336 (on VHF channel 14). In the subsequent discussion with the pilot, it was confirmed that the ship had in fact passed close to Bond Reef.

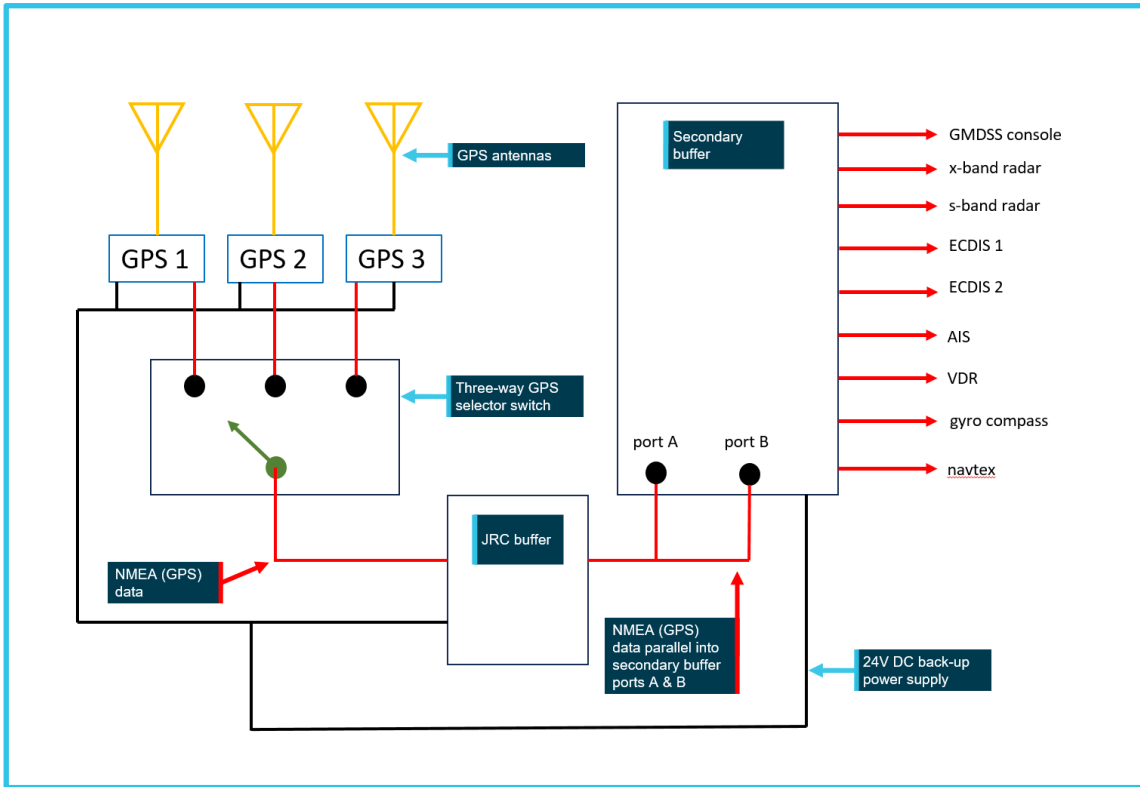
Figure 8: Diagram of bridge equipment configuration

While the secondary buffer was equipped with dual data input ports, the single data output from the JRC buffer had been split into 2 parallel outputs, which were then connected to each port. This configuration meant that all the ship's navigational equipment derived a single source of positional data from the GPS unit selected via the 3-way switch at that time.

While in Australia, the ship's bridge navigational system was updated by shore technicians with new GPS units and a reconfigured wiring system to interconnect the electronic navigational aids. The update facilitated multiple GPS inputs for the different aids, providing greater redundancy in the event of single GPS unit failures.

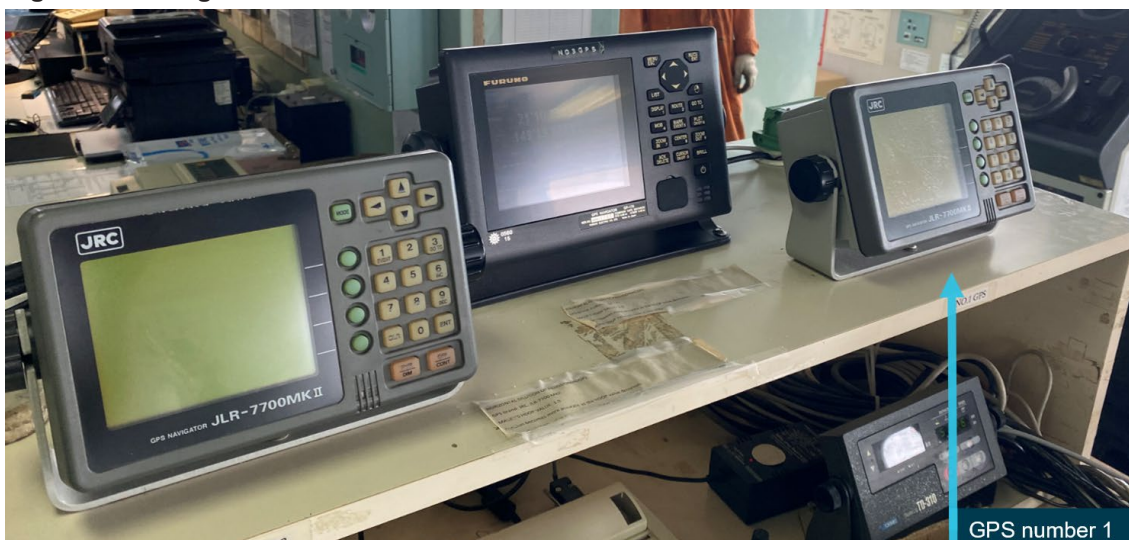
Figure 9: Arrangement of the GPS units

The master and second mate both reported that 'GPS 1' was selected during the pilotage, this being one of the JRC units (Figure 9). Due to the location of the 3-way switch, files obtained from the VDR and ECDIS following the occurrence were unable to provide GPS source information necessary for confirming which of the 3 GPS units was selected during the pilotage.

The JRC units consisted of a JLR 7700MKII differential GPS, paired with a JLR 4331 differential GPS-capable antenna. The manufacture of both the GPS and antenna were discontinued in 2012, and with spare parts no longer available for some time before the occurrence, were considered obsolete. In January 2022, the ship's management company decided to replace the JRC units during the ship's call at Hay Point.

The GPS units' manufacturer, JRC, advised that the likely cause of the error was an internal failure related to the antenna of the selected GPS unit. From the time the GPS unit began to malfunction until 0312:15, when the GPS position was lost, the unit continued to send processed data of invalid position, without updating the accuracy information. Hence, the invalid position data did not generate any positional error alerts on the GPS unit, which would also have triggered alerts on connected navigational aids. It was not until the GPS position was lost that the ECDIS units started displaying that the GPS unit had regressed to dead reckoning mode (to indicate that it had reverted to estimating position based on the ship's heading and log speed). The exact reason why the GPS unit did not detect the positional error could not be determined due to the limited available data.

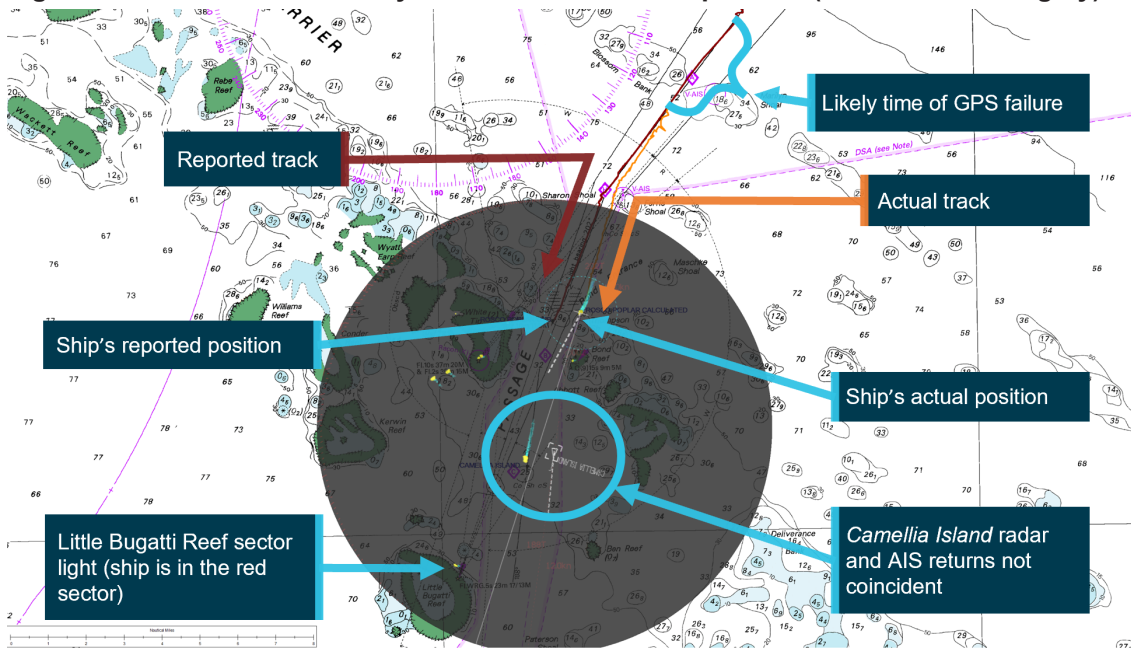
Figure 12: Position indicated by GPS at 0305 vs actual position (radar overlaid in grey)

Following the occurrence, the ATSB reconstructed *Rosco Poplar's* actual track during the approach to Bond Reef using the ship's x-band radar display images recorded by the VDR with corresponding navigational chart features in the vicinity (Figure 12).

From the approximate time at which the GPS unit began providing inaccurate positional data, until the loss of GPS signal altogether at 0312:15, the ship's actual position deviated approximately 0.92 miles (1,704 m) from the position indicated by its GPS. The invalid position placed the ship on the planned 202° (T) track rather than indicating its actual position, with the deviation gradually increasing over this period as the ship actually made good a course of approximately 195° (T) (Table 1).

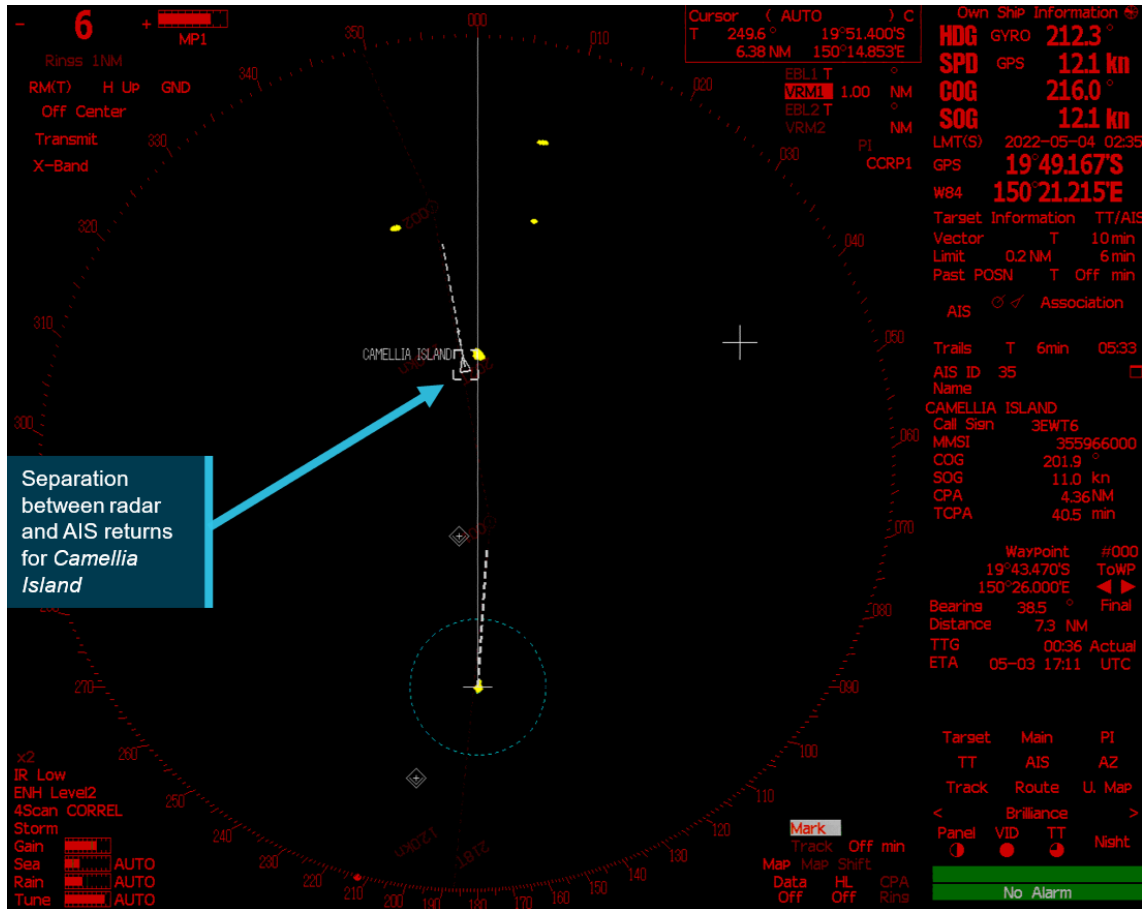
Figure 13: Radar image at 0235

Following the completion of the waypoint input, and returning the radar to active mode, the radar image captured at 0234:52 showed a separation of *Camellia Island's* radar return from its reported AIS position, indicating that the selected GPS unit was no longer providing an accurate position (Figure 13). This separation gradually increased and the ship began to deviate from the planned route towards Bond Reef beacon (visible on the radar display) as the pilot's heading orders were based on the erroneous position and track displayed on the ECDIS and PPU. Assessment of the ship's reconstructed actual track indicates that by about 0256, it had deviated far enough from its planned track to be within the red zone of Little Bugatti reef sector light ahead.

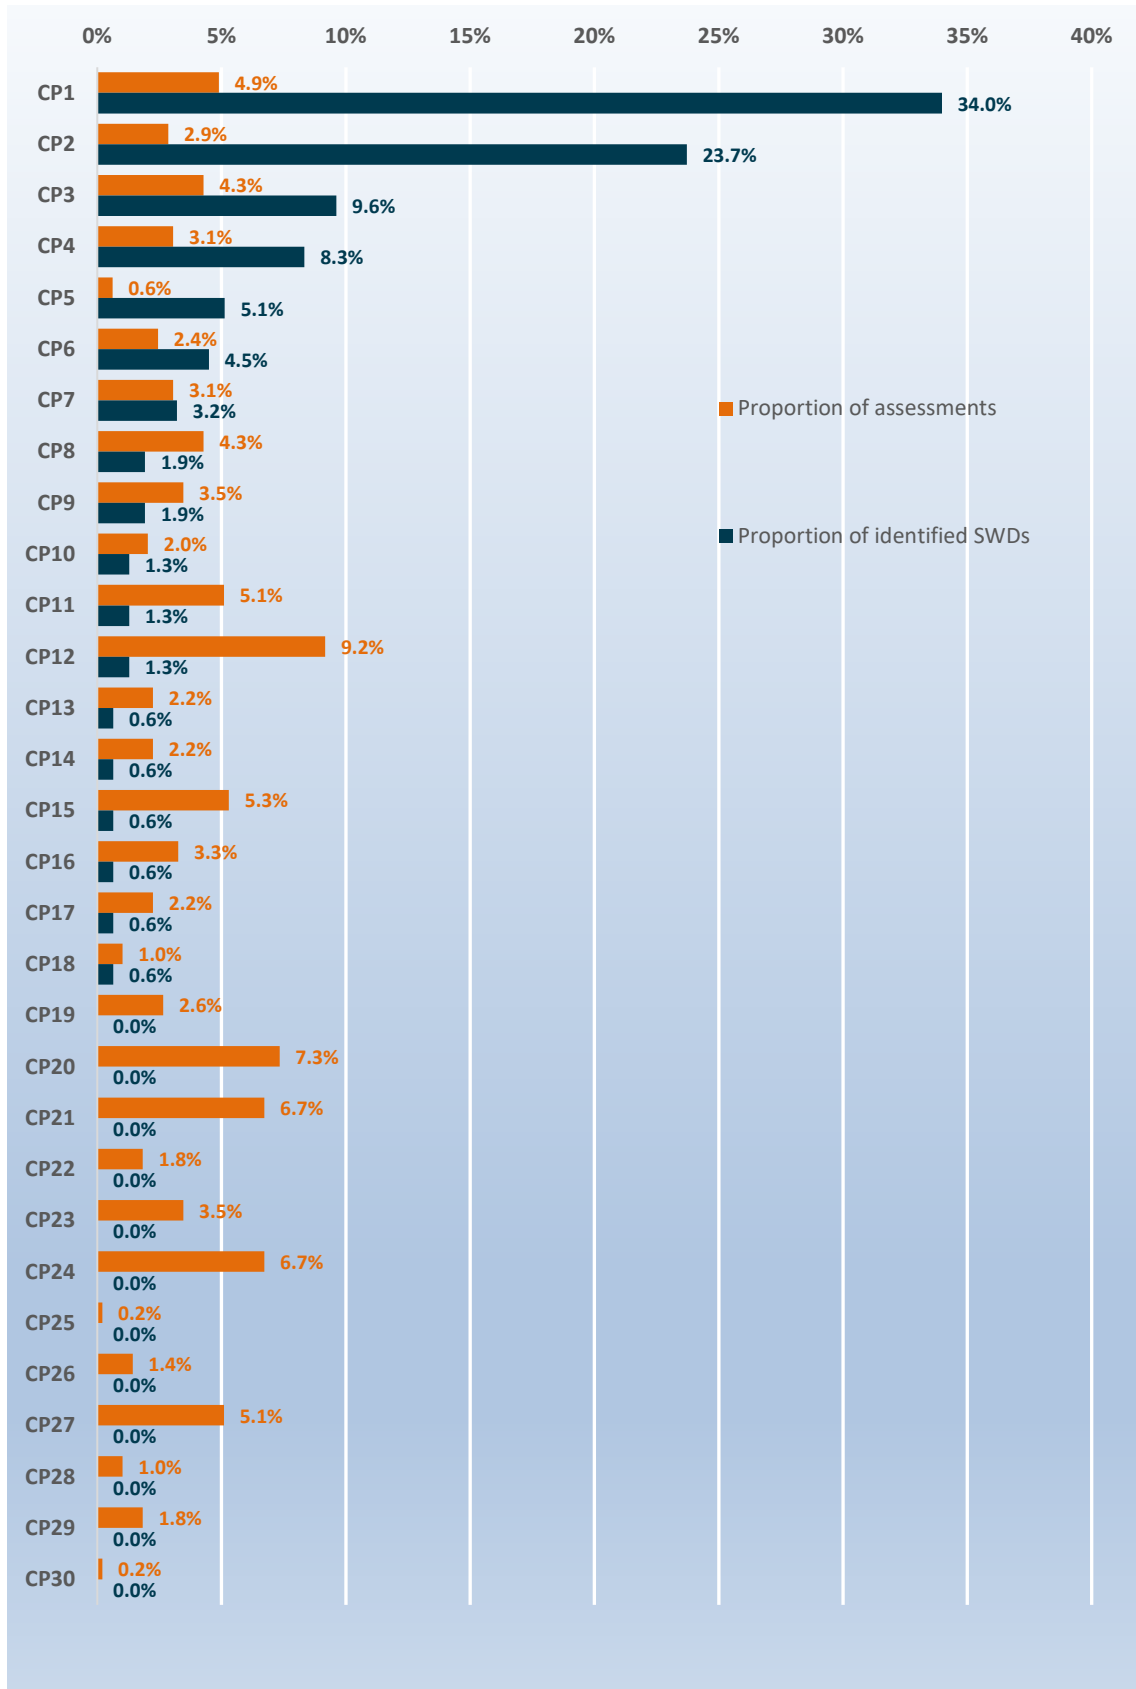
Figure 16: Proportion of deficiencies identified by each check pilot

- Two (2) check pilots (from different pilotage providers) conducted 7.7% of the total number of assessments and accounted for 58% of the total deficiencies identified.
- Eight (8) check pilots conducted 25% of the total number of assessments and accounted for 90% of the total deficiencies identified
- Twelve (12) check pilots conducted 32% of the total number of assessments and never identified any deficiencies

The ATSB applied the Kruskal-Wallis⁴⁶ test to the data to determine whether there was a statistically significant difference between the application of assessments between individual check pilots. This test showed that the probability of obtaining the distribution of such assessment results by random chance alone would be less than 1 in 10,000. That is, the distribution was likely influenced by differences in how individual check pilots conducted their assessments.

The ATSB issued a safety recommendation to AMSA to address factors limiting the effectiveness of its check pilot framework as a system for coastal pilot competency assurance.
