# Level crossing irregularities, involving freight train 3PM7

Werribee, Victoria, on 4 December 2020

**ATSB Transport Safety Report**  
Rail Occurrence Investigation (Systemic)  
RO-2020-020  
Final – 16 August 2024

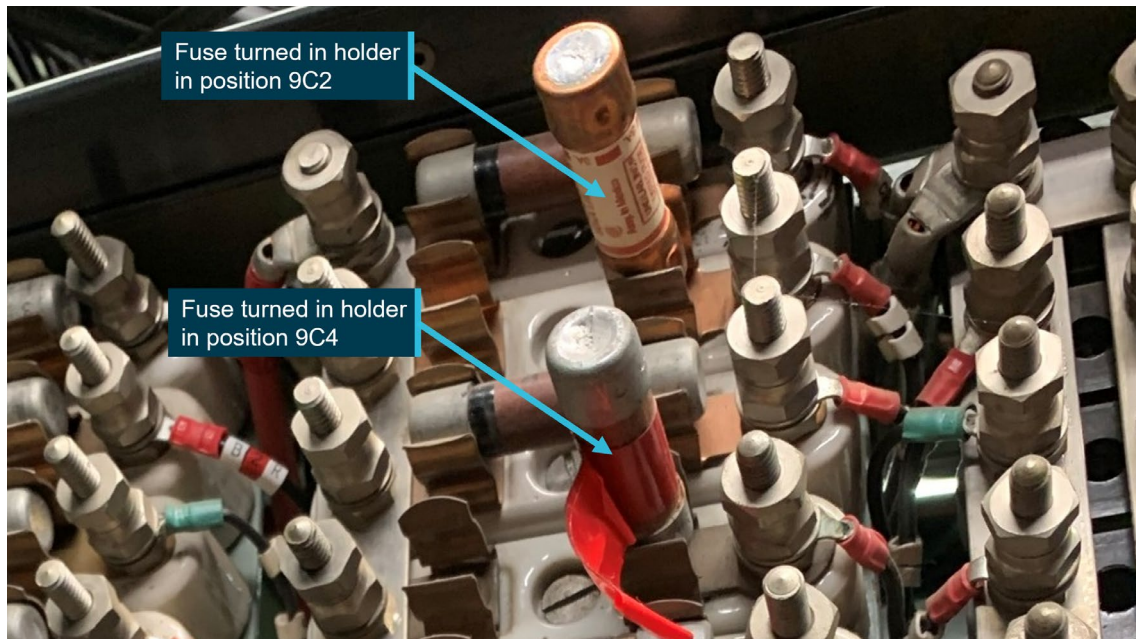
**Figure 2: The probable state of fuses removed on the night of 29 November**

On the night of 29 November, the Werribee relay room was powered down<sup>4</sup> and the temporary circuit configuration installed. Fuses 9C2 and 9C4 were disconnected by them being rotated through 90° (Figure 2) and temporary jumper wires were installed (Figure 3). In total there were 4 jumper wires installed in the Werribee relay room, and 3 in location cases near the level crossings.

The temporary isolation arrangements put in place on 29 November to facilitate the operation of level crossing equipment for standard gauge trains were not removed when the power was restored to the relay room following the changeover of circuits. The temporary jumper wires and disconnected fuses 9C2 and 9C4 remained as they were.

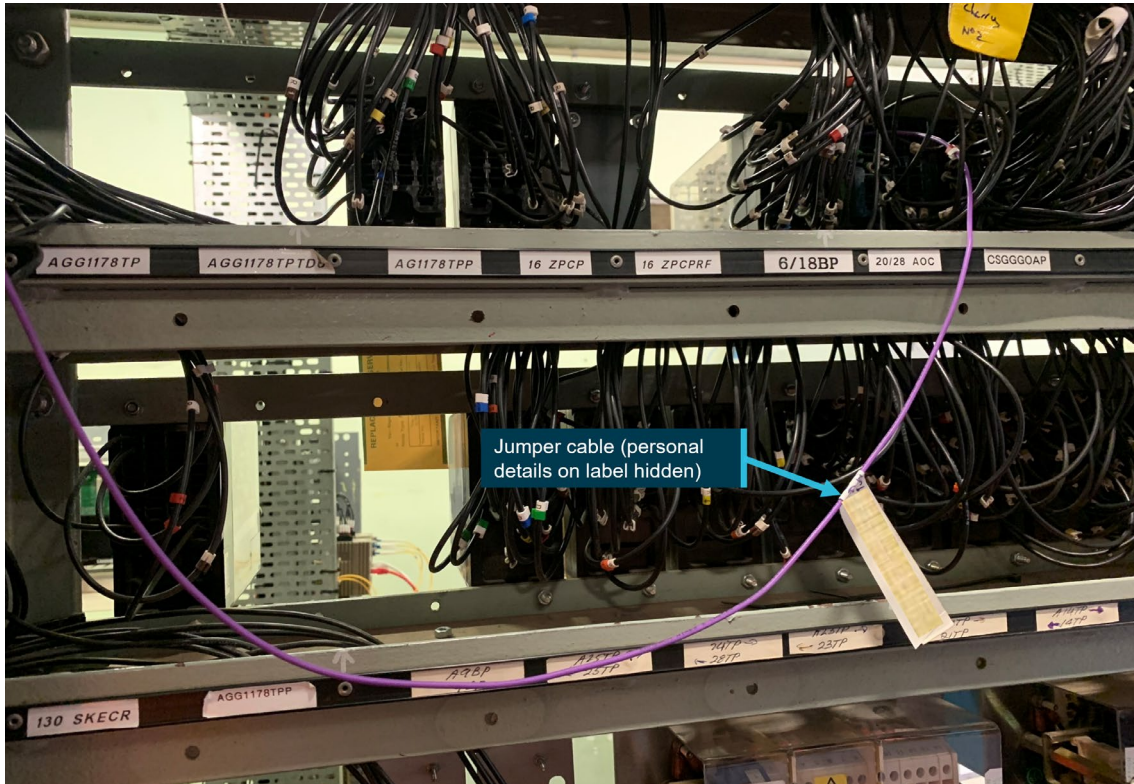
**Figure 3: One of the jumper wires installed in the Werribee relay room on 29 November**

The jumper wire shown in this figure was identified as 'number 2'. Personal details on the wire label have been redacted. Source: MTM, taken on 4 December 2020, annotated by OCl.

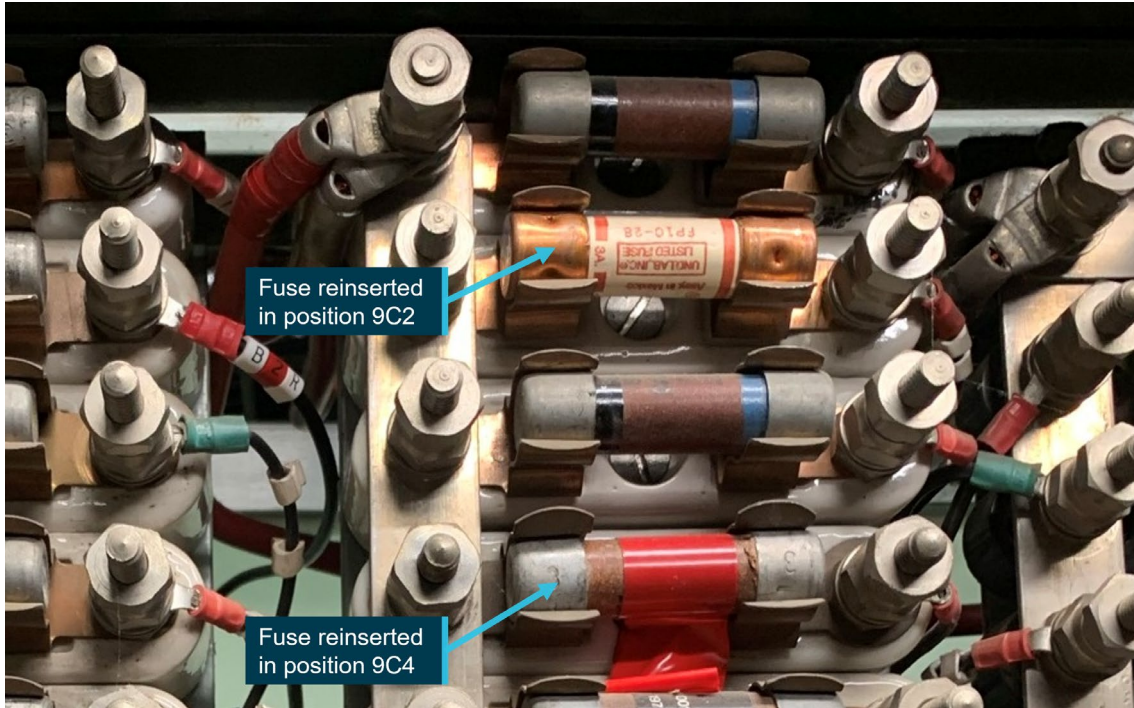
**Figure 4: Fuses 9C2 and 9C4 replaced in Werribee relay room**

The function tests involved the replacement of fuses as required to complete circuits for testing. This was normal practice. At about 0800 and following discussions with others in the project regarding the need to progress the testing of all circuits, the lead tester instructed one of the team to reinstate fuses 9C2 and 9C4 (Figure 4). The testers were not aware that several temporary jumper wires had been installed as part of the level crossing isolation arrangements.

With the jumper wires still in place, control relays remained energised when the fuses were replaced, inhibiting the operation of the level crossing equipment at both Werribee and Cherry Street level crossings.<sup>7</sup>

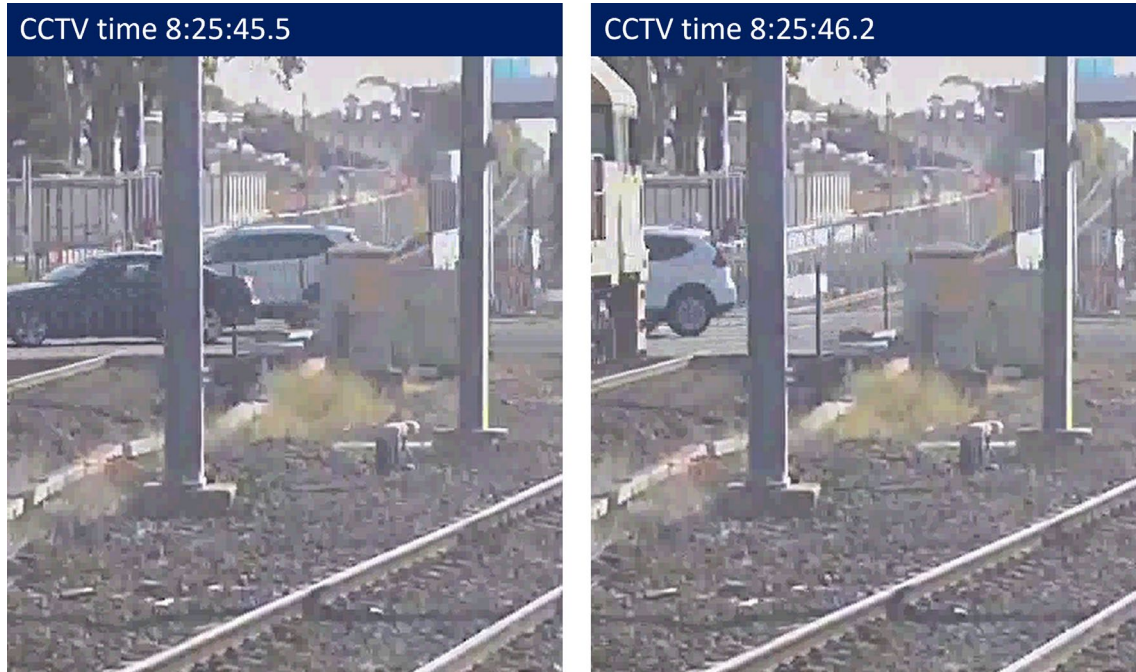
**Figure 5: CCTV images showing road vehicles on Cherry Street as train approaches**

CCTV equipment installed at Werribee Railway Station showed motor vehicles crossing on Cherry Street ahead of train 3PM7 (Figure 5). It is estimated that the cars probably cleared the path of the train less than 2 s before the train occupied the crossing (Figure 6).

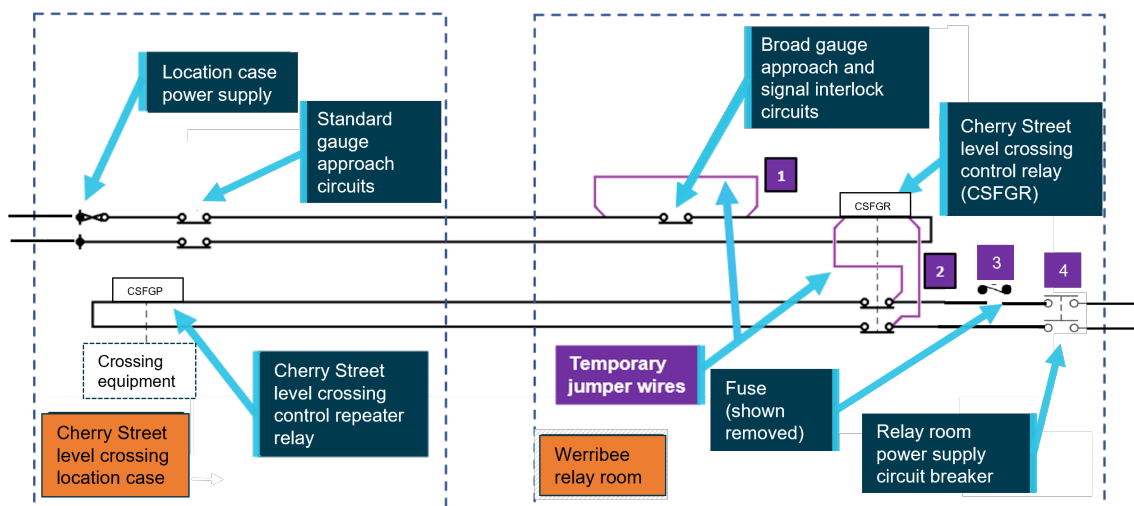
**Figure 11: Simplified representation of isolation for the Cherry Street level crossing**

Image shows a simplified representation of the level crossing circuits for Cherry Street level crossing. Temporary jumper wire number 1 was put in place to bypass the broad gauge approach and signal interlocking circuits for Cherry Street level crossing. Temporary jumper wire number 2 was put in place to accommodate the planned shutdown of the relay room power supply. Source: ATSB and OCI.

Temporary jumper wires were installed to isolate the broad gauge train detection circuits from the level crossing control circuits (label 1). During the planned shutdown of power to the relay room, the temporary jumper wire also allowed an alternative power supply (from the level crossing location case) via the control relay in the relay room to the repeater relay at the location case (label 2). The temporary modification required the removal of the power supply to the relay room by the removal of a fuse (label 3) and opening the relay room power supply circuit breaker (label 4).<sup>15</sup>
