# Collision between banking locomotives and grain train 5446

Near Werris Creek, New South Wales, on 6 January 2022

**ATSB Transport Safety Report**  
Rail Occurrence Investigation (Defined)  
RO-2022-001  
Final – 20 August 2024

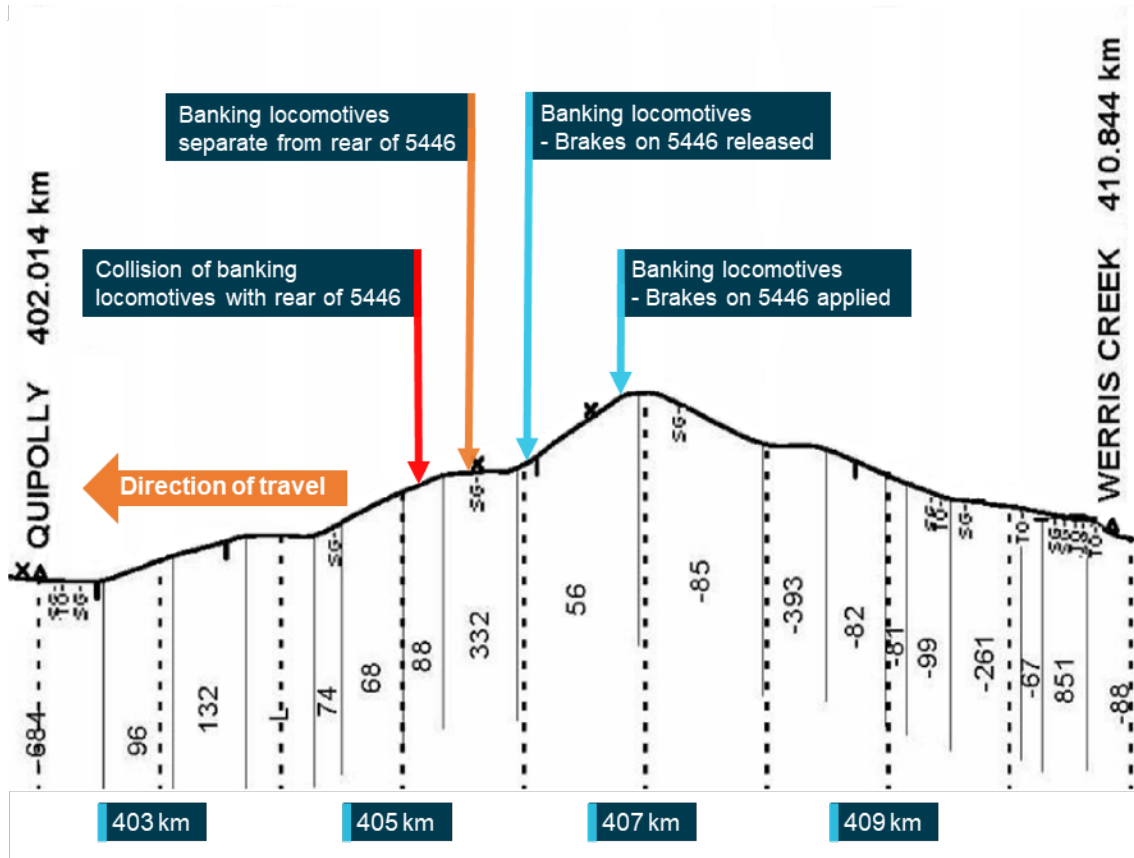
Figure 2: Track profile from Werris Creek to Quipolly

Overview of the track gradients on departure from Werris Creek, and coinciding events relating to the banking locomotives on 5446. Source: ARTC, annotated by OTSI

At 0649:09, with the train’s speed stable at 64 km/h and, coinciding with the banking locomotives tractive power being reduced to a minimum (one notch), the driver of the lead locomotive released the train’s brakes. Seven seconds later, this brake release command took effect on the banking locomotives at the rear of the train.

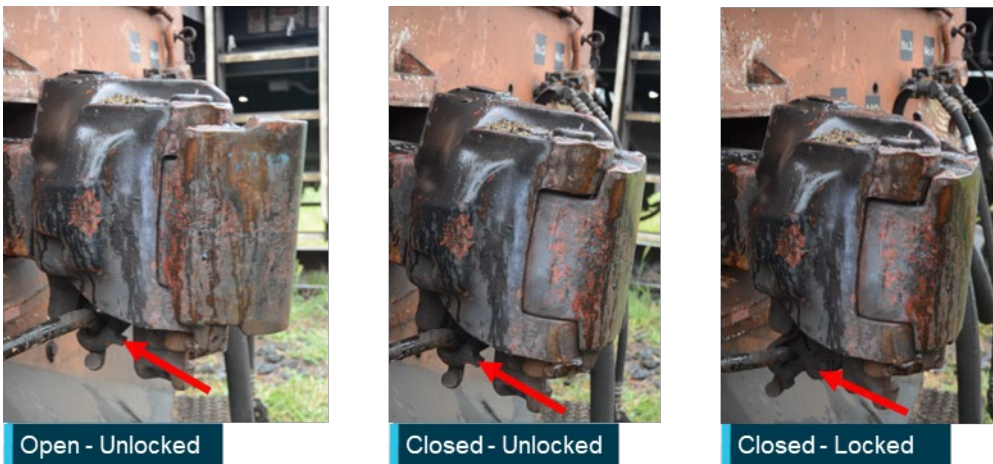
**Figure 14: Bottom lifter operated automatic coupler**

For bottom lifter operation, conversely the lifter and control rod linkage are mounted on the bottom of the automatic coupler body. As shown in Figure 14, the lifter provides almost no appreciable difference in indication of the position of the locking block, irrespective of whether it is in the locked or unlocked position. There is no reliable visual representation of the position of the locking block available for a bottom lifter operated automatic coupler.

Visual appearance of the lifter in various operational knuckle states for the bottom lifter operated automatic coupler that was fitted to locomotive L277, the accident locomotive. Note: the coupler has been bent downwards from the accident.  
Source: OTSI

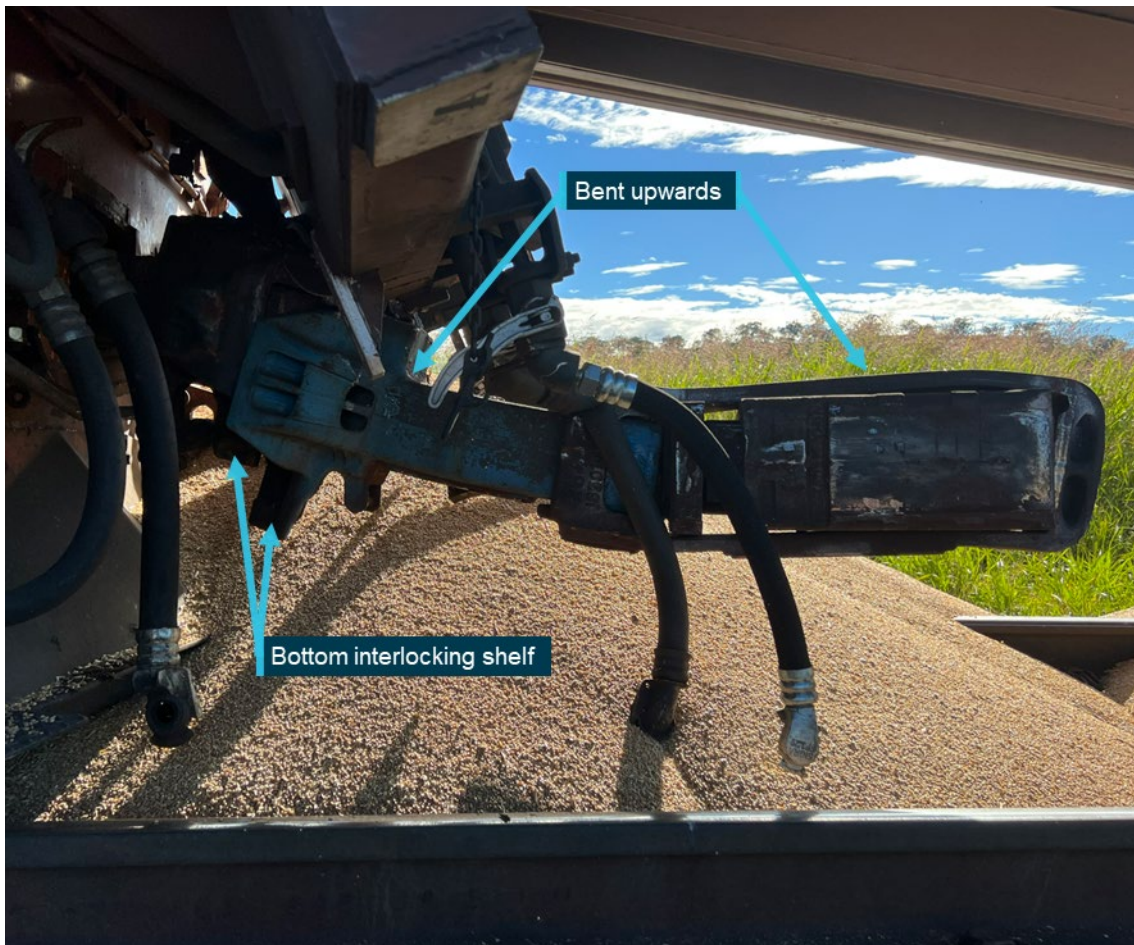
**Figure 15: Coupling between L277 and BGKF 1122F**

A review of evidence taken at the accident site was used to determine the mechanical state of the automatic couplers leading up to the accident. After the accident, the air brake hoses were found to be undamaged and disconnected consistent with separation having occurred between the banking locomotives and the rear of the train prior to the collision. The automatic couplers of locomotive L277 and BGKF 1122F were found to be coupled together and the knuckles locked (Figure 15), indicating that the physical structure of the couplers was sound and the knuckle locking mechanisms functional.<sup>22</sup> In addition, both couplers were fitted with bottom interlocking shelves, which prevented vertical disengagement of the knuckles while in transit.

*Note: Both the locomotive and wagon's brake pipe taps were closed post-accident.*  
 Source: SSR, annotated by OTSI

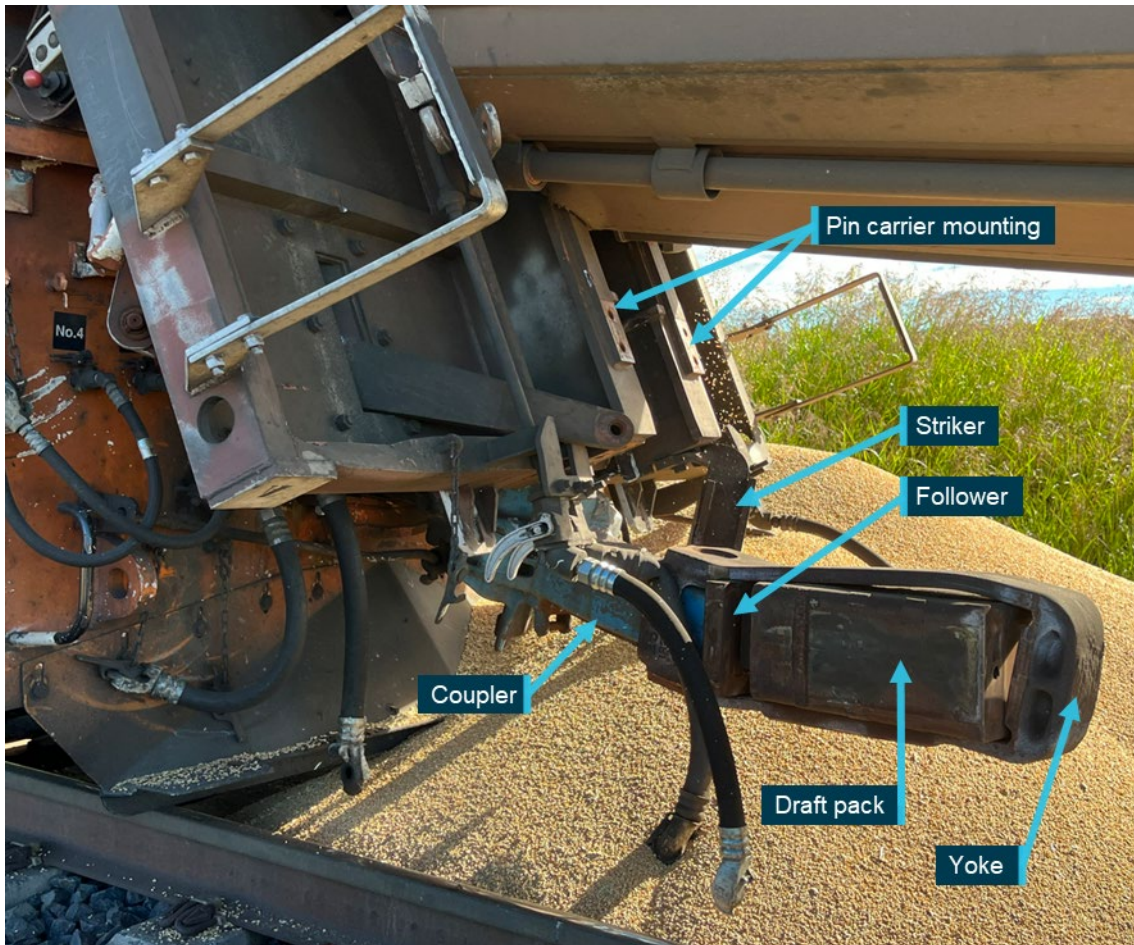
Figure 16: Wagon BGKF 1122F coupler components

All coupling components were accounted for at the accident site including the coupler, yoke pin, follower, draft pack and yoke, indicating that there had not been a catastrophic mechanical failure of the coupling mechanisms en route (Figure 16).

Finally, the bent nature of the striker, sheared-off pin carrier plate and upward bend of the coupler and yoke of BGKF 1122F, was consistent with the coupling mechanism being located within the wagon body at the time of the collision and upward lift of the wagon as it lodged into the long hood of locomotive L277.
