# Operational non-compliance involving Boeing 777-3D7, HS-TKD

15 km south of Melbourne Airport, Victoria | 24 July 2011

**ATSB Transport Safety Report**  
Aviation Occurrence Investigation  
AO-2011-086  
Final

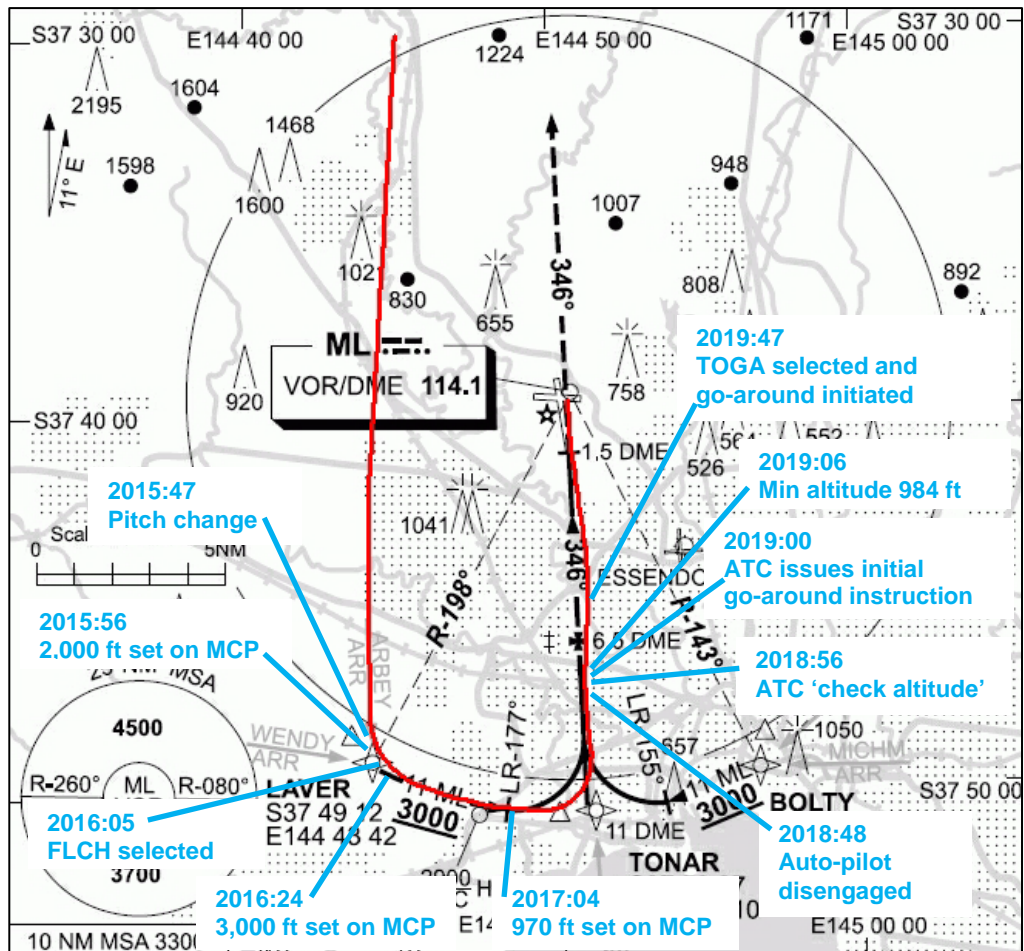
**Figure 1: Recorded track of the aircraft (in red) and key events (in blue)**

The aircraft’s track and some of the key events associated with the first approach are depicted in Figure 1. A sequence of events table listing the active AFDS modes and various altitudes during the occurrence is at Appendix B.

The flight crew's reselection of FLCH mode resulted in the aircraft commencing an unrestricted descent to 970 ft at a higher than required rate of descent. As a result, the aircraft descended below the SMSA of 1,950 ft about 3 NM (5.6 km) prior to reaching 6.5 DME. By 7.9 DME (6.4 NM (12 km) to the threshold), the aircraft had descended to an altitude of 984 ft. At that distance, based on the recommended approach profile, the aircraft should have been at an altitude of about 2,400 ft.
