Loss of separation involving a Cessna 310, VH-XXT and a Cessna 210, VH-RQD

Darwin Airport, 17 February 2012

ATSB Transport Safety Report

AO-2012-030

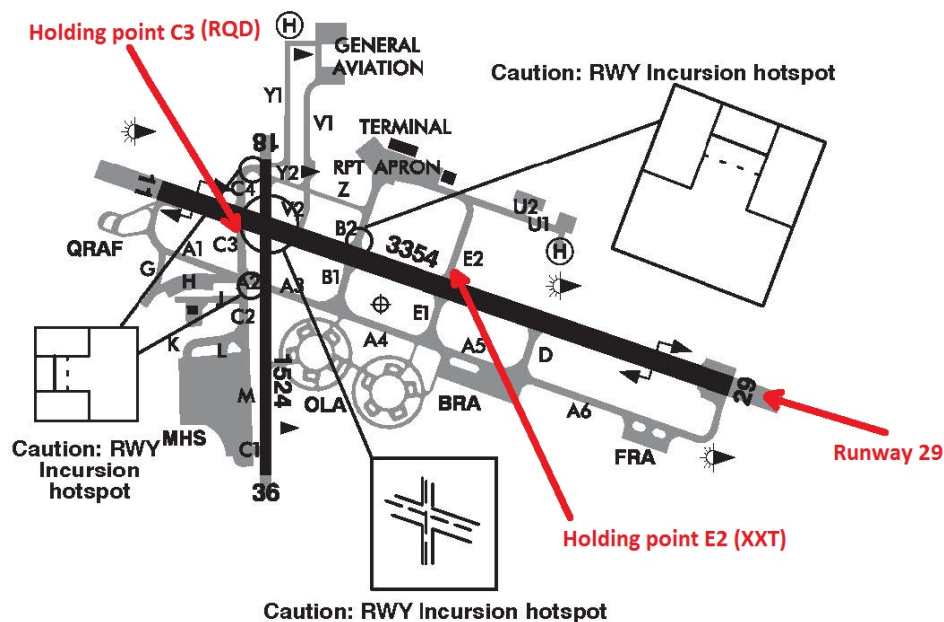
Figure 1: Darwin Airport

RQD vacated runway 18 to the left via taxiway Alpha and held short of runway 29 at holding point Charlie 3 (C3) (Figure 1), in accordance with instructions issued by the surface movement controller (SMC). At the same time, a Cessna 310, registered VH-XXT (XXT), was holding at taxiway Echo 2 (E2) for an intersection departure from runway 29.

The runways in use at the time of the incident were runway 29 and runway 18. Taxiways Charlie 1 (C1) and Charlie 2 (C2) were unavailable due to explosive ordinance loading on the military hardstand. This restriction required all landing aircraft on runway 18 to backtrack and vacate no earlier than taxiway Alpha. The extended unavailability of taxiways C1 and C2 was unusual and resulted in restrictions and coordination outside the experience of the controllers.

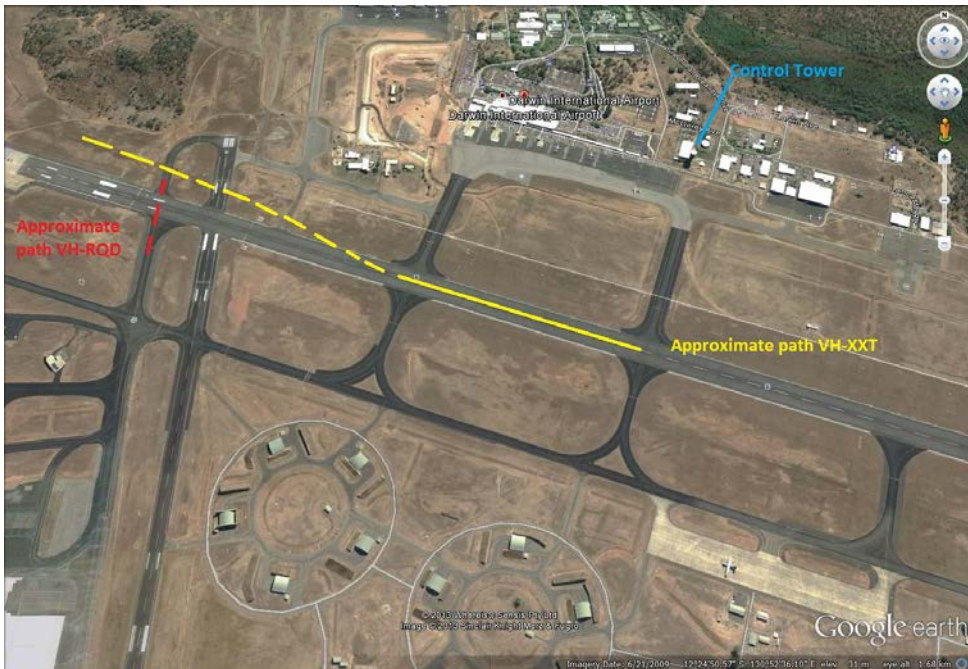
Figure 2: Approximate path VH-XXT and VH-RQD

It was estimated both visually and by radar that XXT then overflew RQD crossing the runway by between 150 ft and 500 ft (Figure 2).
