Runway loss of separation between Bombardier DHC-8-202, VH-ZZJ and Aerospatiale AS332 L1, VH-LOJ

Darwin Airport, Northern Territory, 4 September 2012

ATSB Transport Safety Report
Aviation Occurrence Investigation
AO-2012-119
Final – 23 April 2013

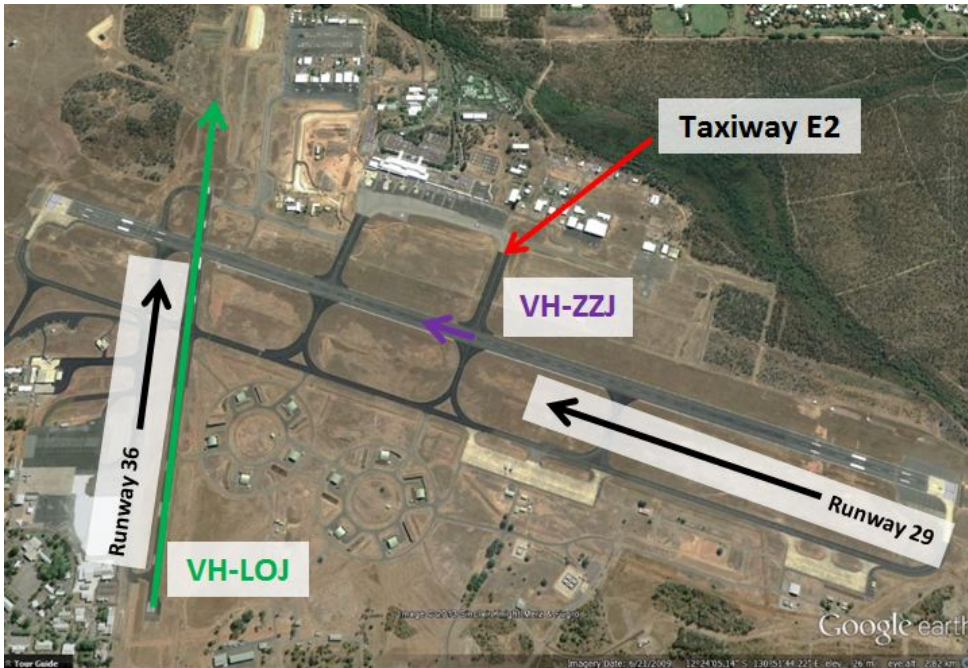
Figure 1: Track of VH-LOJ (green) and position of VH-ZZJ (purple)

Between 1440 and 1533 Central Standard Time¹, on 4 September 2012, an Aerospatiale AS332 L1 helicopter, registered VH-LOJ (LOJ), was being used to conduct flying training operations on runway 36, at Darwin Airport, Northern Territory (Figure 1). For the majority of the time, LOJ was restricted to operate south of runway 29.

At 1528, and before ZZJ had commenced the takeoff roll on runway 29, LOJ called ready on runway 36 for departure to the north. The ADC cleared LOJ for takeoff and instructed the pilot to maintain upwind. The instruction to 'maintain upwind' effectively cancelled the restriction on LOJ to operate south of runway 29 and required the helicopter to continue tracking northbound after takeoff, i.e. not to turn left or right.

The pilot of ZZJ heard the transmission and, believing that there would have been a risk of a collision if he commenced takeoff, delayed his departure until after LOJ had crossed the intersection of the two runways.
