Power loss involving Robinson R44, VH-NWD

Mount Molloy, Queensland. 11 October 2012

ATSB Transport Safety Report

AO-2012-136

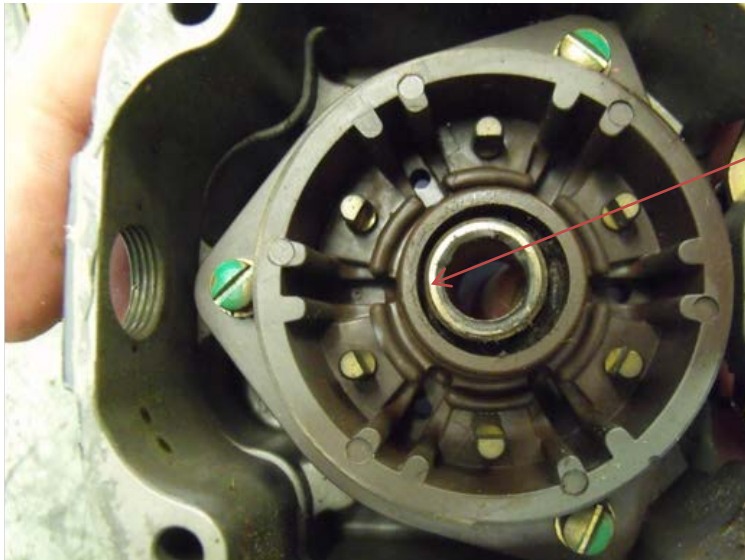
Figure 1: Left magneto distributor block

The aircraft was transported by the insurer to a contracted maintenance organisation for inspection. The magnetos were removed, inspected and checked for timing. The right magneto timing was found to be correct. The timing gear on the left magneto was found to be worn with a large amount of play. On disassembly, the left magneto was found to have a badly worn distributor block, which allowed the timing gear to move and alter the internal timing by approximately 40°.

Severe wear of bushing in distributor block.
