Runway excursion involving Piper PA-39, VH-MMN

Innamincka Township (ALA), South Australia, 26 October 2012

ATSB Transport Safety Report
Aviation Occurrence Investigation
AO-2012-145
Final – 27 February 2013

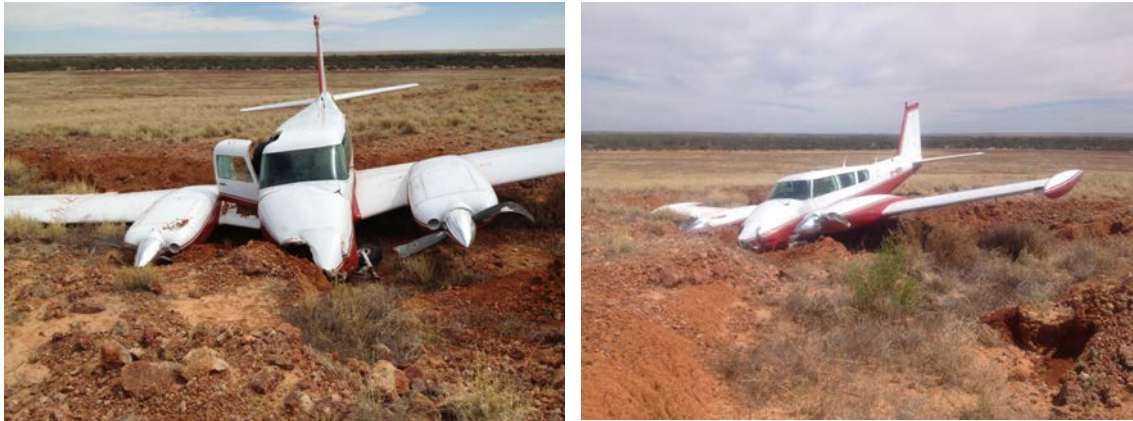
Figure 1: VH-MMN

When the aircraft was about half way along the runway, the pilot realised that the aircraft's speed was too fast and he applied full braking. The pilot determined that it was too late to commence a go-around. He reported that the braking appeared to be ineffective due to the surface of the runway and the aircraft continued beyond the runway end. The left landing gear struck a depression, and then the aircraft spun to the left and came to rest in a 1 m deep gully. The pilot and passenger exited the aircraft and the aircraft sustained serious damage (Figure 1).
