# Controlled flight into water involving Robinson R22 VH-HOA

89 km NNW of Innamincka (ALA), South Australia, 31 October 2012

**ATSB Transport Safety Report**  
Aviation Occurrence Investigation  
AO-2012-146  
Final – 27 February 2013

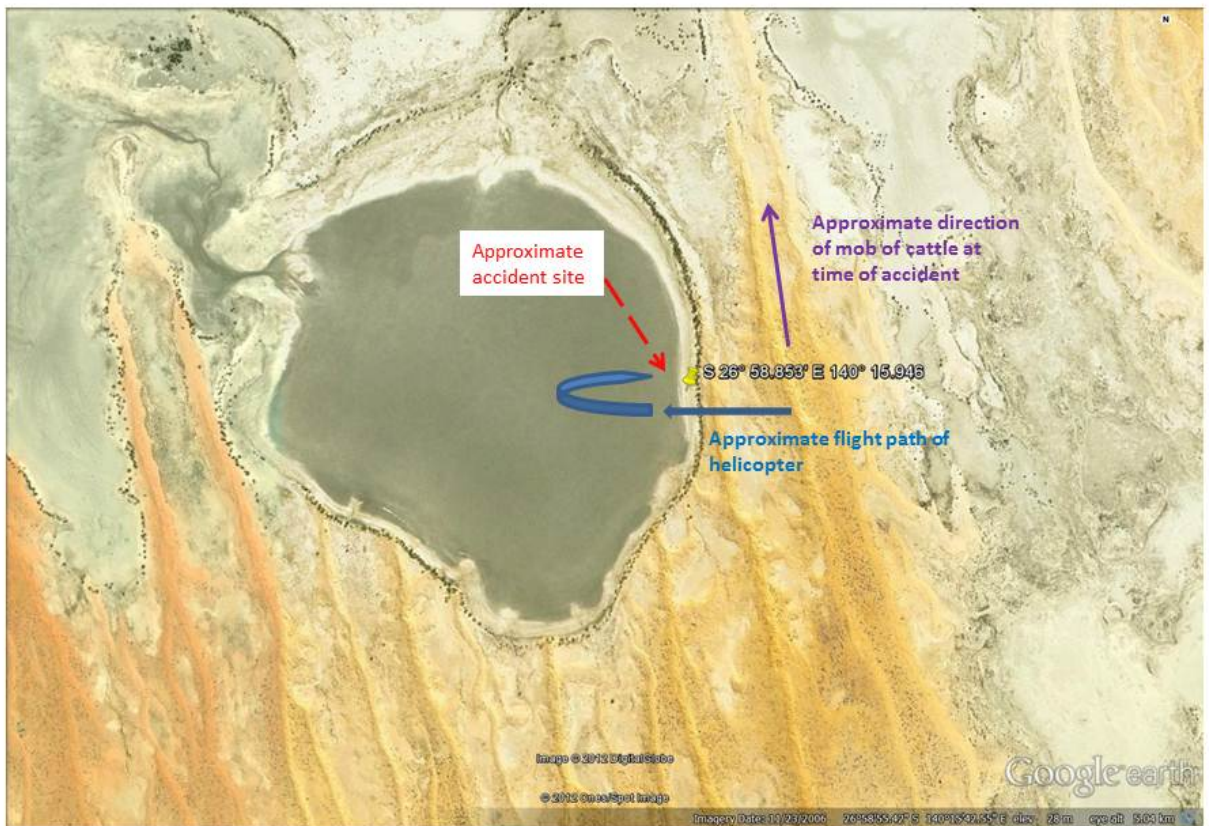
**Figure 1: Accident site – Lake Marradibbadibba**

At about 1520, HOA was traveling west at 60-70 kts between 120-150 ft above the ground. With about 19 inches of manifold pressure, the pilot conducted a turn to the east, over the edge of the lake. A few seconds later, the helicopter collided with the water and sank rapidly into 8-10 ft of water. The pilot exited the helicopter without injury and swam to shore. However the helicopter was seriously damaged.
