Pilot incapacitation event involving a Hawker B200, VH-FDT

70 km NNW of Brisbane, Queensland, 5 November 2012

ATSB Transport Safety Report
Aviation Occurrence Investigation
AO-2012-147
Final – 23 April 2013

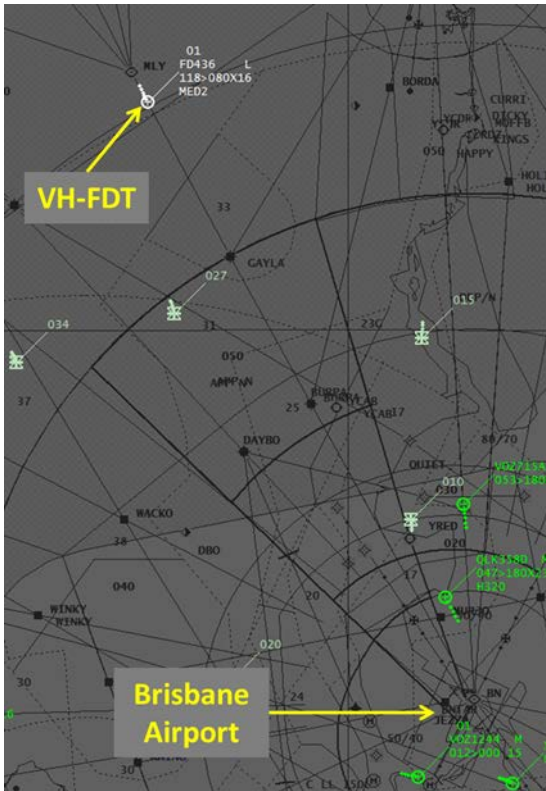
Figure 1: Aircraft position at 1556

At 1556, Brisbane Centre instructed the pilot to contact Brisbane Approach. No response from the pilot was received. At that time, the aircraft was observed on Airservices Australia surveillance data descending through FL118 (Figure 1).

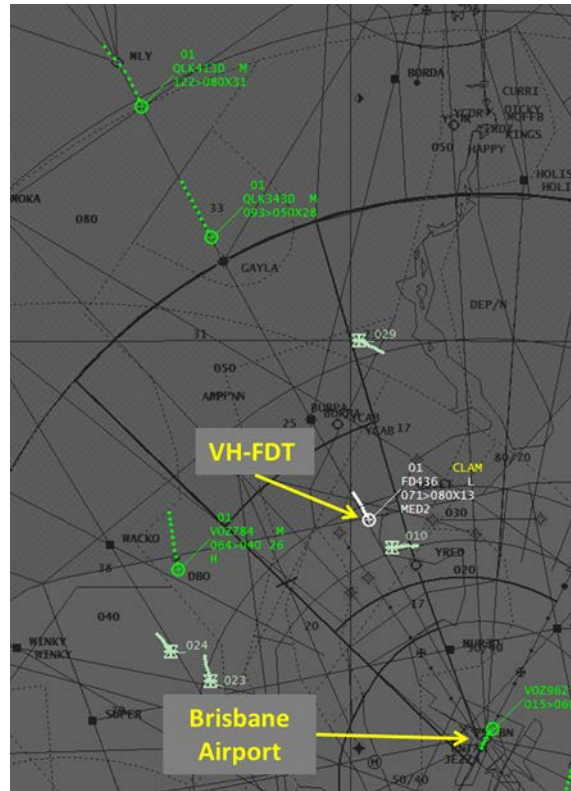
Figure 2: Aircraft position at 1607

At 1606, the Brisbane Approach controller observed FDT commencing a descent. Shortly after, the cleared level adherence monitoring (CLAM)⁵ alarm activated, indicating the aircraft had descended below the assigned level of 8,000 ft.

At 1607, the pilot contacted Brisbane Approach and established communications (Figure 2). After a number of short transmissions between the pilot and Brisbane Approach, the pilot received ATC instructions for approach sequencing into Brisbane.
