Collision with terrain involving Cessna 172N, VH-JGR

Near Kagaru Queensland, 7 November 2012

ATSB Transport Safety Report
Aviation Occurrence Investigation
AO-2012-148
Final – 21 March 2013

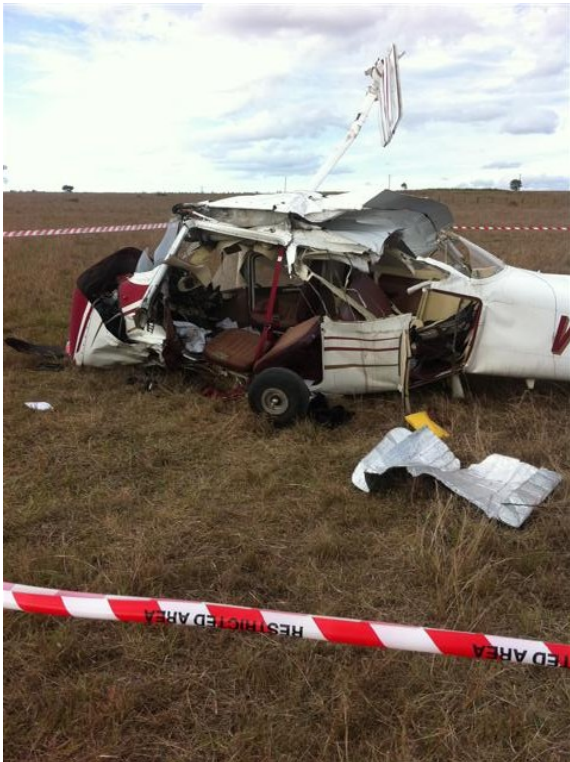
Figure 1: VH-JGR

On 7 November 2012, at about 1000 Eastern Standard Time¹ a Cessna 172N registered VH-JGR (JGR) departed Archerfield Airport, Queensland on a training flight. The purpose of the flight was to conduct solo pre-test revision, prior to the pilot performing the Private Pilot Licence (PPL) flight test. The aircraft was booked for 2 hours. During the flight, the aircraft impacted terrain and was substantially damaged (Figure 1).

A representative of the insurer attended the accident site and examined the wreckage. The insurer concluded that JGR collided with the ground at about 50-60 knots at about 60° left wing down and about 20° nose down, at a high rate of vertical descent with the engine at idle power.

In response to this accident, the flying school has amended their procedures so that a student pilot is not provided with the aircraft keys prior to the flight being appropriately authorised.
