Engine power loss involving Piper Cherokee Six, VH-TSZ

Jandakot Airport, Western Australia | 23 November 2012

ATSB Transport Safety Report
Aviation Occurrence Investigation
AO-2012-158
Final – 30 May 2013

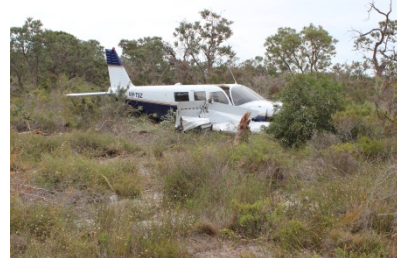
VH-TSZ accident site

With insufficient height and speed to reach the runway, the pilot force landed the aircraft into wooded bushland within the airport precinct, approximately 150 m short of a cleared area in the undershoot of runway 30. The aircraft was substantially damaged by impact with trees. The occupants exited the aircraft with only a minor injury to one passenger.

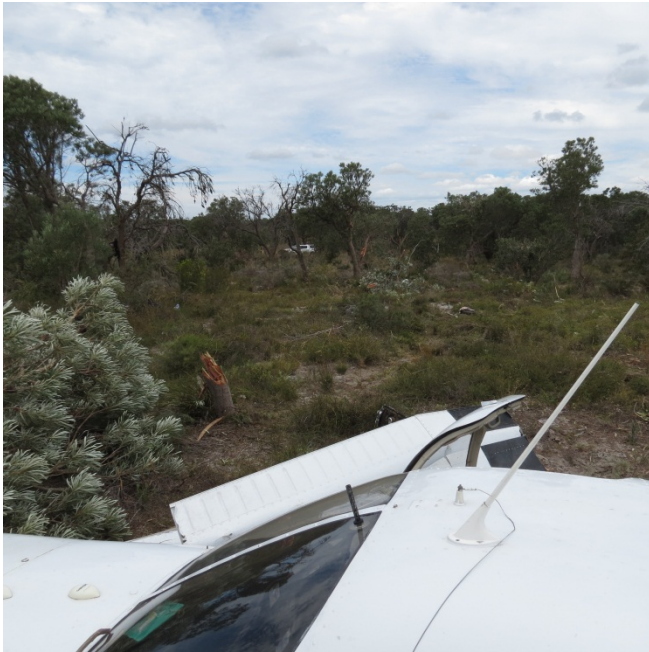
The aircraft collided with several trees, initially removing the right wingtip and then successively the right wing and nose landing gear. The aircraft then slewed right and came to rest approximately 45 m from the initial tree impact point (Figure 1). The occupants immediately evacuated the aircraft and retreated to a safe distance.

Figure 1: VH-TSZ, looking back along the wreckage trail

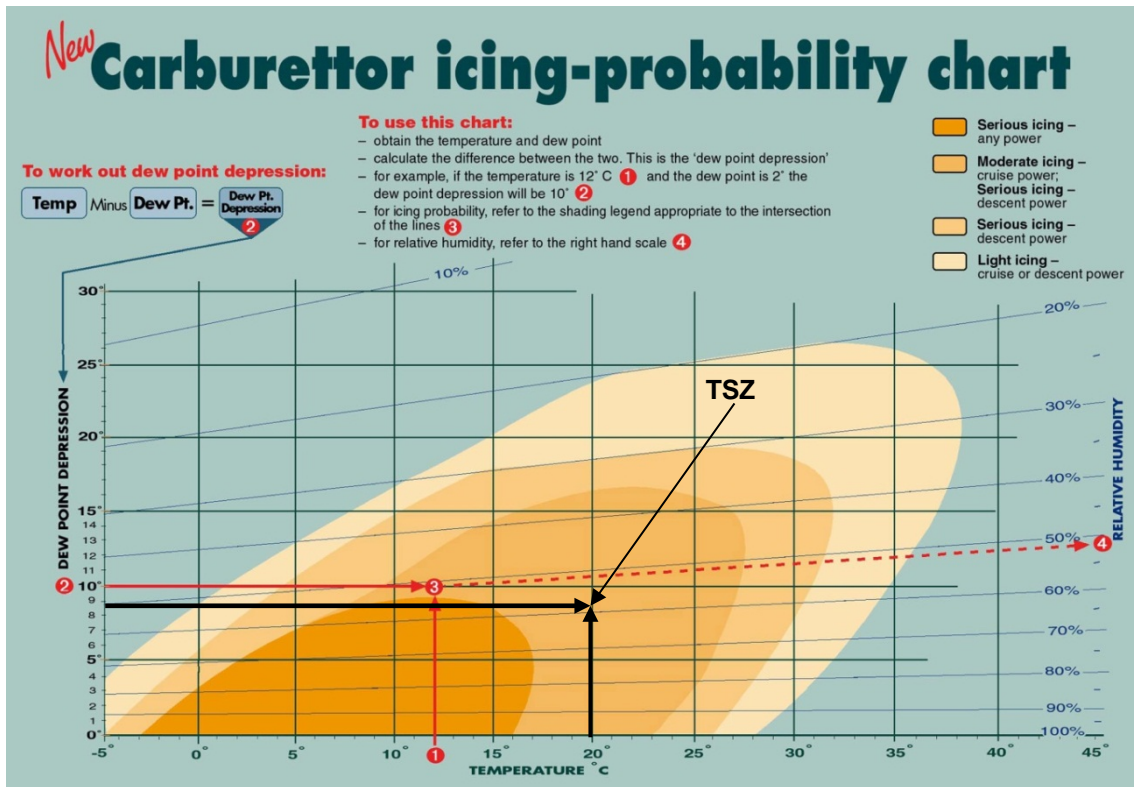
Appendix A – TSZ carburettor icing probability at departure

The temperatures were plotted on an icing probability chart (Appendix A) with a calculated dewpoint depression³ of 8.6 °C and a relative humidity of approximately 60 per cent. The charted intersection of these values placed the icing probability in the region of 'moderate icing – cruise power, serious icing – descent power'.

In considering carburettor icing, the ATSB found that the evidence was equivocal. Supporting the formation of carburettor icing were environmental conditions conducive to some degree of icing. Furthermore, the aircraft was reported to be susceptible to icing at all engine power settings, including high power. Also consistent with carburettor icing was the report from the aircraft occupants that the engine continued to operate at about idle power, indicative of a possible induction restriction as a result of ice accretion.
