Significant wind change during takeoff involving Boeing 737, VH-VZL

Perth Airport, Western Australia, 4 December 2012

ATSB Transport Safety Report
Aviation Occurrence Investigation
AO-2012-168
Final – 17 May 2013

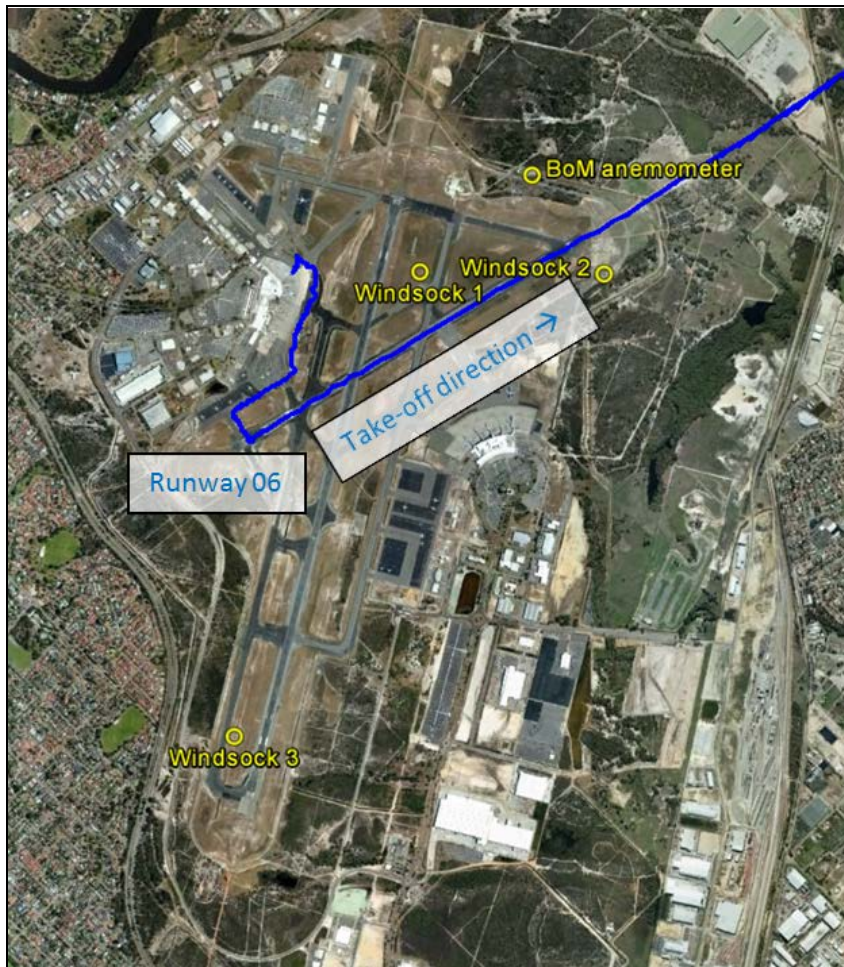
Figure 1: Take-off path and windsock locations

There were three windsocks at Perth Airport (Figure 1); however, there was no windsock near the threshold of runway 06. Before takeoff, the captain observed that windsock 1 was indicating a headwind component. The first officer also confirmed that windsock 2 was showing a headwind component. Any headwind component was acceptable for takeoff as the performance figures had assumed nil wind.

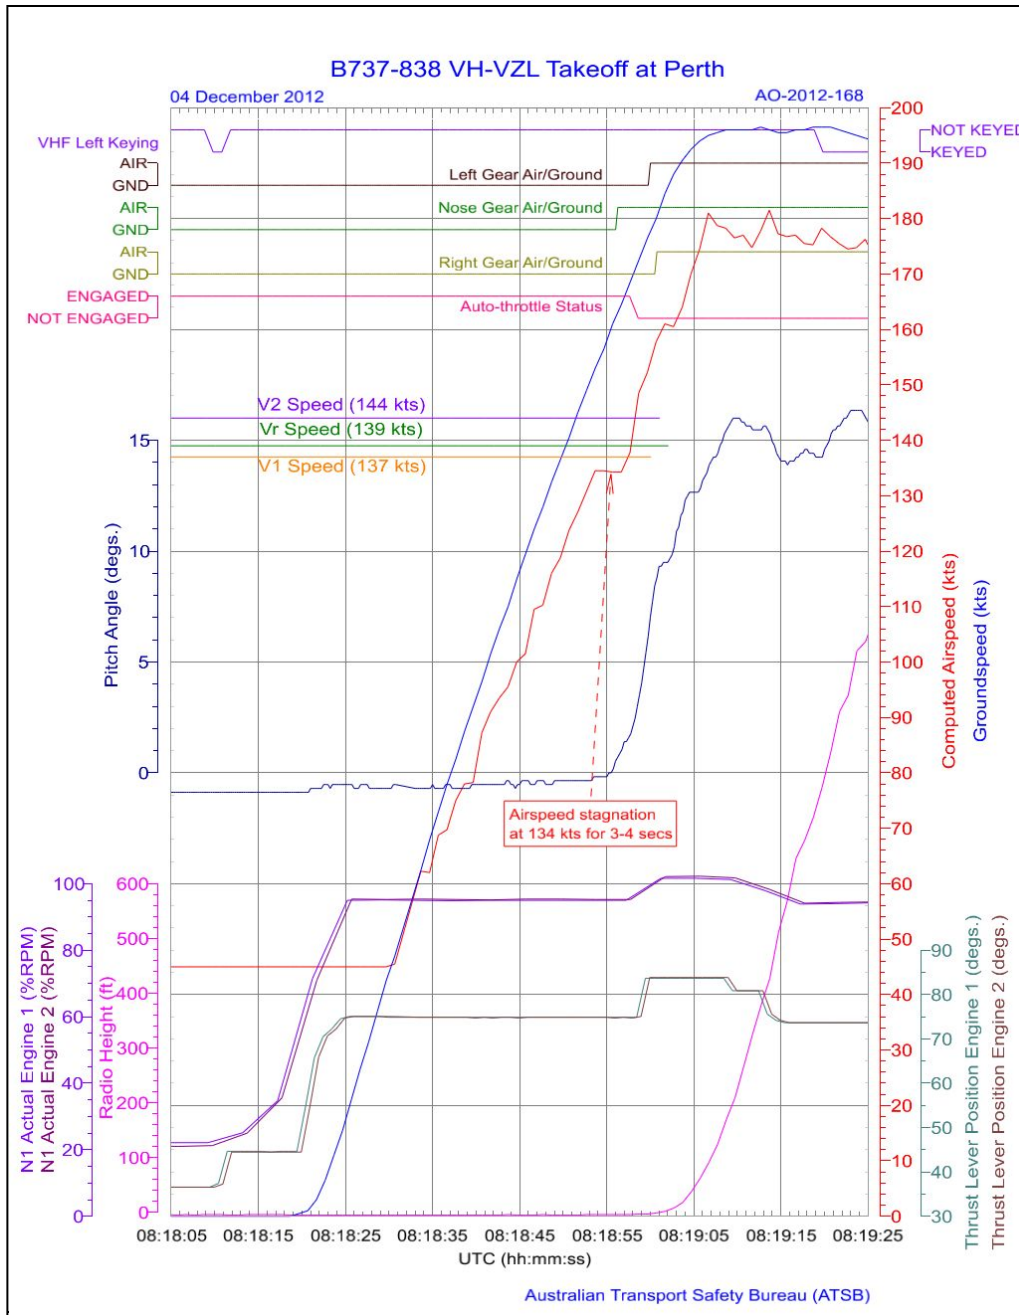
Figure 2: QAR data

Quick access recorder (QAR) data was obtained from the operator and analysed by the ATSB (Figure 2). The data showed that the airspeed stagnated¹⁴ at 134 kt for 3-4 seconds just below the V₁ speed of 137 kt, the auto-throttle was disconnected and maximum thrust was set.

Just after the aircraft became airborne, the wind was recorded at 282°T and 25 kt. No windshear warnings were recorded. Recorded latitude, longitude and radio altitude data showed that the aircraft passed over the end of runway 06 (threshold of runway 24) at a height of about 10 ft above ground level.

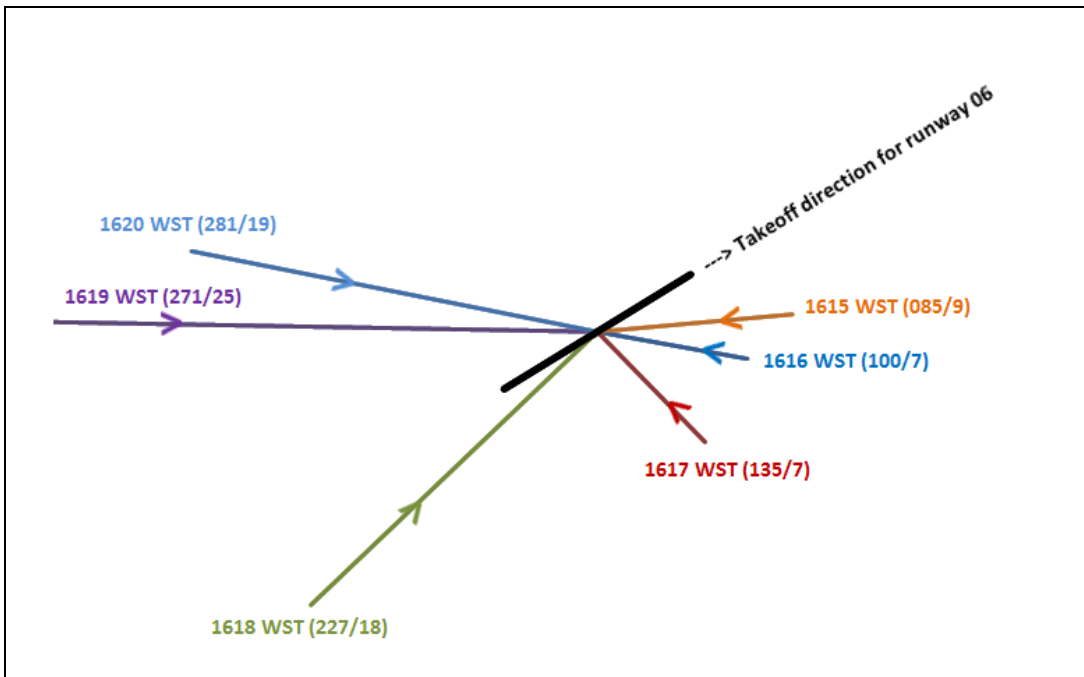
Figure 3: BoM anemometer data – maximum wind gusts

The Bureau of Meteorology (BoM) provided one minute wind readings from their airport anemometer. The anemometer was located near the northern end of runway 06 (Figure 1). The maximum wind gusts during the one minute periods around the time of takeoff are shown to scale in Figure 3. The wind direction value is averaged over a one minute period. Wind values are given in wind direction/wind speed format in units of °T/kt.

The anemometer experienced a significant wind change at 1618 that would have resulted in tailwind conditions at least near the northern part of runway 06.
